SAFE HOMES CANADA HOME INSPECTION REPORT

ADDRESS: xxx, Oro-Medonte, Ontario

DATE: January 24, 2017

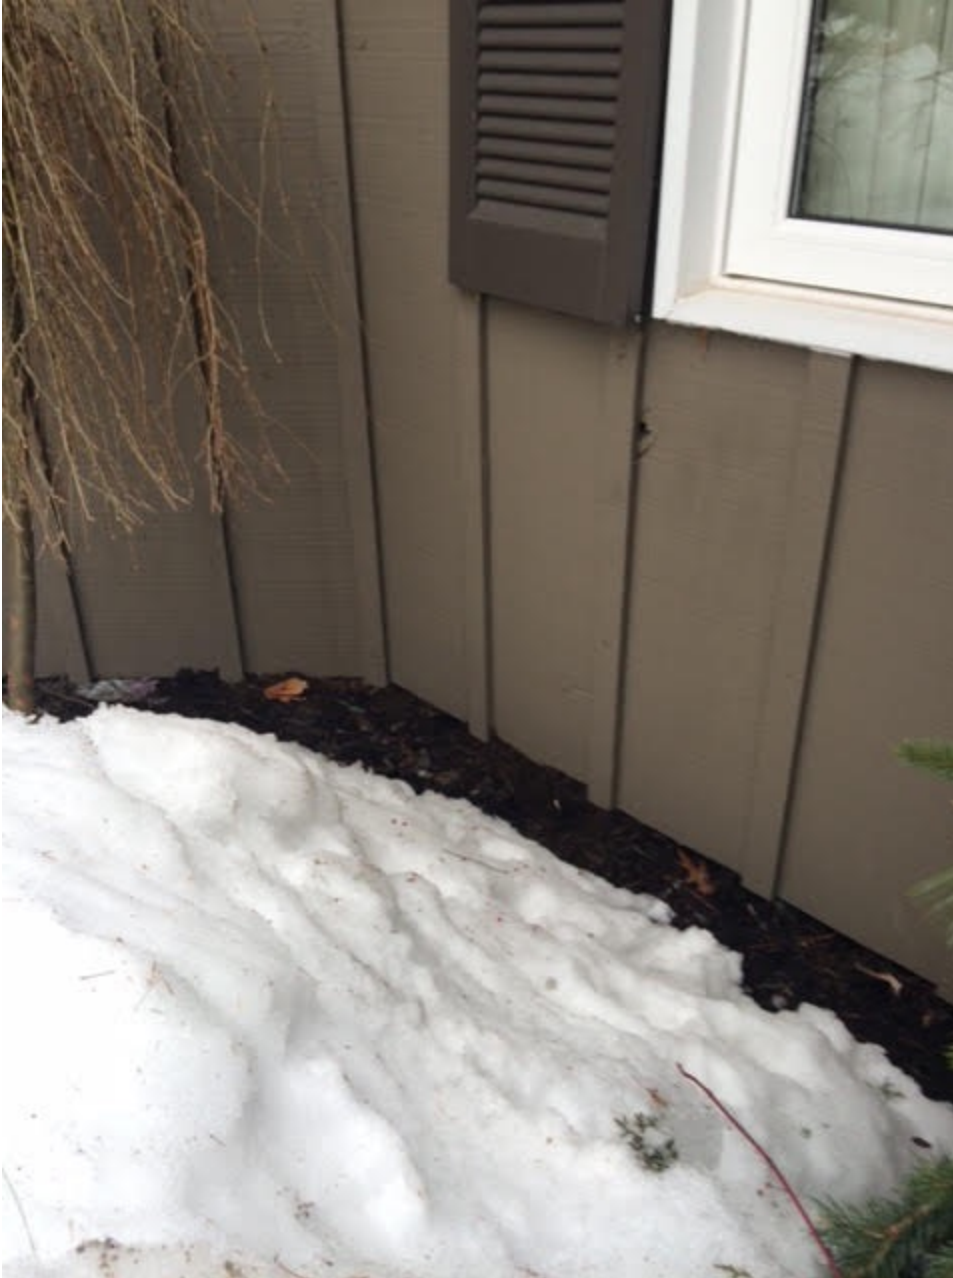
The outside face of the foundation walls are not observable at a few locations, including left of the front door where the exterior grade (garden earth) is close to the bottom of the siding, and at the locations where exterior decks are in place. (photo below)

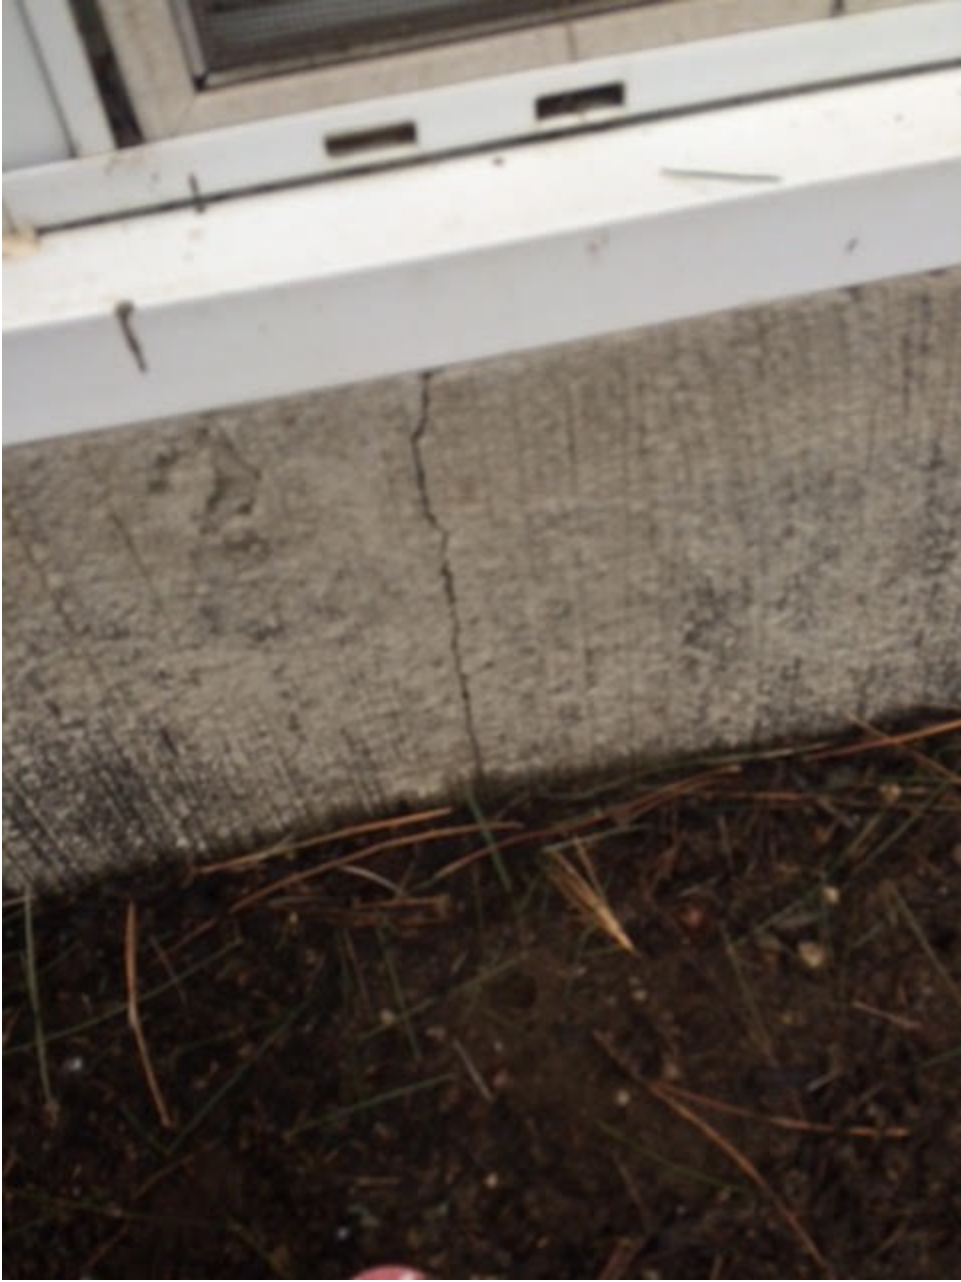
Settlement/stress cracks are observable at the left/front garage foundation wall, near the middle of the rear foundation wall, near the middle of the right foundation wall, and near the middle of the front foundation wall. (photos below)

The cracking at the foundation level is completely normal. No action is required/recommended to dig down and seal a crack.

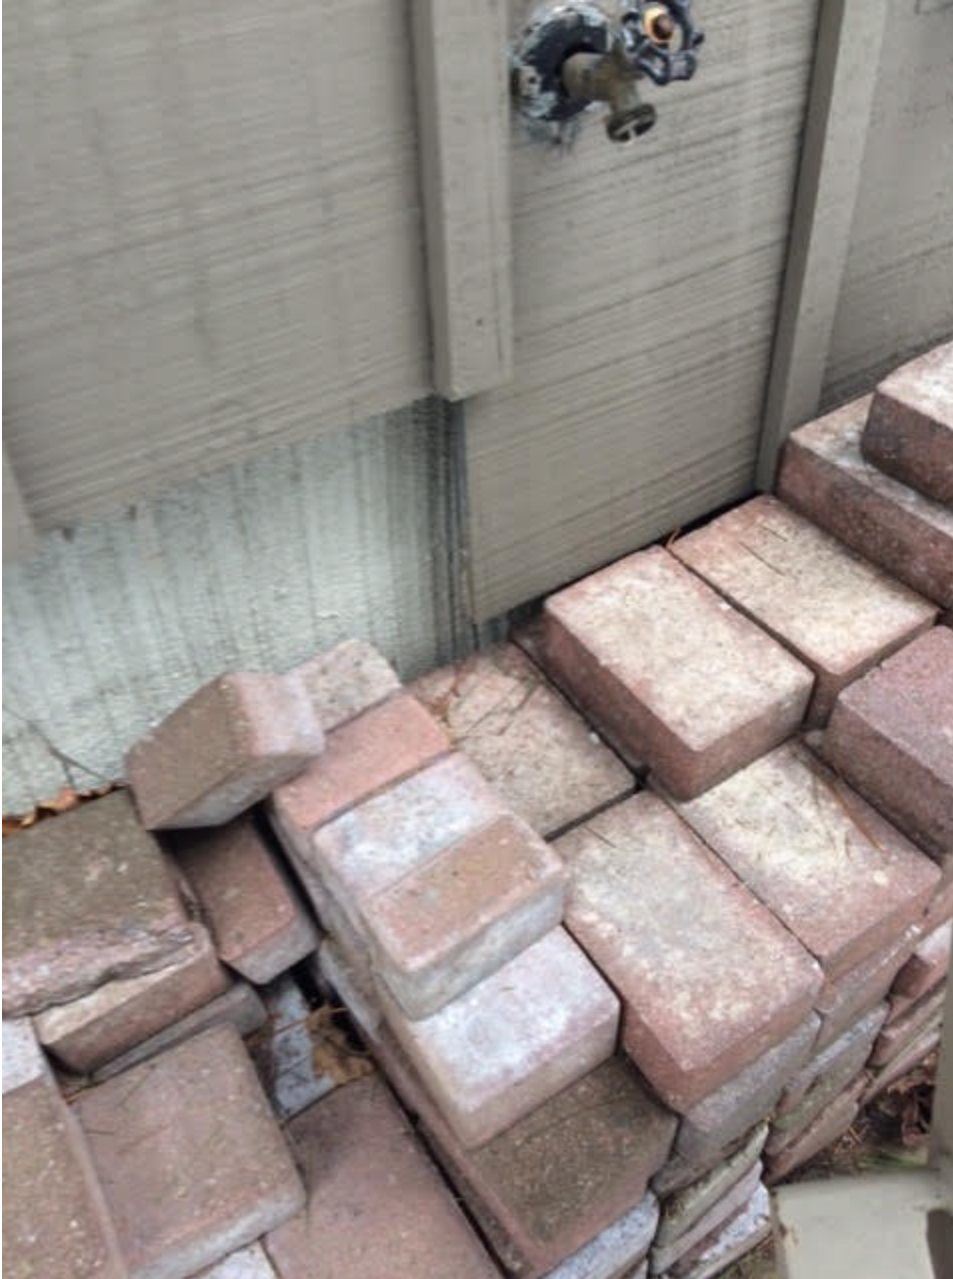
A pile of paver stone units prevents observation at the rear wall, at a possible 'step down' location. (below)

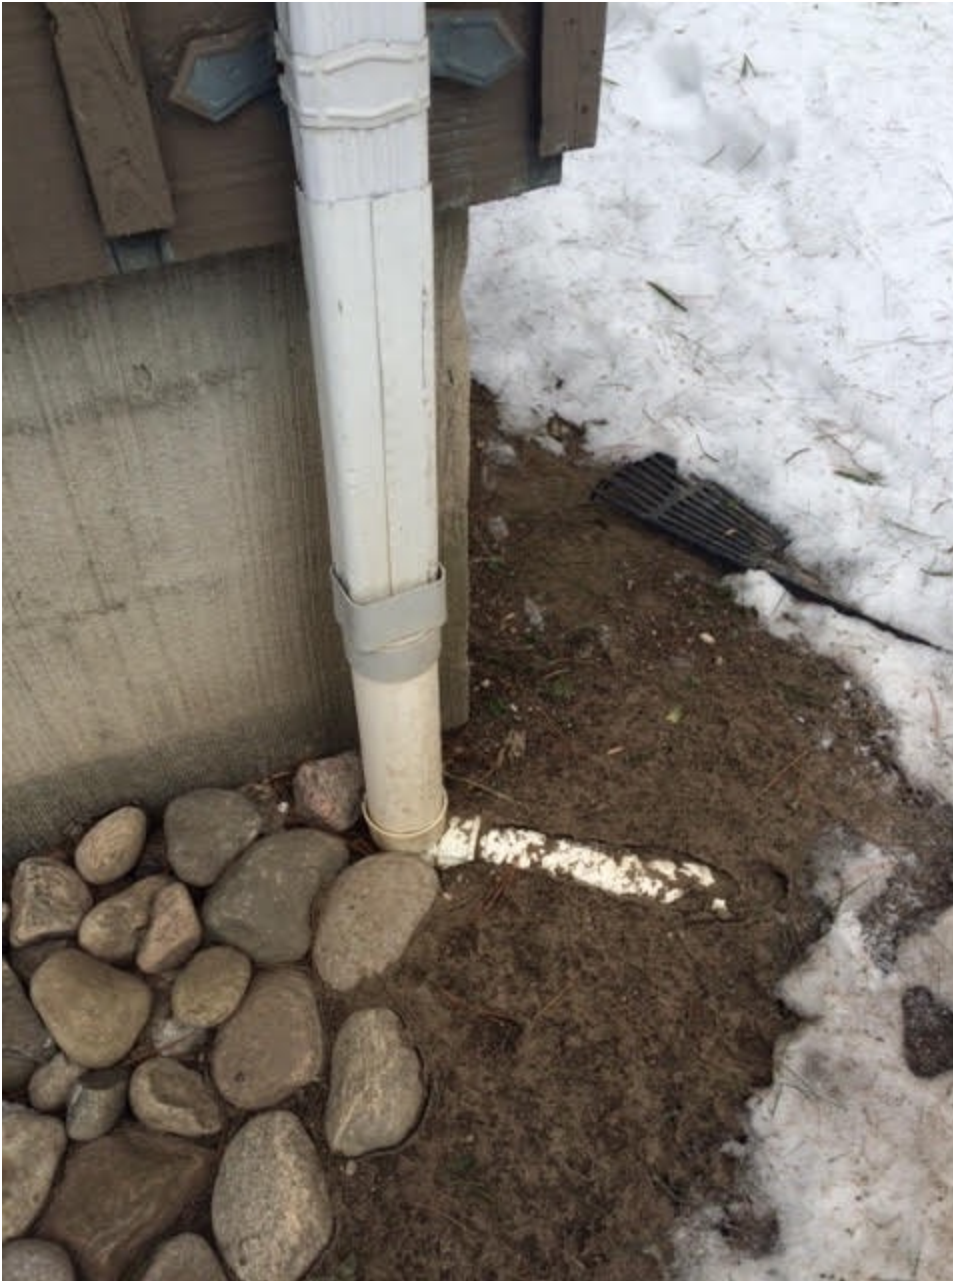
Some eaves trough down pipes have been buried/connected to in-ground pipe extensions.
(below)

This inspector feels burying eaves troughs down pipes is inappropriate, as it often causes clogging and/or freezing, and can promote water infiltration. It is recommended that eaves trough down pipes be extended well away from the home, on top of the ground.

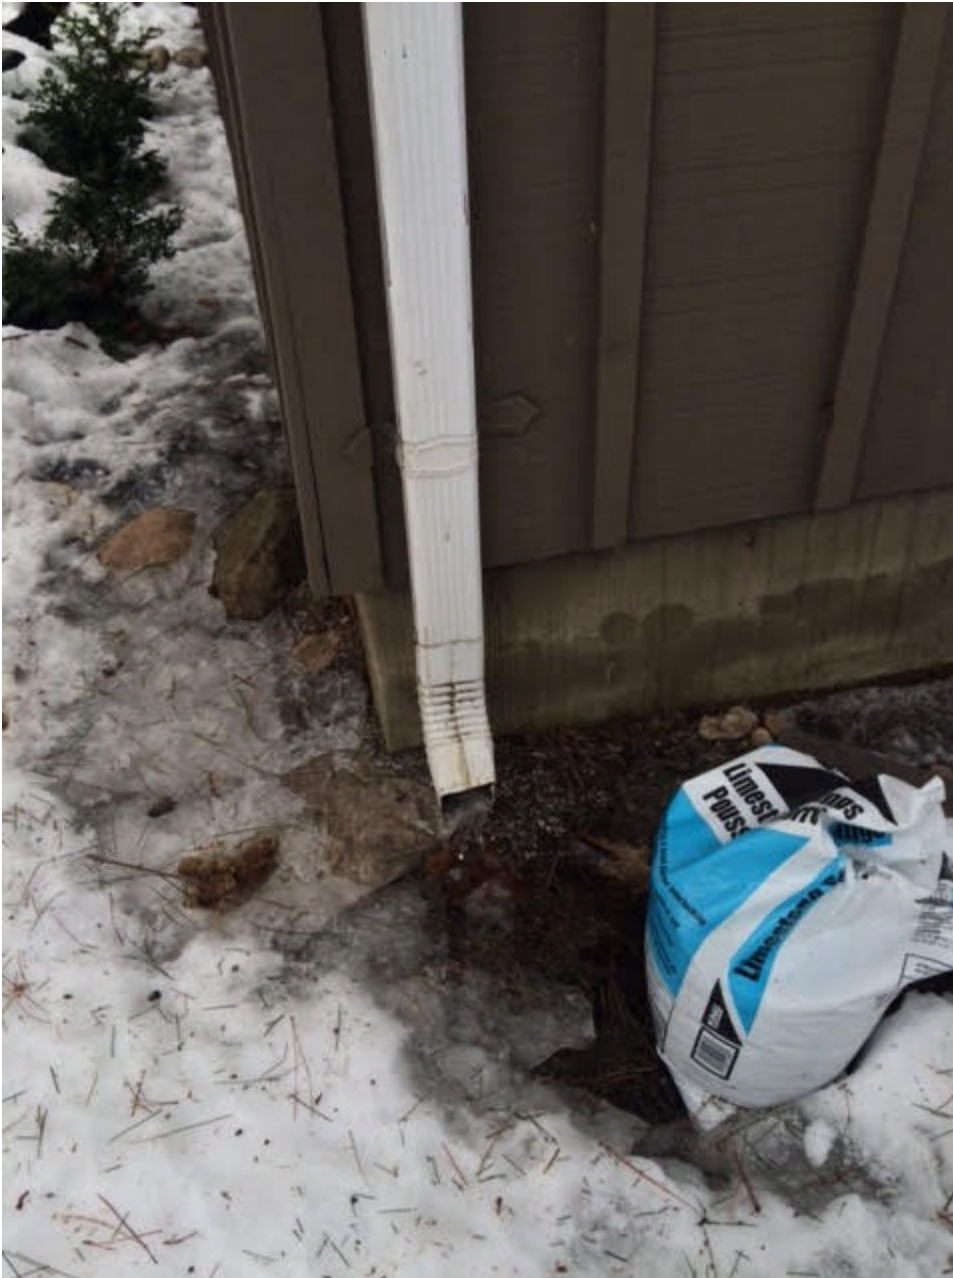
Some down pipes are draining directly against the foundation. (below)

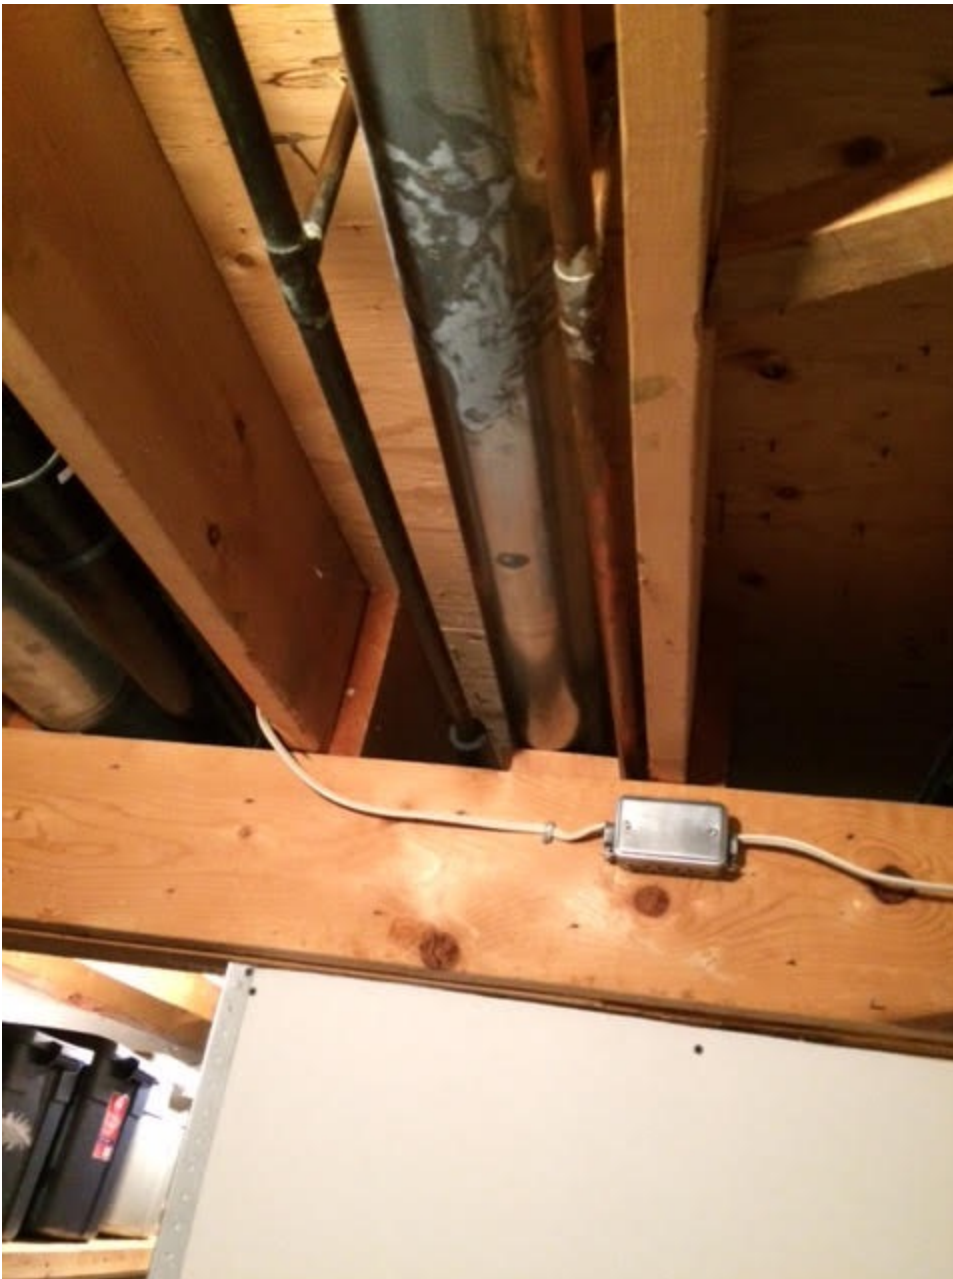
There is no evidence of curling, cracking or separation at the joists, including at observable overlap locations. (below)
