## **SAFE HOMES CANADA HOME INSPECTION REPORT**

**ADDRESS:** 76 xxx Street, Acton, ON

**DATE:** February 18, 2021

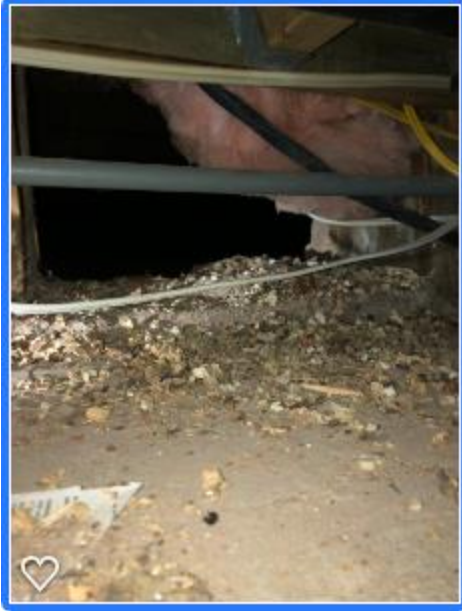
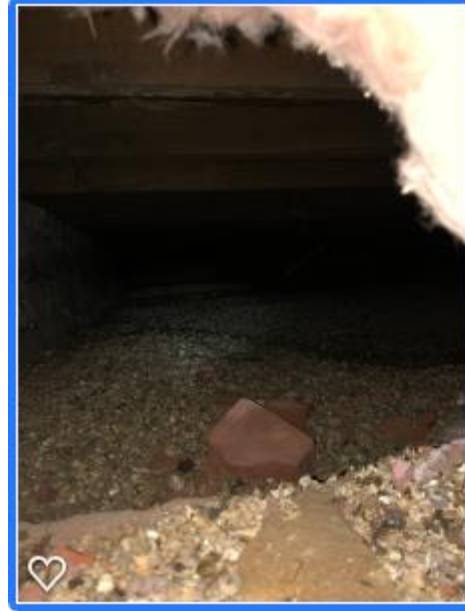
**There is no access into the back right crawlspace. It is strongly recommended that an access be created, so all elements can be examined/assessed, and so the vermiculite can be sampled regarding the possible presence of asbestos.**

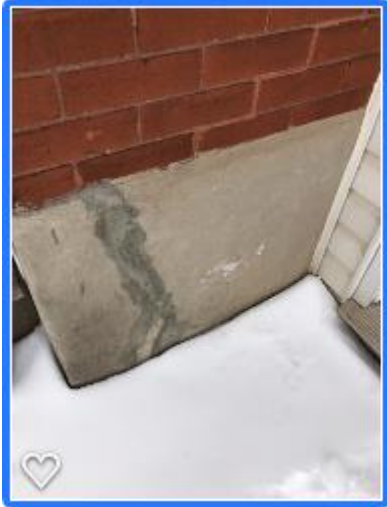
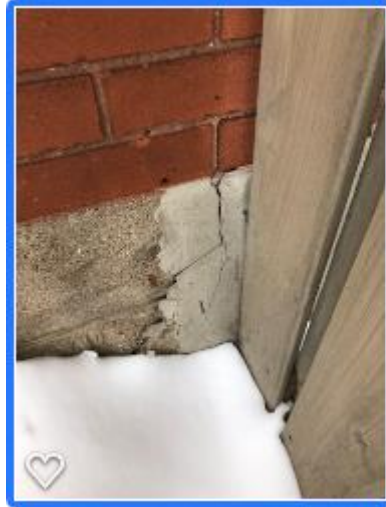
One or two normal settlement/stress cracks are observable.

It would be completely normal to see half a dozen (or more) cracks at a house of this age, size and configuration.

It is recommended that the cracks shown above be fully exposed and formally sealed – at least long term – to prevent water entry and further degradation.

They should be accessed and examined at the inside face if possible; if memory serves, there may be finishes in place at this time.

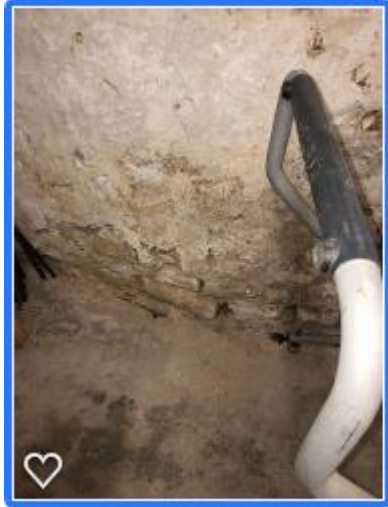
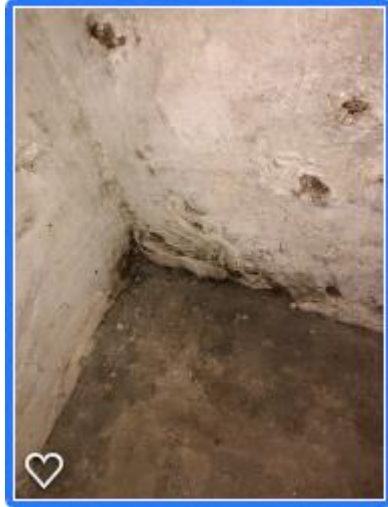
However, water staining was observable at a number of locations where the foundation wall meets the floor slab. Try sealing that junction and all obvious possible entry points for water using hydraulic cement and/or poly urethane or similar products.

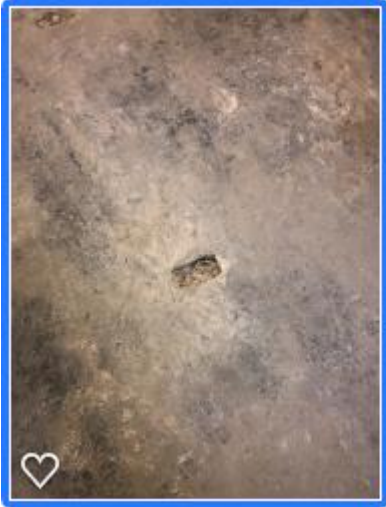
Openings/holes in the concrete slab are observable; be sure to fully seal them.

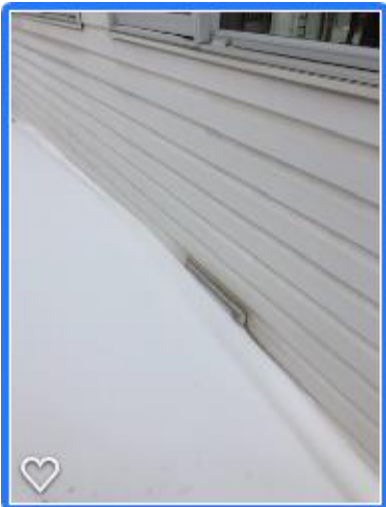
Small window wells are required for the HRV/air handler vents at the left foundation.

Be sure to patch minor openings at the outside face of the foundation.

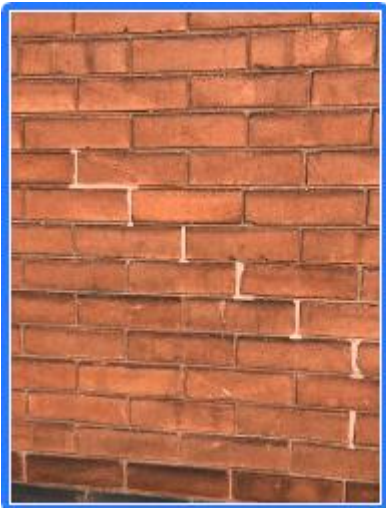
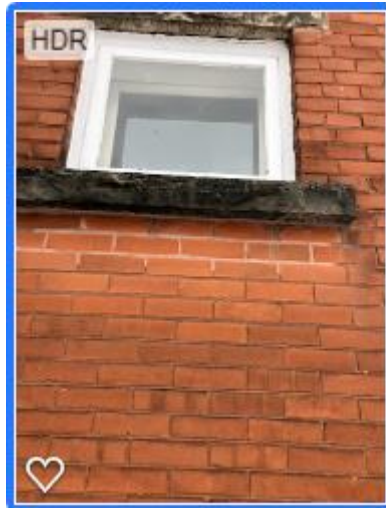
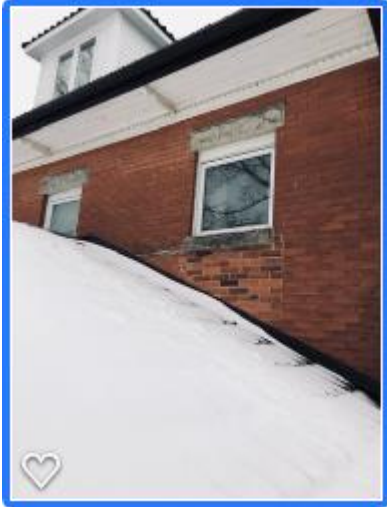
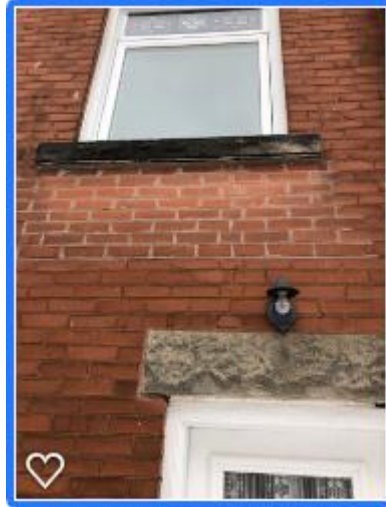
A few normal settlement/stress cracks are observable at the brick system.

As noted, formal patches have been carried out at a number of locations.

No action is required at any crack, although minor cracks can be sealed if desired.

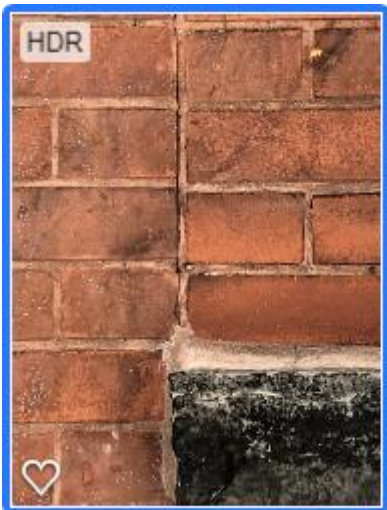
Minor caulking is required at a number of locations, including at the ends of some of the stone sills and at long vertical joints.

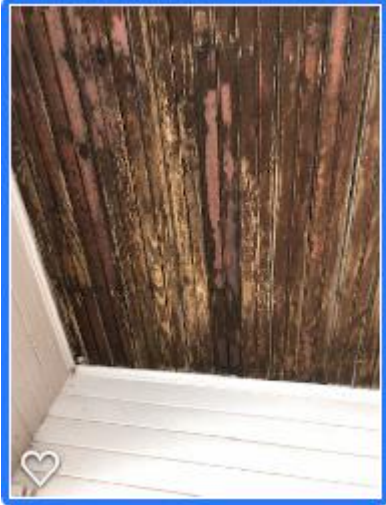
The wood soffits/ceilings require re-finishing.

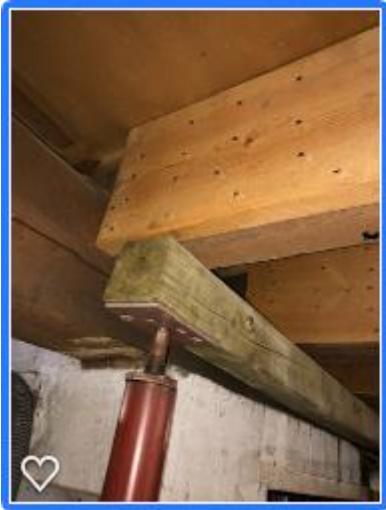
While not critical work, bracing hardware would be a benefit at a number of post/beam and beam/joist junctions, including at the back left crawlspace.

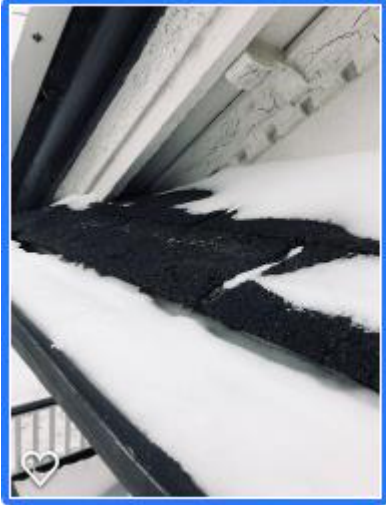
The shingles outside the front door should be replaced without delay.

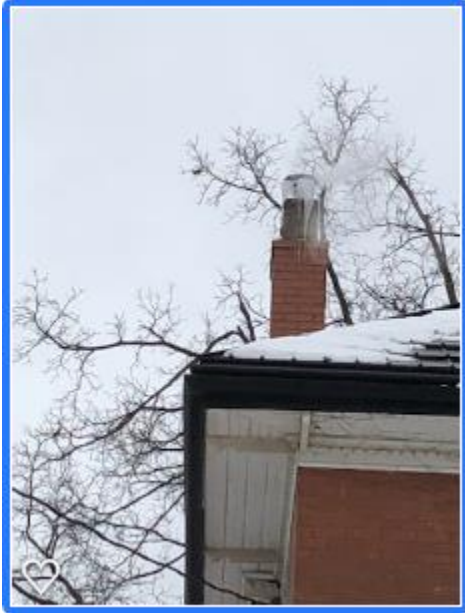
Some ice is observable at the top of the chimney. The reason for that buildup is unknown. Be sure to have a contractor access the top of the chimney to make sure the crown is fully sealed, as step one.

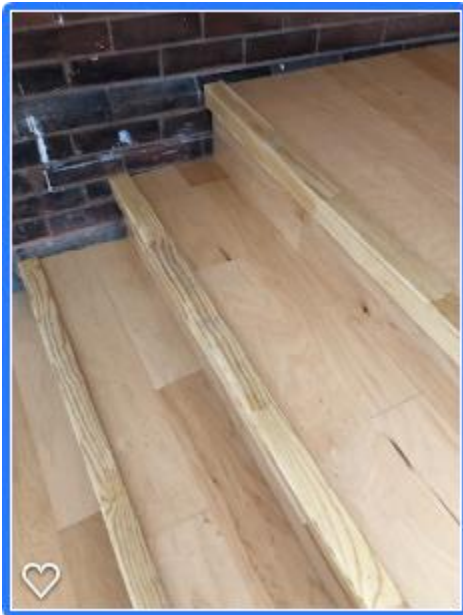
**Beware the child/toddler and general falling hazards at the basement stair. The basement stairs are quite steep, and there is no guard rail.**

**The ‘bullnose’ elevated lip presents somewhat of a trip hazard at the great room stair.**

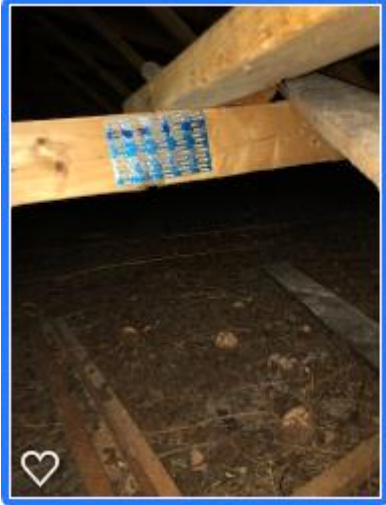
**A major animal droppings mess requires formal remediation in the garage attic.**

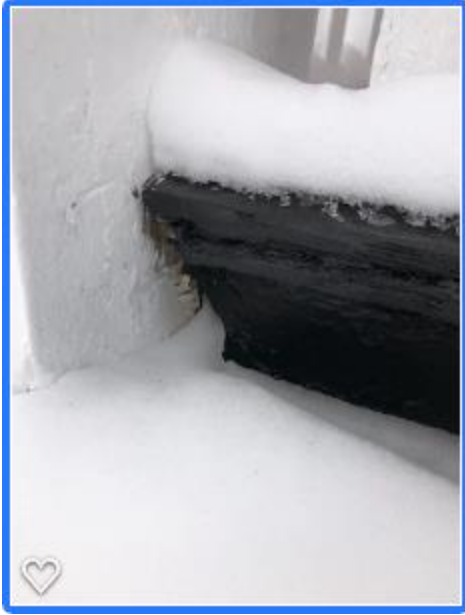
**The veranda is partly rotted Be sure to repair and re-finish exterior wood as required.**

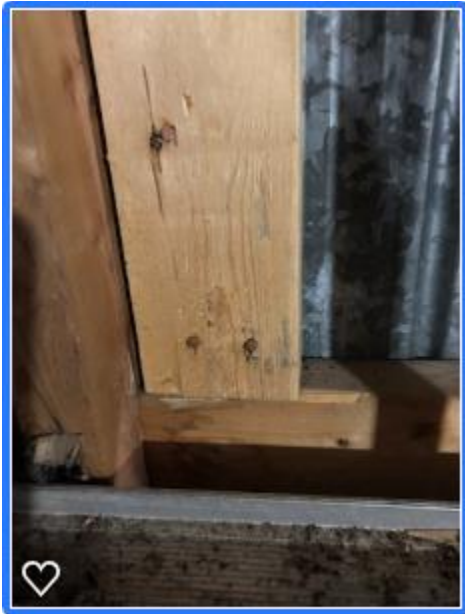
**Additional support is required at some of the newer beams in the garage.**
