SAFE HOMES CANADA HOME INSPECTION REPORT

ADDRESS: xxxxxxxxxx, ON

DATE: July 31, 2020

This inspection is a Tarion Warranty inspection for a new home.

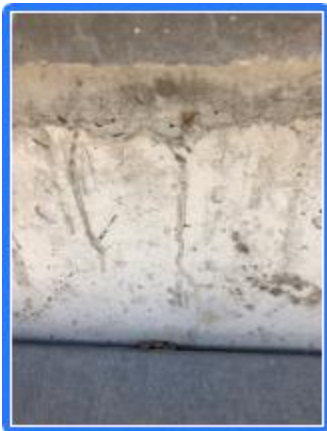
The poured concrete foundation walls are completely stable, as observable.

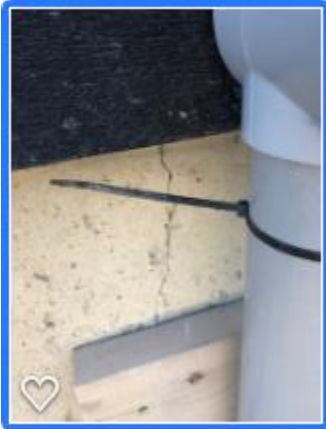
One normal settlement/stress crack is observable.

The crack is normal.

The quantity of cracks is less than normal.

It would be completely normal to see half a dozen cracks at a house of this age, size and configuration. This inspector feels confident that most cracks result from the foundations being loaded at the time of construction.

No action is required to seal the crack here.

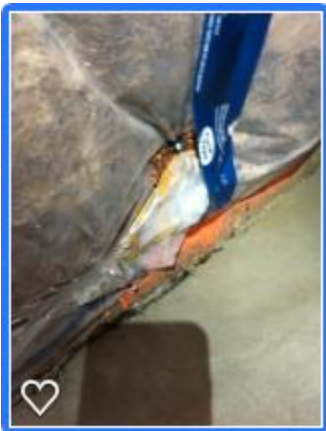
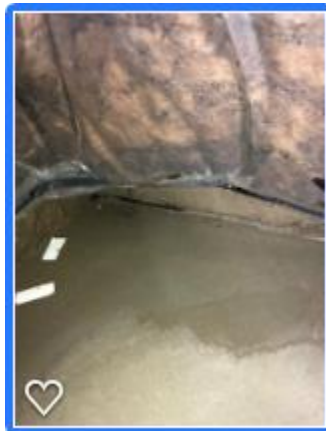
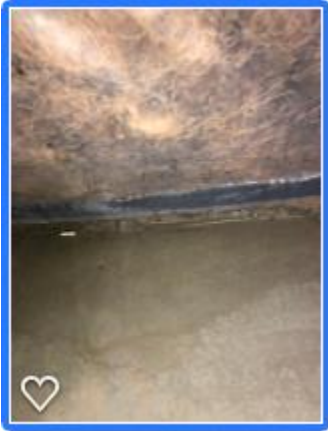
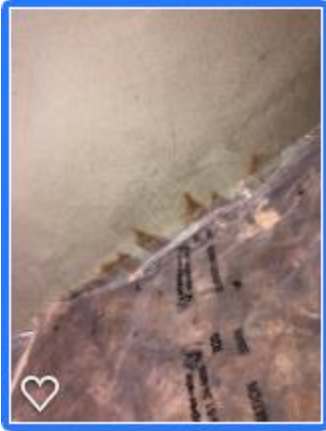
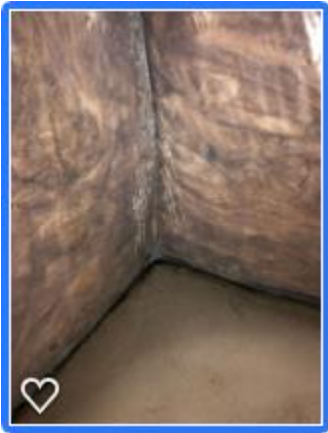
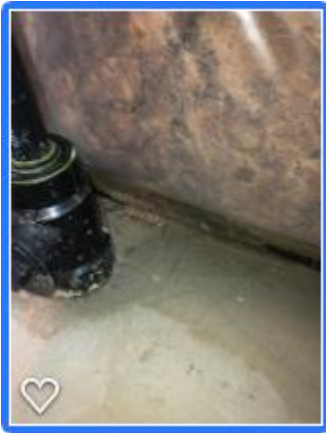
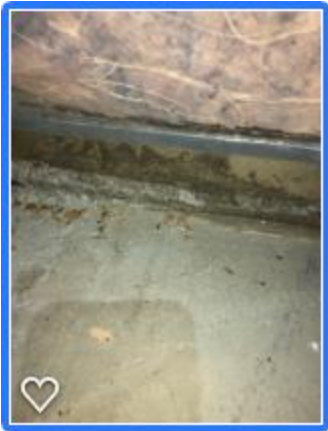
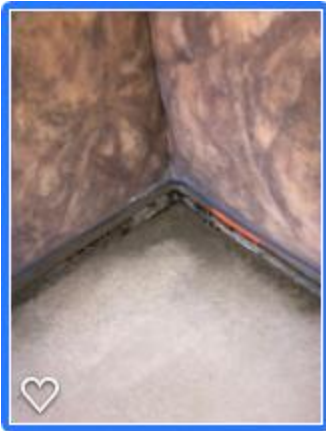
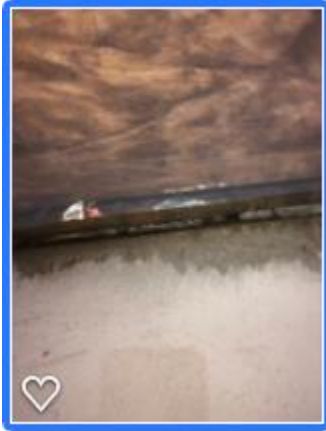
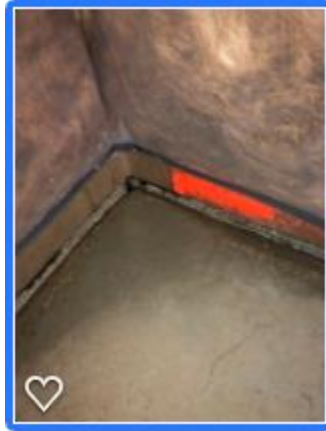
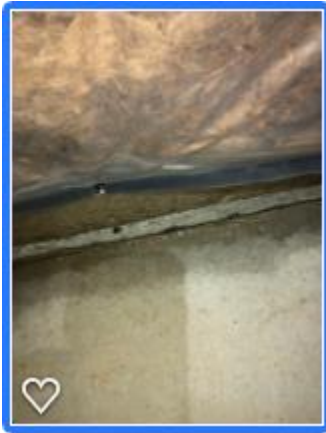
The basement is wet! Standing water and water stains are observable at various locations in the basement.

There should be no standing water in the home. The water has likely infiltrated through specific entry points. It is unlikely that the standing water is from the time of construction. If it was, it should have been cleaned up/dried out by now.

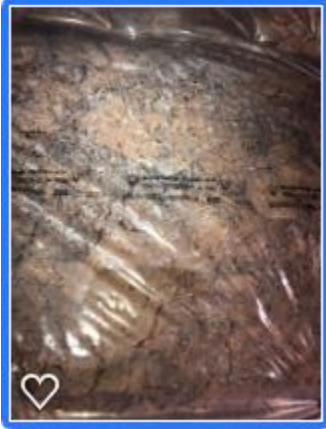
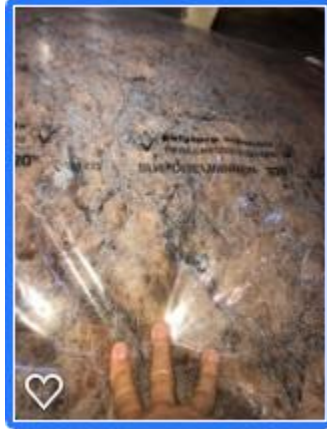
Moisture is observable behind the poly vapour barrier, at the inner face of the insulation in the basement, at many locations. It is a major concern. The formation of moulds is a major concern. The impact upon air quality is a major concern. Damage to the insulation is a major concern. This moisture behind the vapour barrier is not 'o.k.', and is not 'normal'. The basement should have been effectively dried out before the vapour barrier was installed. At this point, it is strongly recommended that the entire insulation system be removed. Damaged insulation should be disposed of. The entire basement should be fully dried.

An examination of the entire inside face of the foundation can be carried out at that time, so all possible access points for water can be fully sealed.

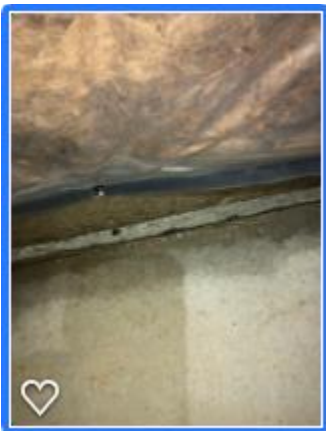
Note that possible water infiltration up through the joints where the concrete floor slab meets the foundation walls is a definite concern. After all other work has been carried out to control water effectively away from the home and to seal possible entry points, further investigation will be necessary to determine whether water is infiltrating up through that junction.

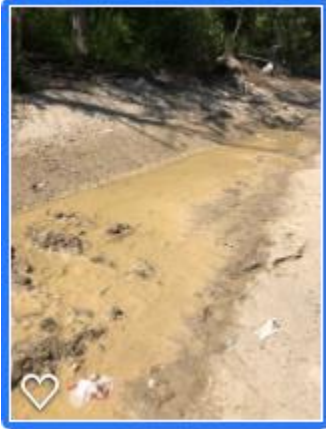
The buyer is concerned – quite reasonably – about standing water, a wet area that has been wet for some time, at the rear of the home. Some kind of drainage work – such as the addition of drainage material – may be necessary there.

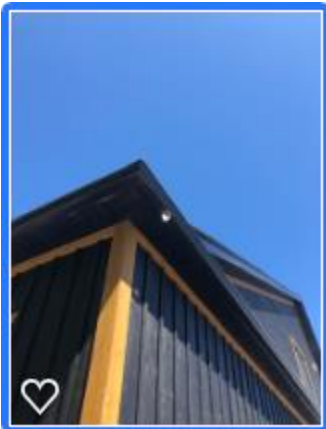
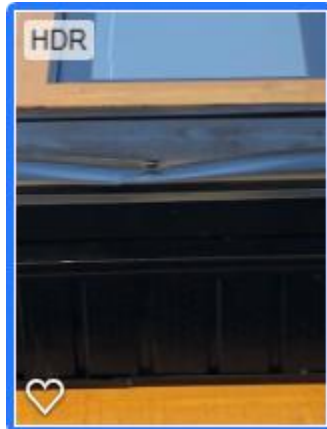
1. All eaves trough and sump water must be transported well away from the home, on top of the ground. A down pipe is missing at the back left corner of the home. One section of trough is damaged.

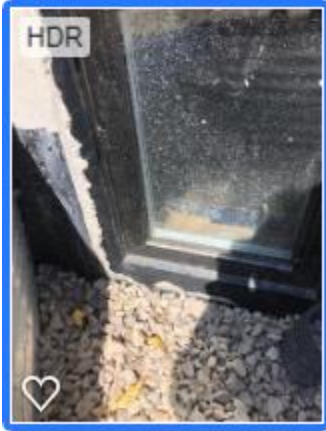
2. Open joints at basement windows must be fully sealed. Caulking is required at the front left basement window.

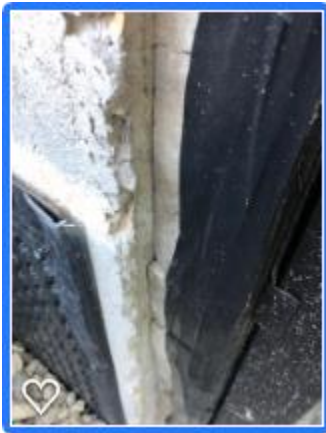
3. Formal flashings and fully caulked joints are required where a cementitious material/compound has been used informally at one of the right windows, where the opening in the foundation wall is larger than the window.

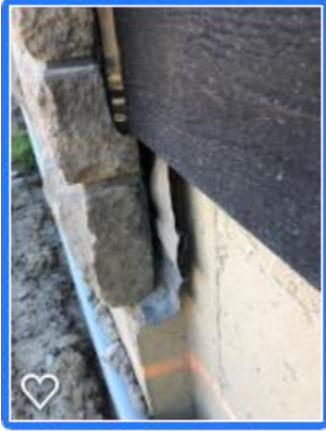
4. Formal sealant work – including flashing and caulking work – are required where the unit masonry system meets the foundation wall at the front part of the right wall.

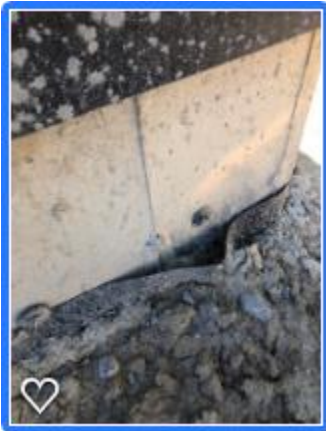
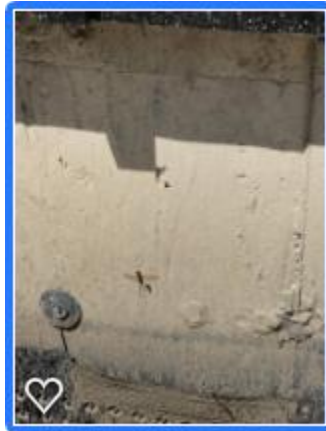
5. The foundation wrap system has been pulled away from the wall at various locations; the fasteners are no longer connected to the system. Minimally, the entire top of the system should be formally re-fastened to the foundation. This inspector feels that the top edge of the entire system should be sealed against the foundation, but some specs do not require that work. The specification for the system should be examined, to determine whether sealant work is required at the top edge.

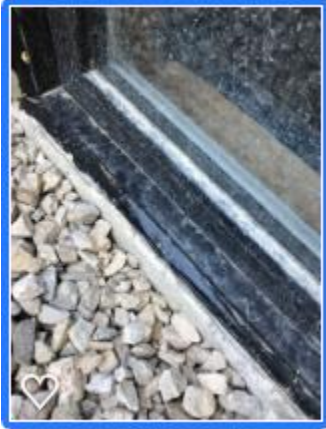
6. The concrete at some of the basement window sills has been finished such that a ridge of concrete extends up from the window sills, and will contain water against the caulking joints at the bottoms of the windows. This is not 'normal', and containing the water in this fashion will degrade the caulking prematurely. The ridges should be removed.

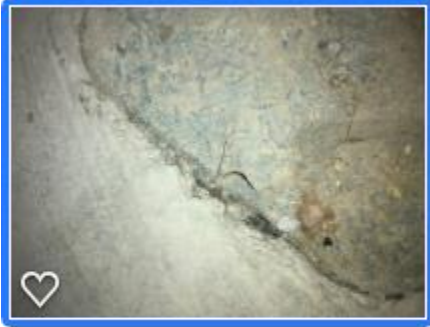
The container for the backflow prevention device is not fully sealed against the concrete slab; it should be to help prevent water/insect entry. Further, the cover is broken.

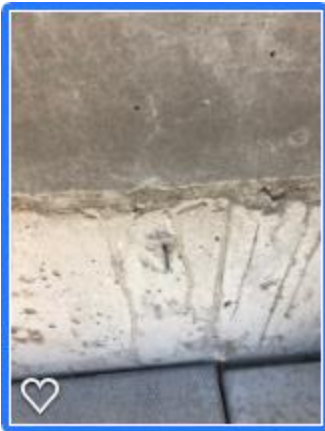
The form ties at the front foundation should be removed and the resultant cavities patched.

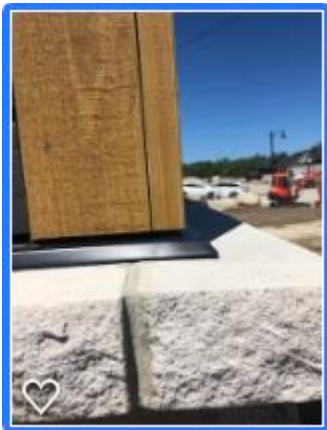
Caulking is required at the horizontal mortar joints in the masonry sills. It is normal that builders caulk such joints, which helps prevent cracking and degradation at the mortar.

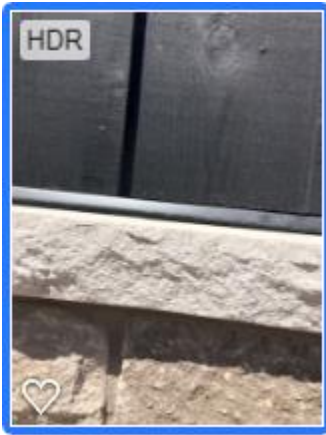
It is difficult to assess whether the aluminum flashings should be fully sealed against the masonry sills. This inspector feels if the flashings are very tight against the sills, caulking is less important. But at locations where a gap is observable, such gaps present obvious, possible entry points for insects and

water. They should be sealed, including here, at the front left corner of the home.

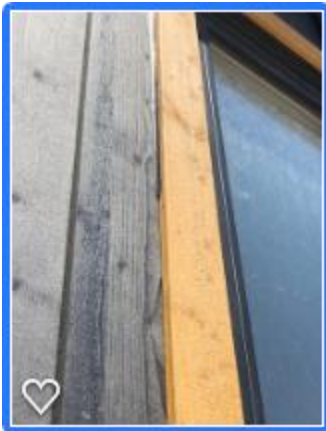
Caulking is required at the rear side of one of the left windows, where it is incomplete.

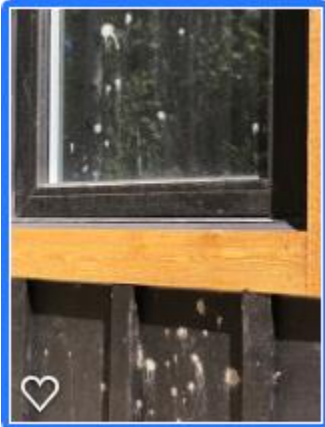
Significant cleaning is required at the siding and at a window or two.

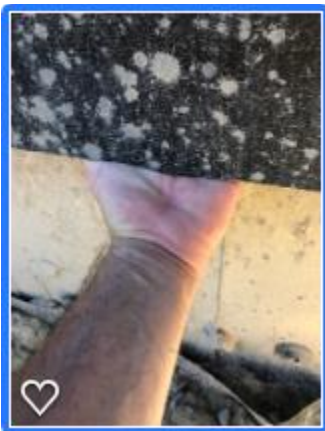
Insect entry and possible habitation within the siding is always a concern, when the bottom of the siding and mouldings is not fully sealed. The system is open at a number of locations. While a drip edge flashing along the bottom would be a benefit, the important thing is to seal the locations where cavities or open joints can be felt up inside the system. Examples can be found at the right siding, and at the back left mouldings.

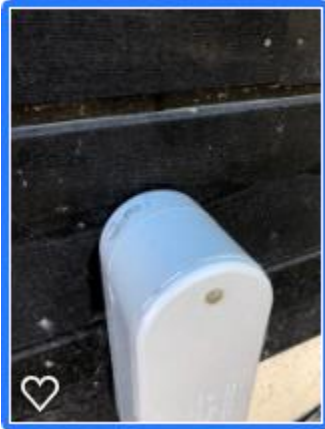
Caulking is required at the main electrical feed, where it meets the siding.

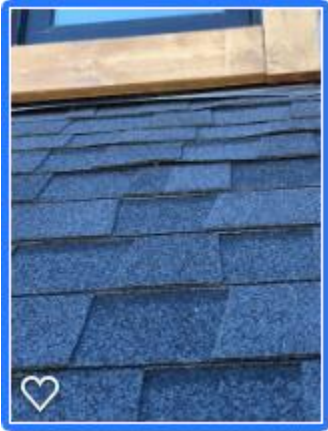
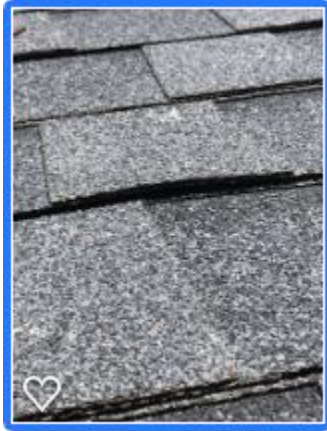
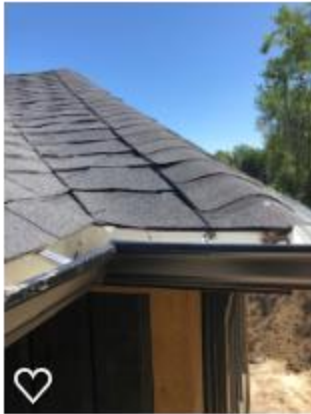
A dozen or so nails were not fully sunk at the shingles. The roofer/builder should be invited back to fully sink all nails to help prevent shingles from blowing off the roof.

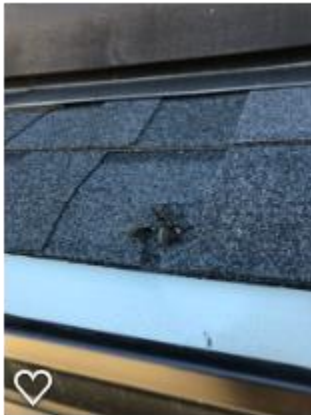
One shingle is damaged at the right strip of roof.

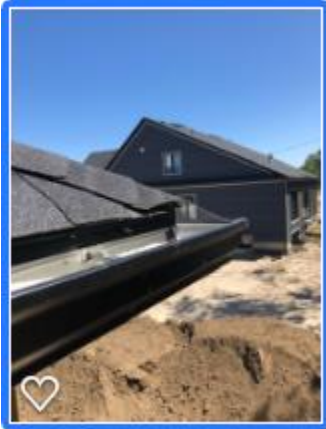
The shingles should be fastened down at the very bottom of the back left ridge.

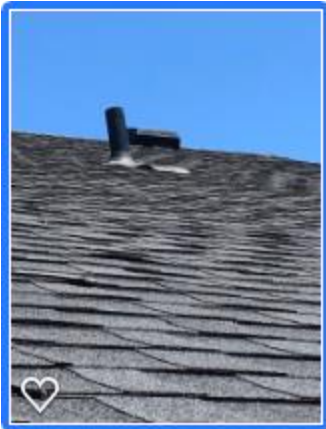
The bottom edges of the vent flanges have not been sealed to the roof; they should be, and water/insect/wildlife entry is a concern.

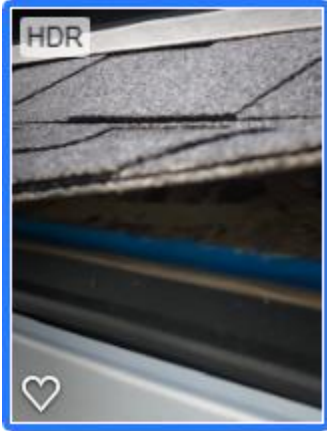
The shingles are not supported by a drip edge flashing where they extend over the eaves troughs. Because of that, they are susceptible to cracking. Drip edge flashings should be installed to prevent cracking.

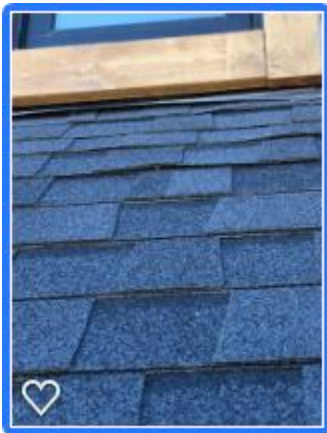
Additional fastening is required at the junction flashings, including where the front low roof meets the higher wall.

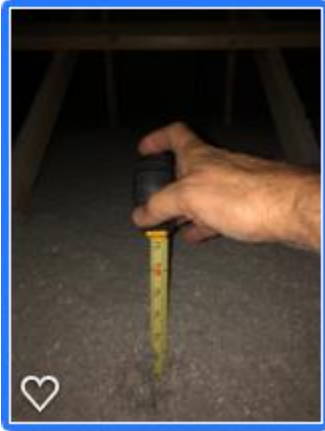
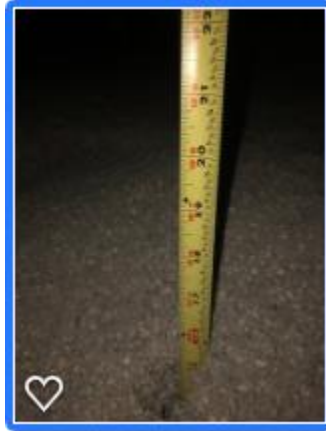
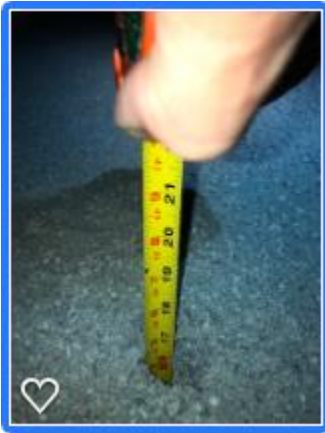
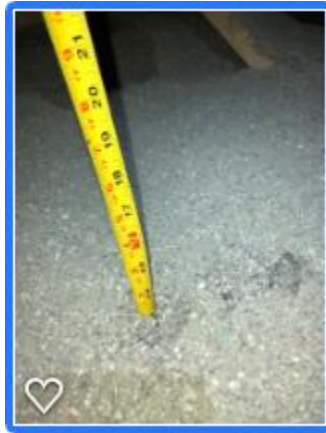
The insulation here is loose cellulose. There is no spec sheet at the access point, which would show the exact required depth for this product to provide R60, the current building code requirement.

The depth as measured near the upper access varied from 12 inches to 16 inches, so the insulation is definitely deficient. Ask the builder to provide the exact spec for the product. Based upon a brief internet search, it takes between 19 and 22 inches to provide R60 at a cellulose system/product. Thus, the insulation is likely about 6 to 8 inches low, approximately, on average.

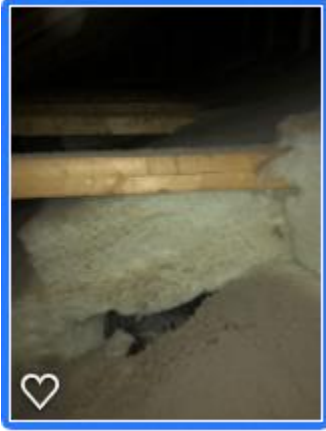
Further, one pot light was observed at a gap in the batts from the back left low attic. There was very little insulation between the light and the attic space. R60 must be provided at every light, and throughout all attics, including throughout the cathedral areas. The following photo shows a pot light's plastic cover.

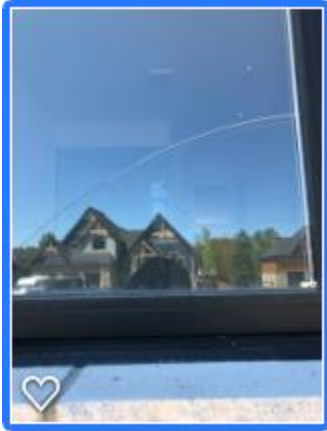
The ensuite bathroom window is broken.

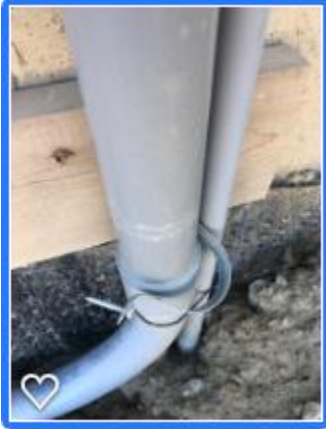
The fasteners are not fully sunk at the main power feed conduit.

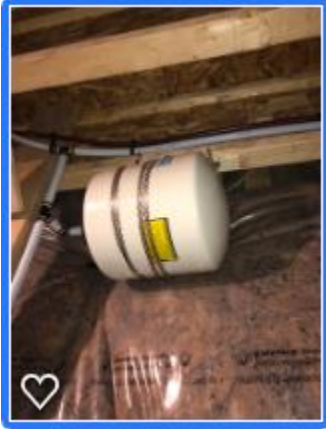
A second valve should be added on the 'house side' of the pressure relief tank, to minimize water flow quickly in the event of a pipe failure.

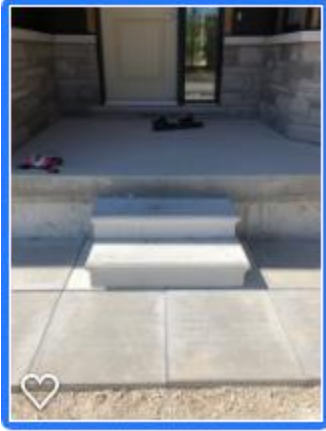
Beware the child/toddler and general falling hazard at the front landing, where the step does not extend the full width.

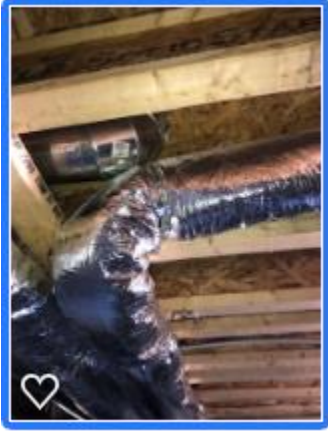
Note that the ducts that serve the heat recovery ventilator (HRV) have been choked significantly by the clamps that fasten them to the underside of the floor assembly.
