# SAFE HOMES CANADA HOME INSPECTION REPORT

## Tarion Inspection – First Year

**ADDRESS:** xx Mumberson Street, Cookstown, ON

**This inspection is a Tarion Warranty inspection for a new home.**

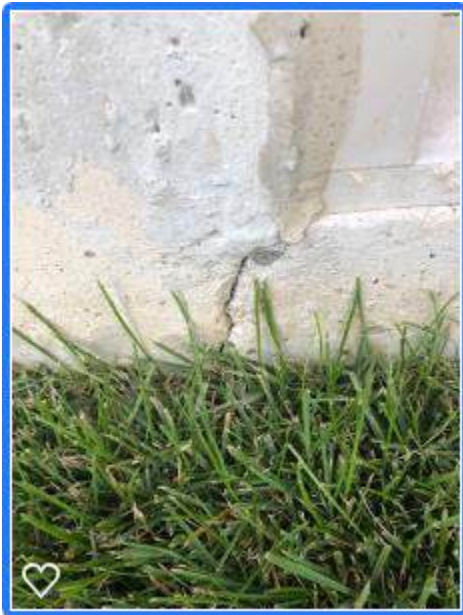
**The crack at the front part of the right wall is quite decisive, and open. A high quality sealant compound – such as hydraulic cement – should be applied at the front right crack above the waterproofing membrane, at the outside face.**

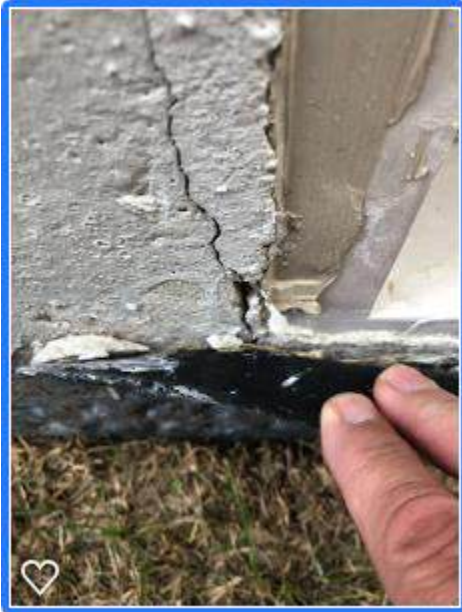
**A cracked area of concrete requires repair at a left basement window.**

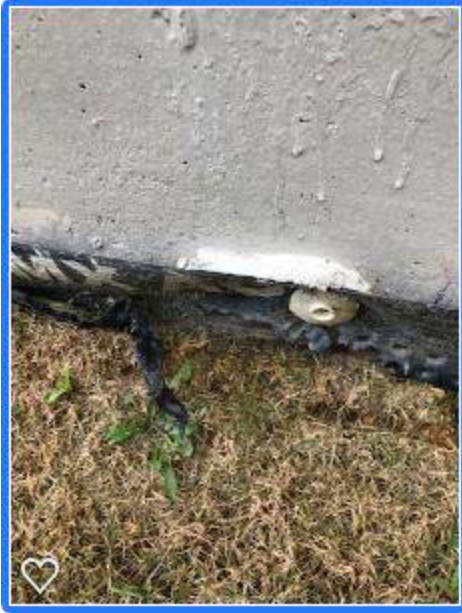
**Debris is observable – and creates a gap – between the waterproofing membrane and the outside face of the foundation walls. The debris should be removed, as possible, and the top edge of the membrane should be formally fastened. (Note: for reasons unknown, sealing the top edge of membrane systems outside foundation walls is not required as per specifications.)**

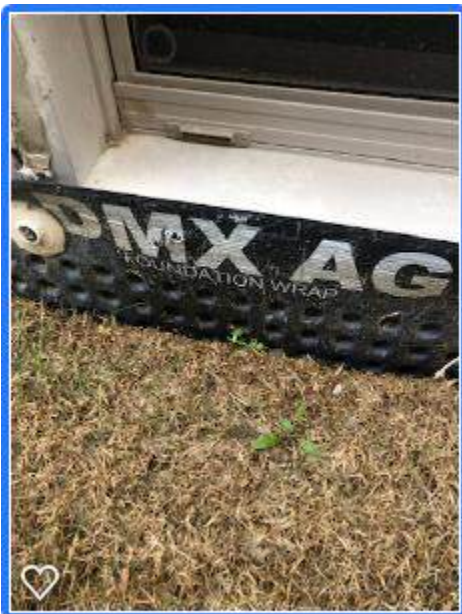
**The membrane system has not been formally trimmed at basement windows. Such systems are normally trimmed formally below the window sills.**

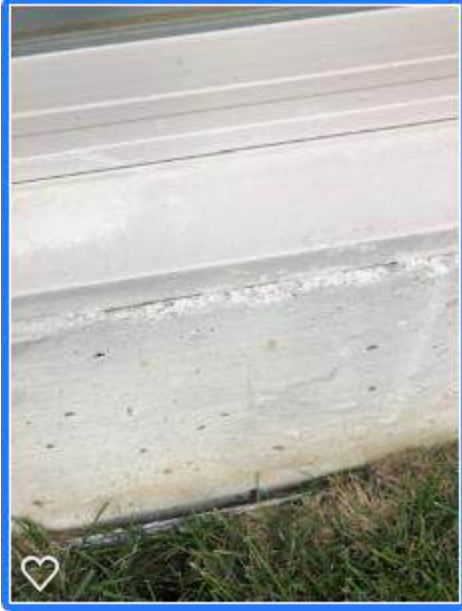
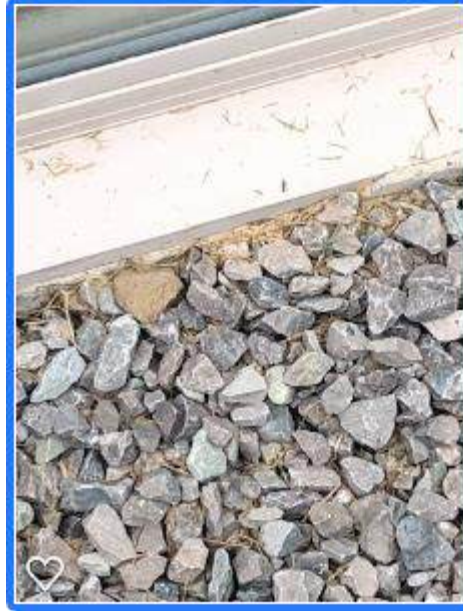
**Informal parging material prevents formal caulking at the joints where the basement windows meet the foundation walls. All basement window joints must be fully and formally caulked.**

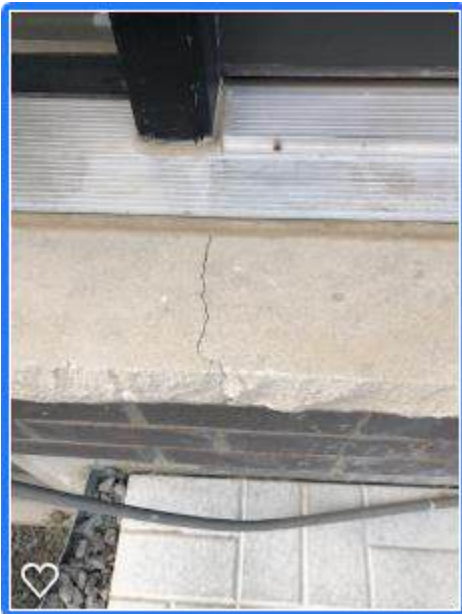
**The crack in the rear door sill should be formally cut and sealed, or sealed in a visually acceptable fashion.**

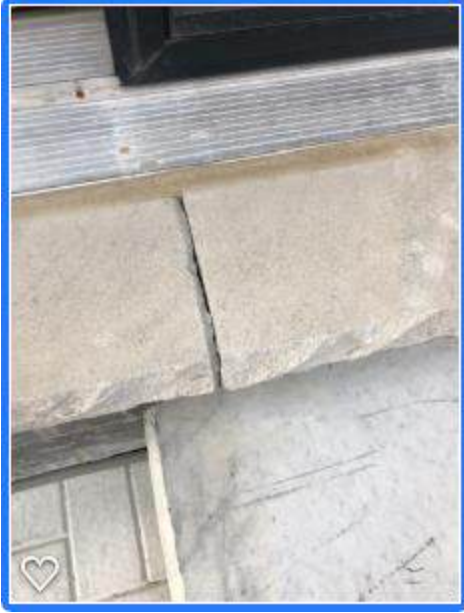
**The mortar joint within the rear door sill should have been formally caulked.**

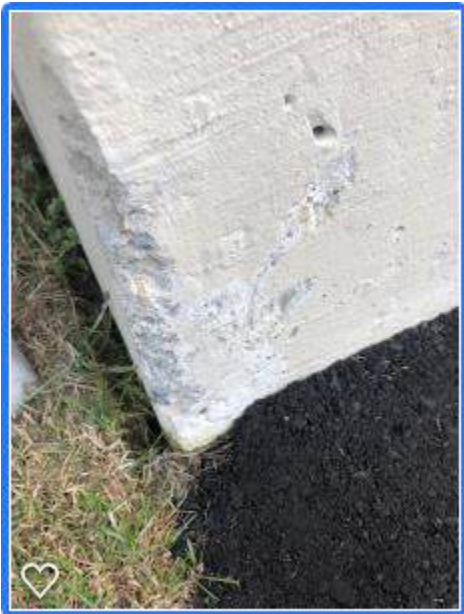
**Patching and finish work is required at damage at the front left corner.**

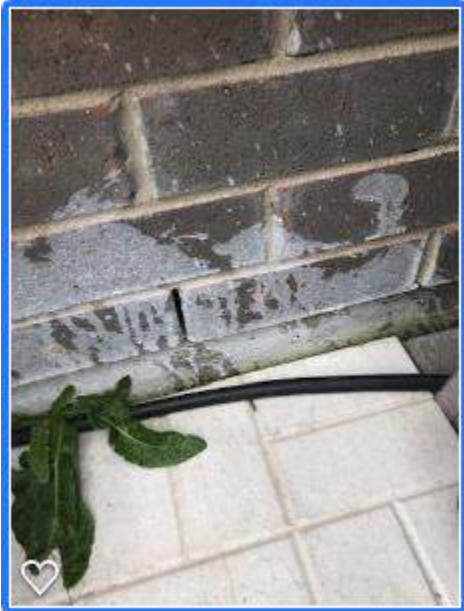
Some kind of major stain requires removal at the rear wall.

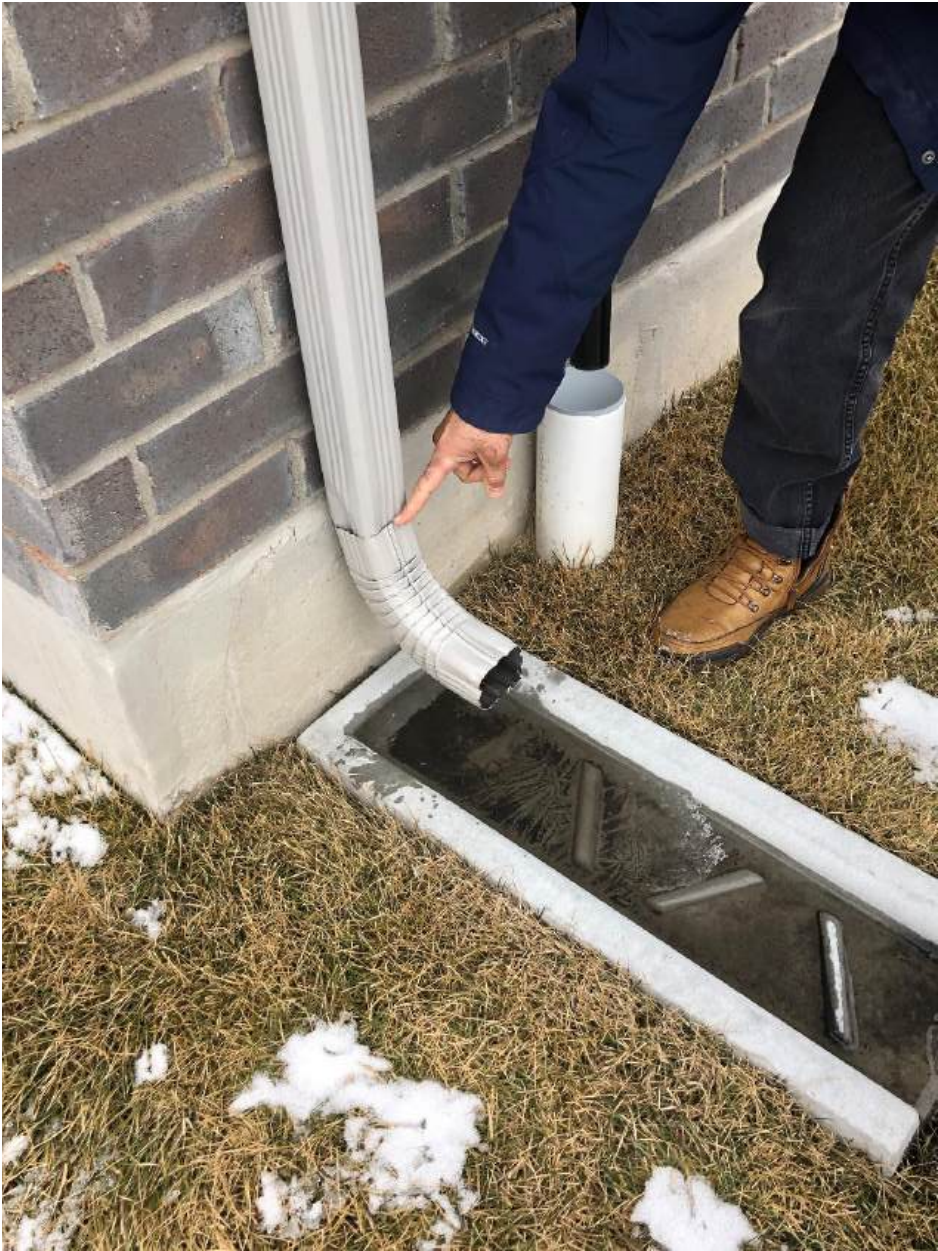
The bottom piece of the front right eaves trough down pipe requires formal fastening.

The splash pad at that (front right) down pipe is sloping down toward the home.

Some fastening is required at the down pipes, and the front right splash guard is sloping in the wrong direction.

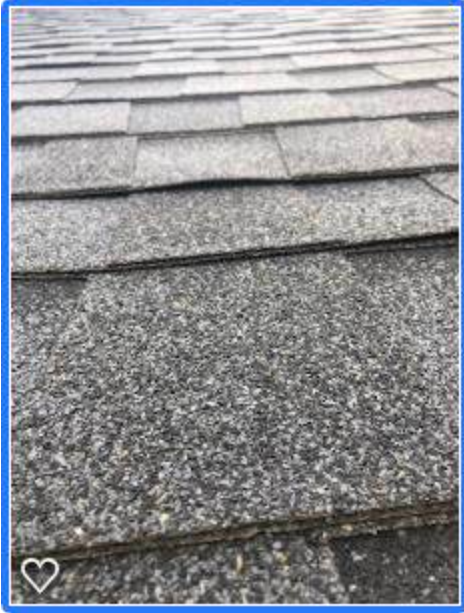
**Half a dozen or so nails were not fully sunk at the shingles.**

**The roofer should be invited to fully sink all nails to help prevent shingles from blowing off the roof.**

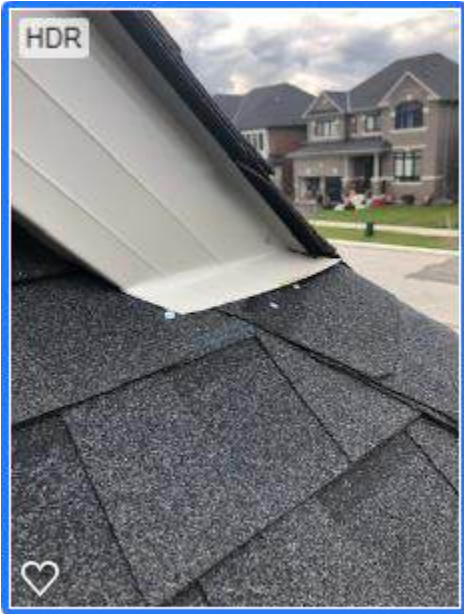
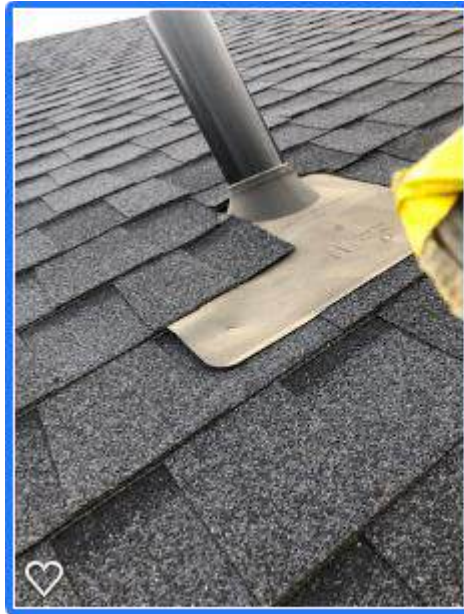
**All exposed nail heads must be fully caulked.**

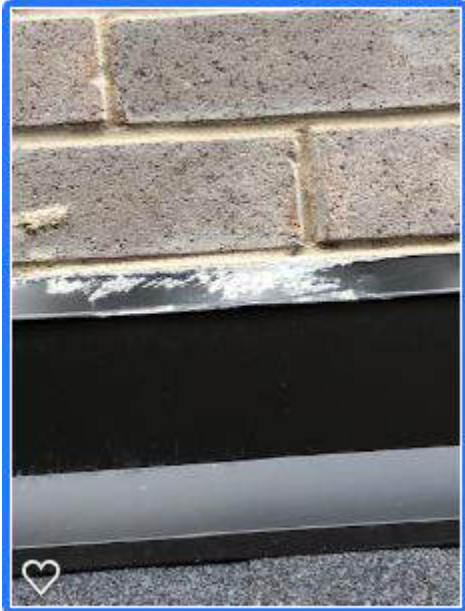
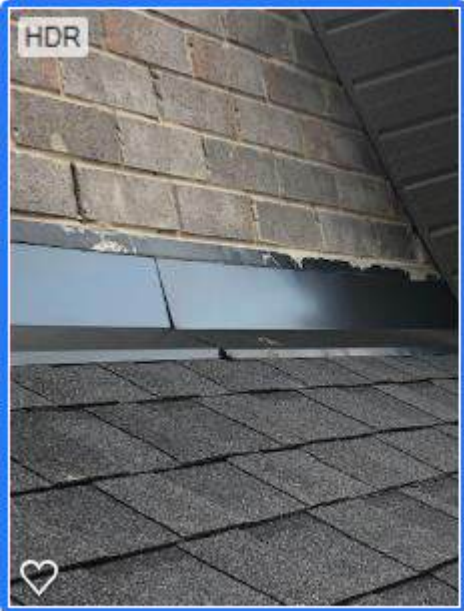
Formal cleanup is required at the metal junction flashings.

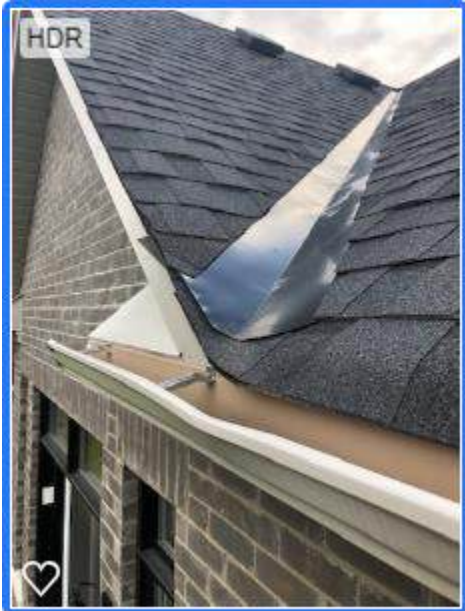
The metal valley flashings must extend all the way to the bottoms of valleys or shingles at the bottom of the flashing will degrade far prematurely.

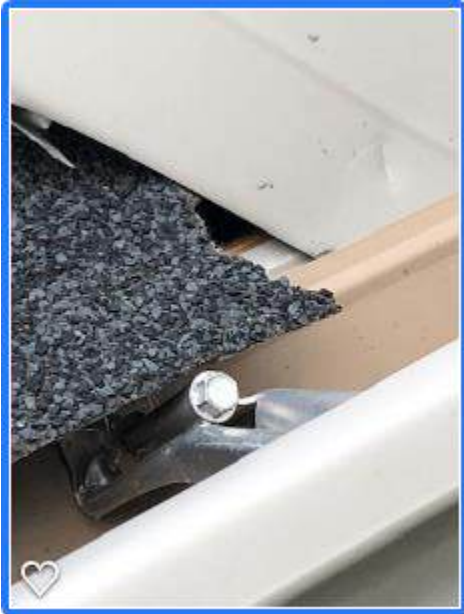
**The roofing is incomplete at the end of one of the lower strip sections, at the bottom of a diagonal metal piece.**

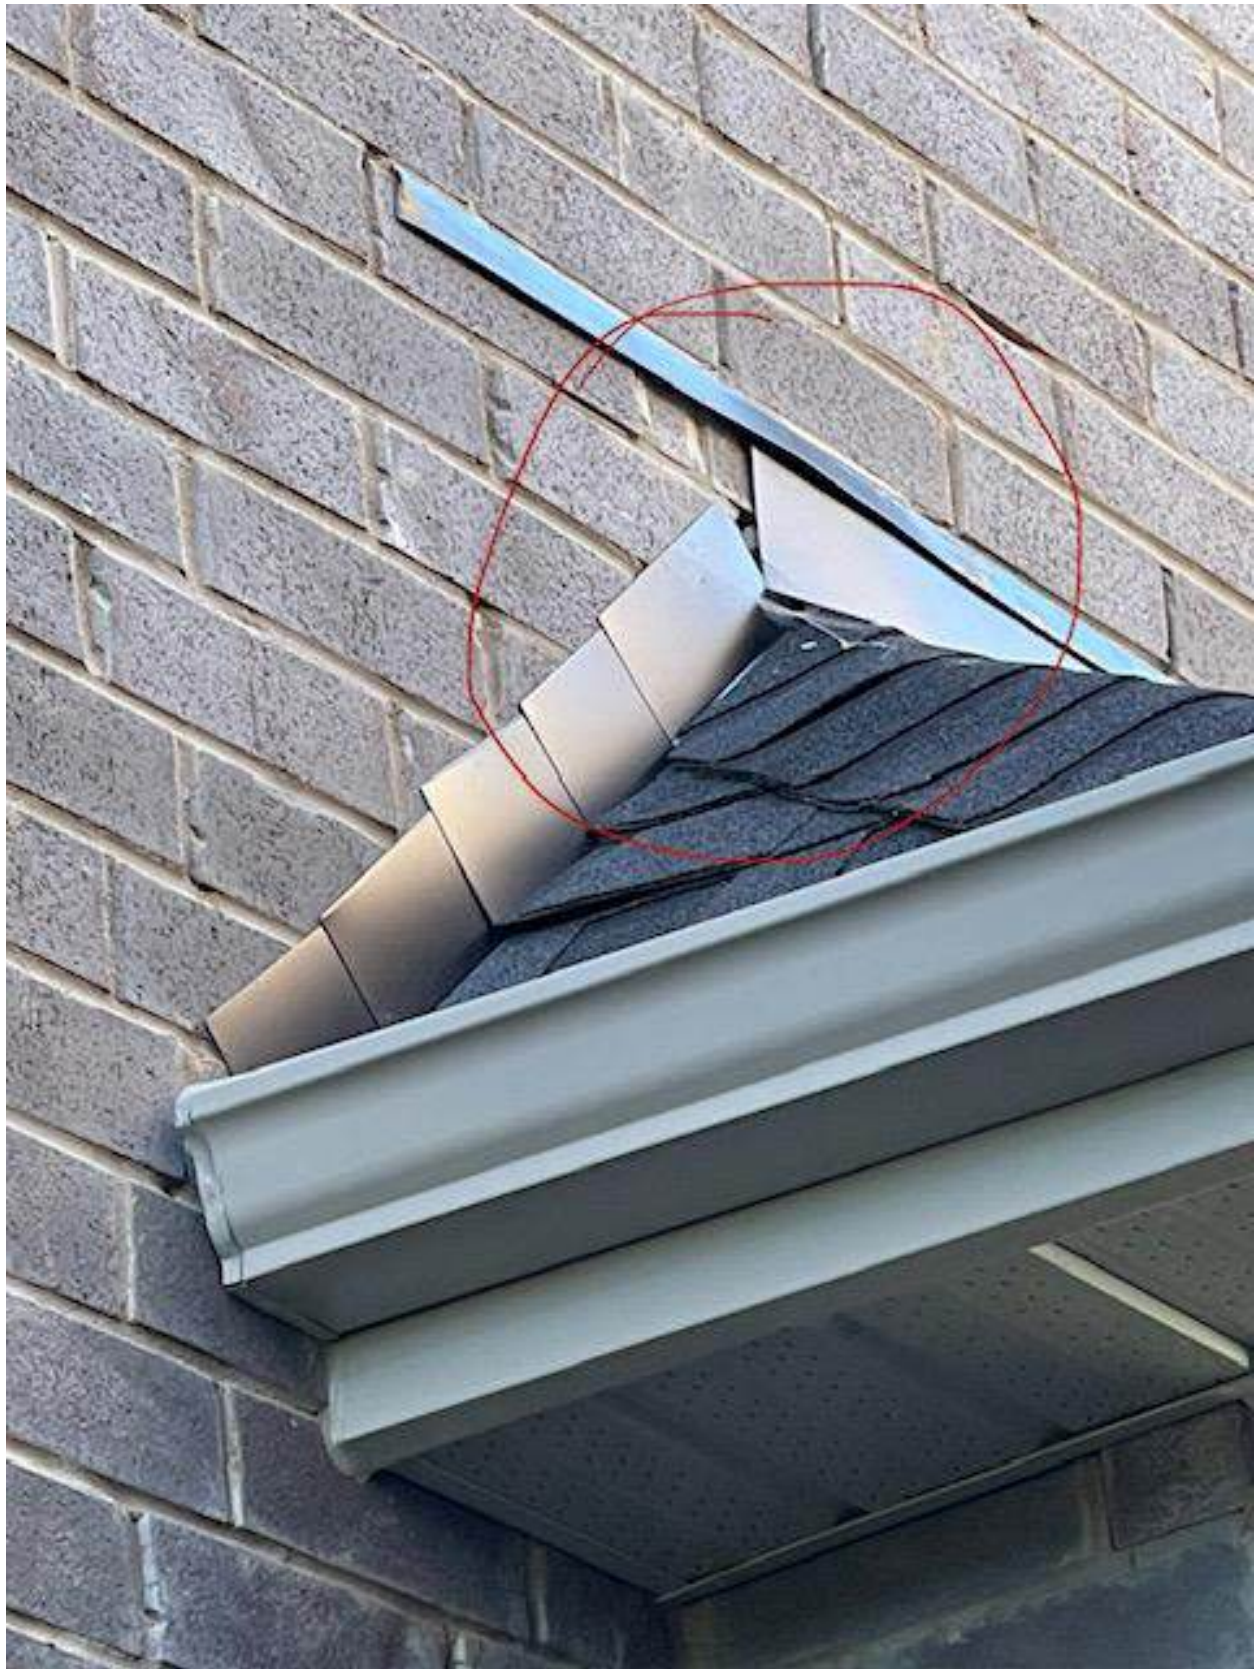
**The metal junction flashing is incomplete and not sealed. There is a space between the angled part of the flashing and the horizontal part of the flashing. A formal, continuous and fully-sealed flashing must be provided by the builder. Also, two of the shingles are not fully seated at the left side low roof, as shown in the photo.**

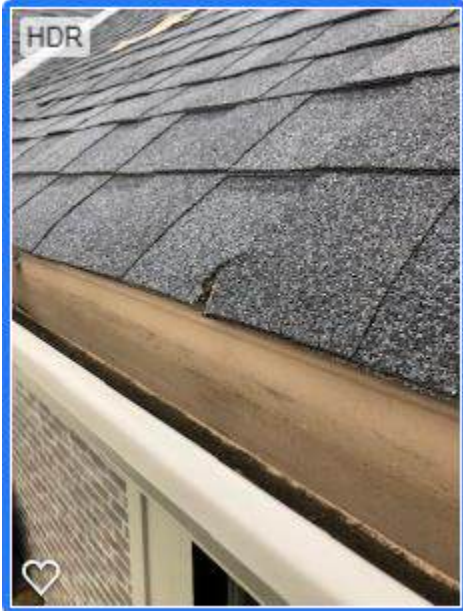
**One shingle is ripped at the bottom of the rear slope.**

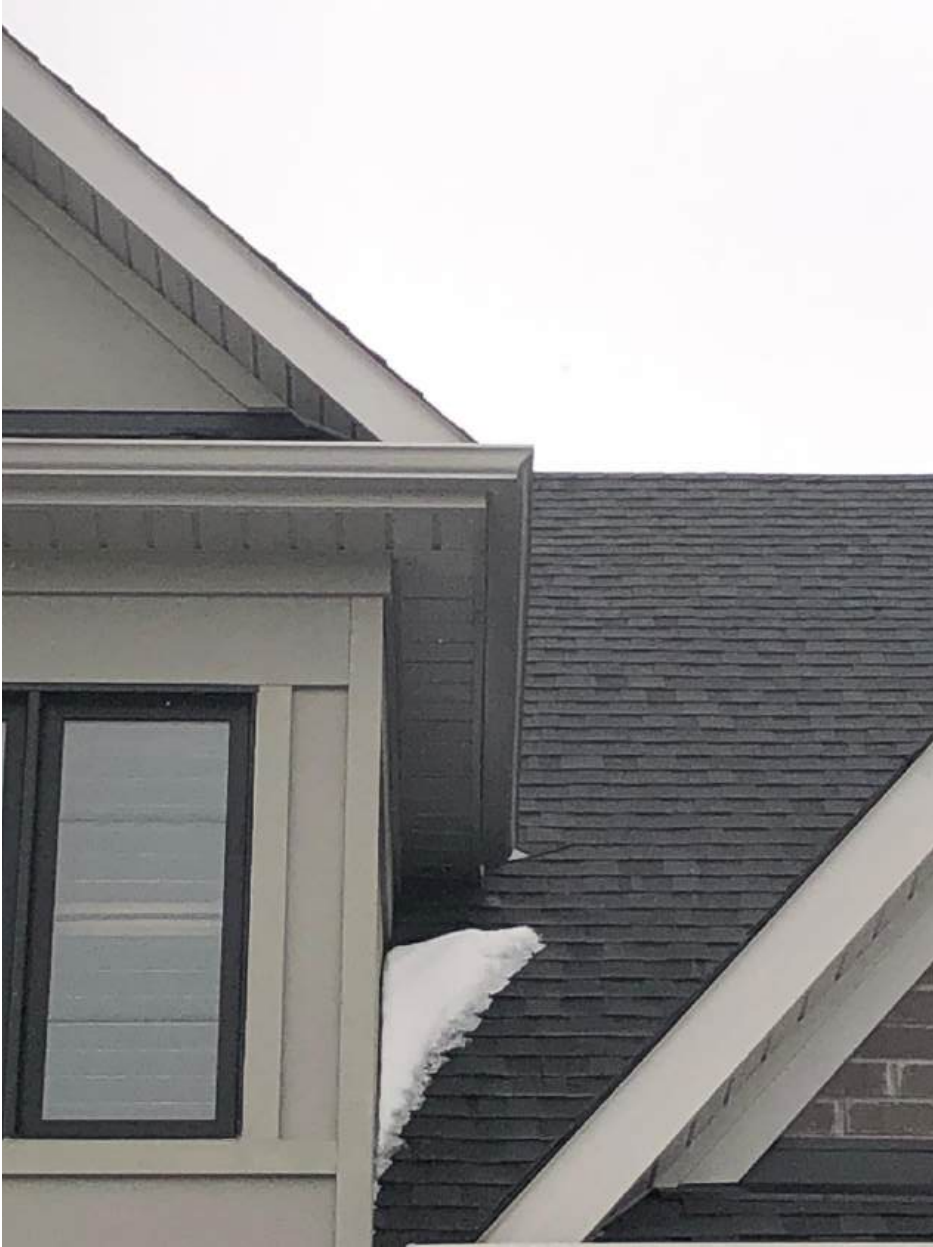
**Water is currently infiltrating through a central vacuum pipe near the garage stair. That pipe is directly below the location where the rear end of the down pipe is dumping water at the back right corner of the dormer. The builder's forces should be invited to determine exactly where the water is infiltrating, and correct/seal the deficiency.**

**Possible water entry is a concern at the right side of the front dormer, as evidenced by the water dripping through the pipe at the ceiling, just inside the right entry to the garage.**

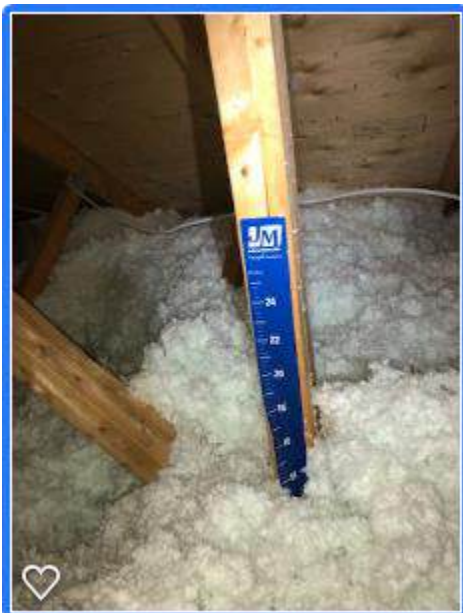
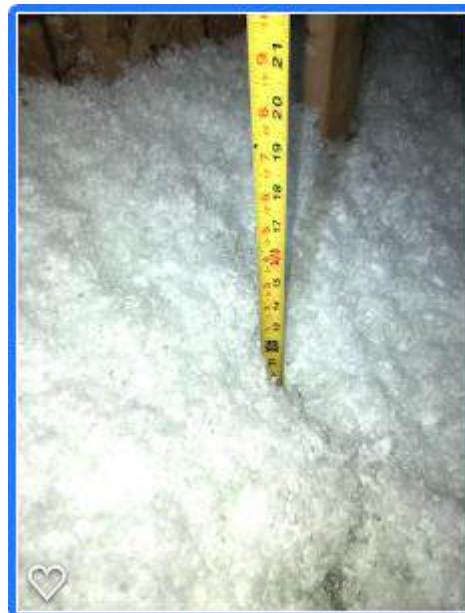
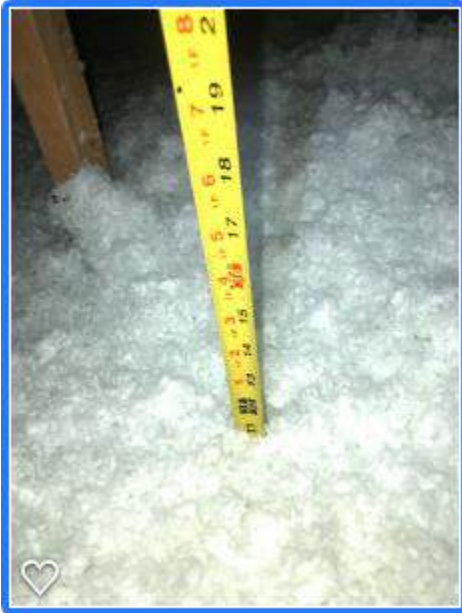
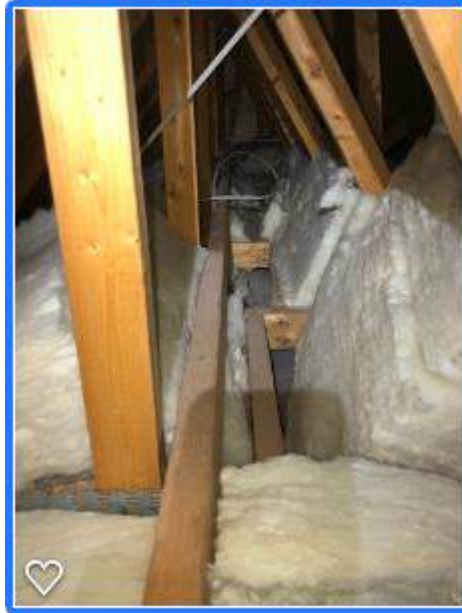
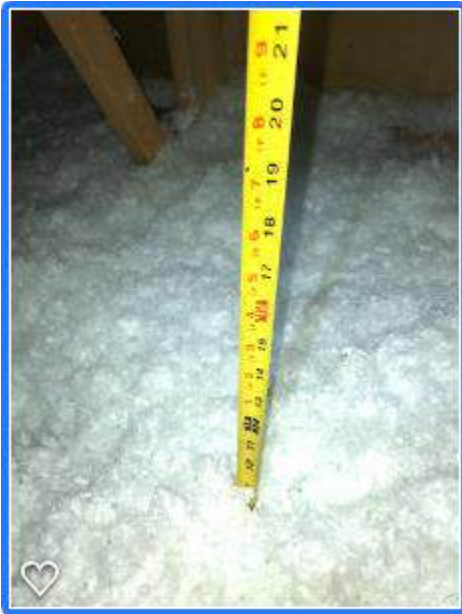
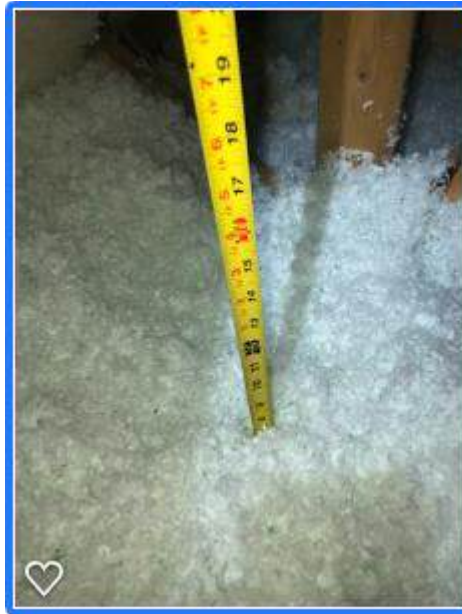
Insulation is significantly lacking at much of the attic; that includes at the loose insulation and the batts that have been installed over cathedral assemblies.

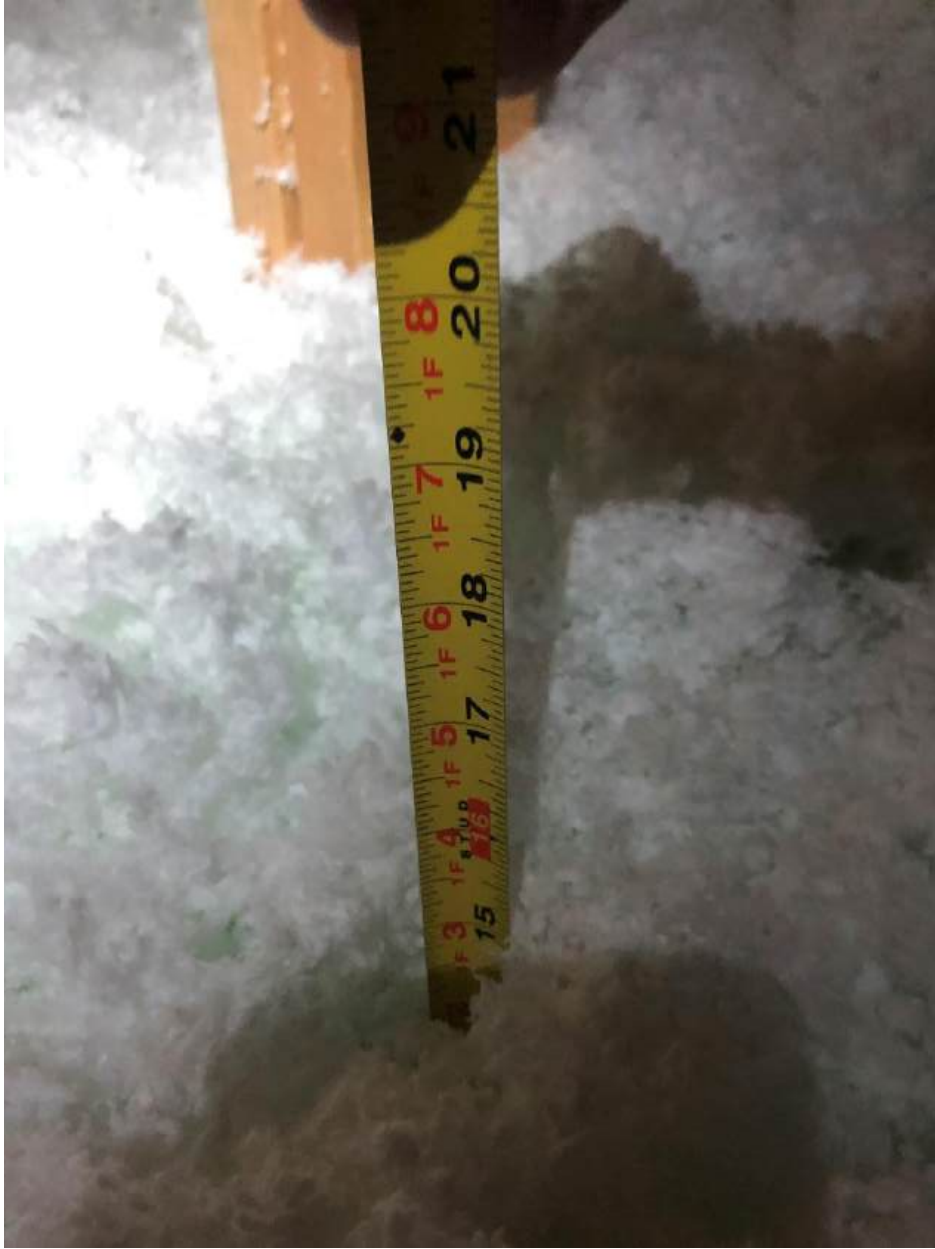
**However, the insulation is a few inches low just rear of the access point in the rear attic; it should be topped up there.**

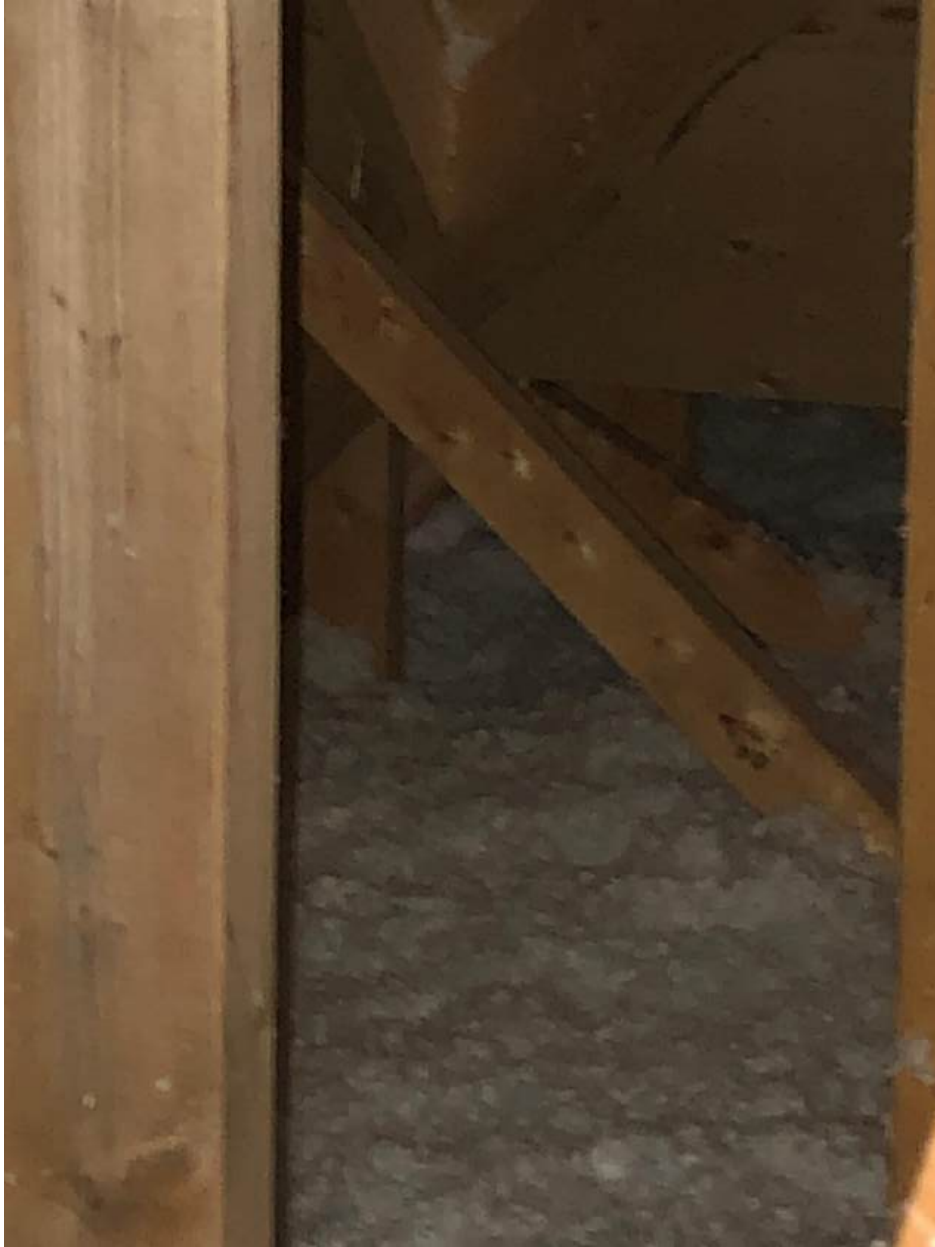
**Further, there appear to be low spots above the middle part of the front second floor bedroom. Those low spots are observable from the access to the high attic. And, the thought that the spots might be low were confirmed by thermal camera readings in the middle of the bedroom. The lowest ceiling reading of 19.5 degrees C was found at the middle of the right part of the front bedroom. The builder should be invited back to the home to address this deficiency.**

**A reading of 18.6 was taken at the right wall that separates Fatima's bedroom from the attic space above the front door and living room area.**

**So the coldest part of the room is the wall in between the front right attic and the bedroom and the second coldest part of the room is the floor in the bedroom.**

**The warmest part of the room is the ceiling, which means insulation is lacking above the garage and at the wall in between the bedroom and the attic.**

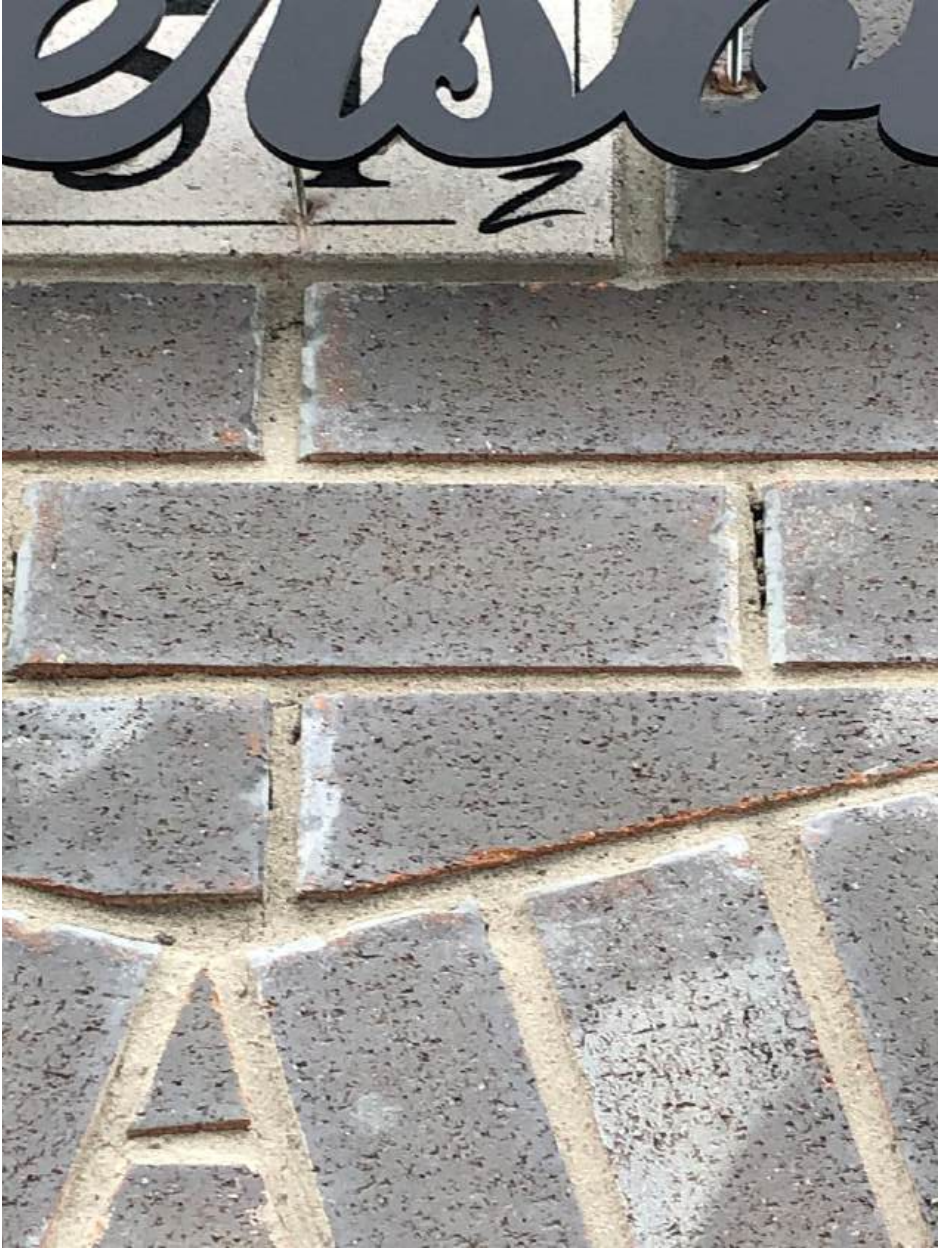
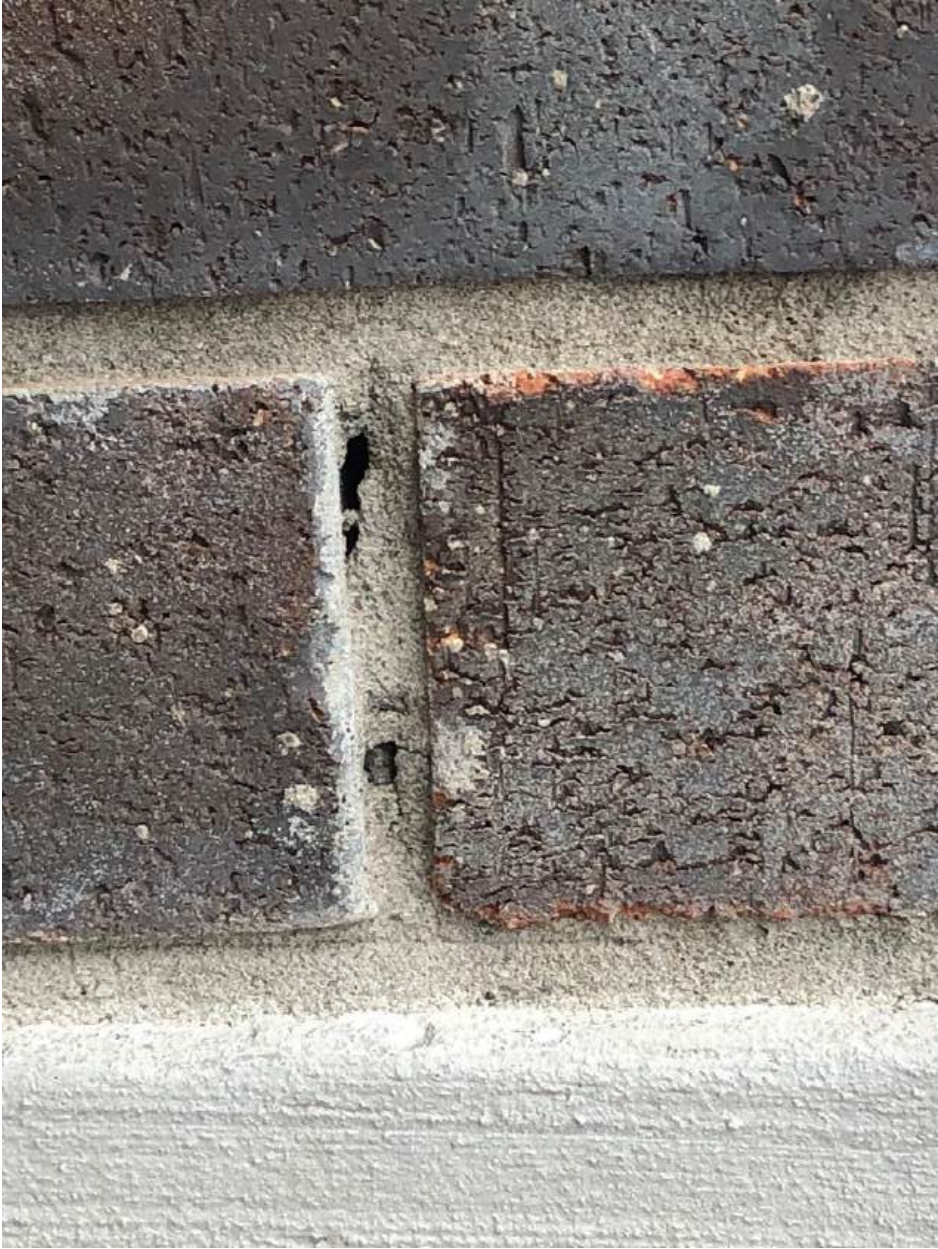
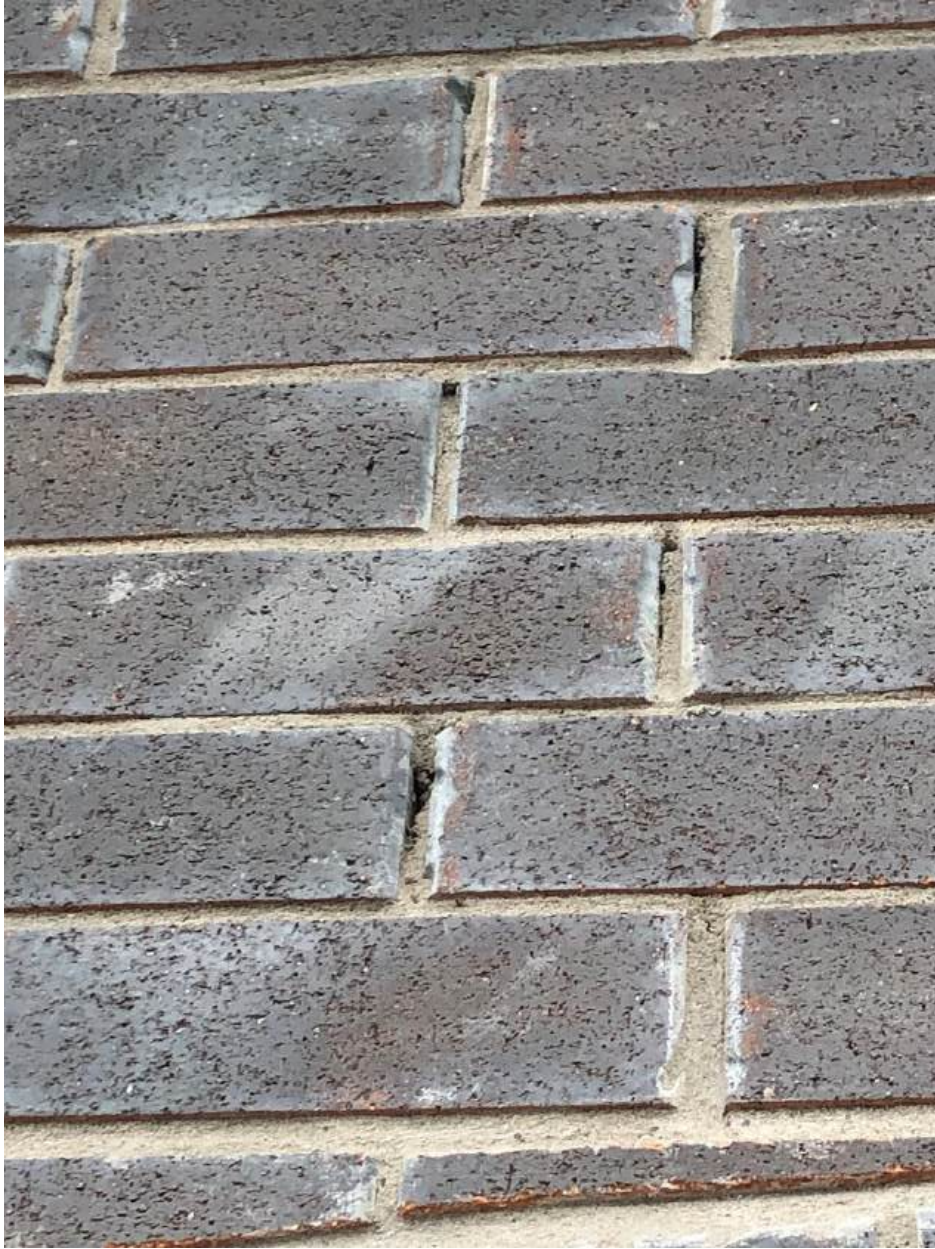
**Gaps, imperfections and openings are observable at many – something approaching 100 – locations at the brick masonry system. A masonry restoration expert will be required to match the colour of the brick mortar when correcting these obvious deficiencies.**

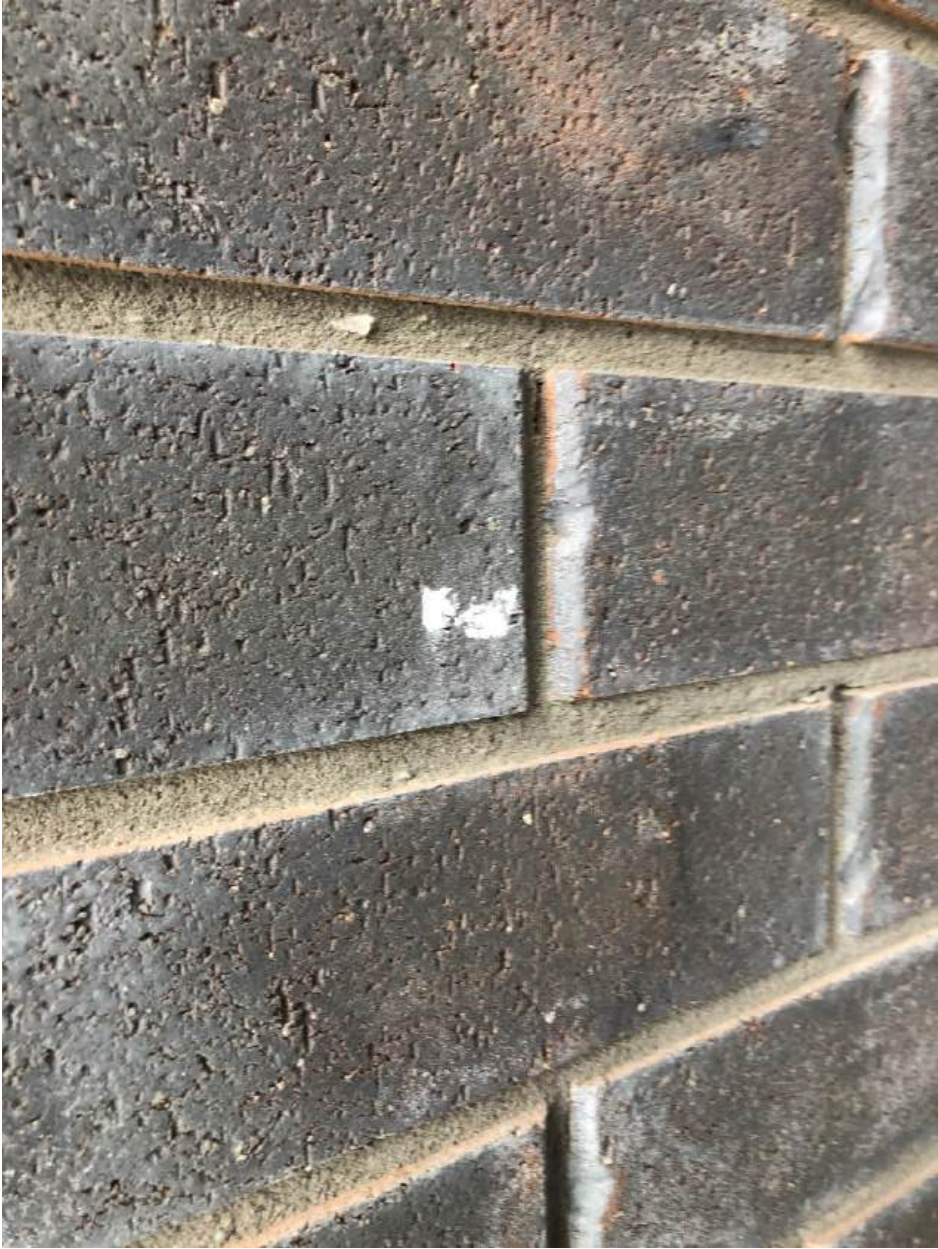
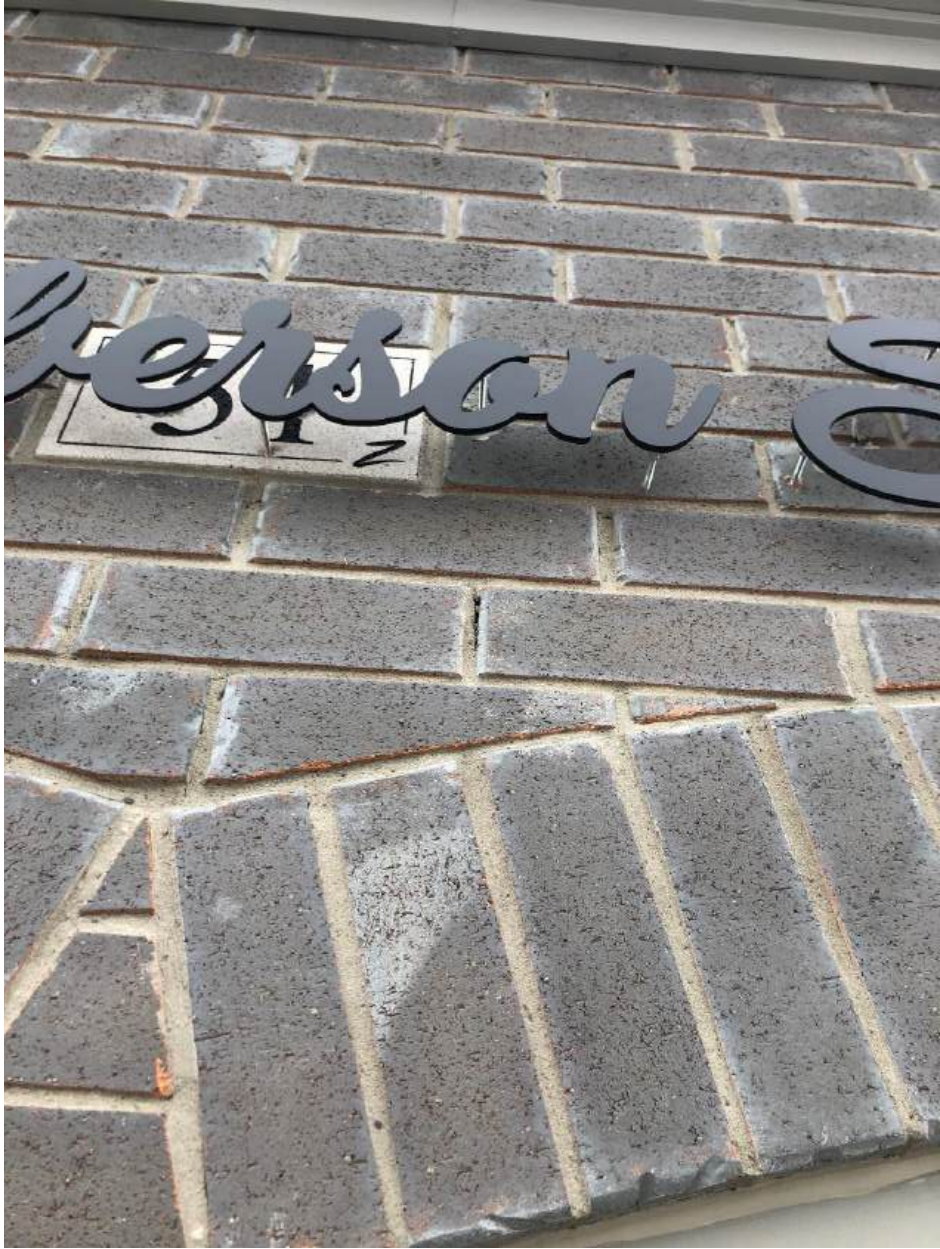
**Some cleaning is required at the brick system, including outside the front and rear doors.**

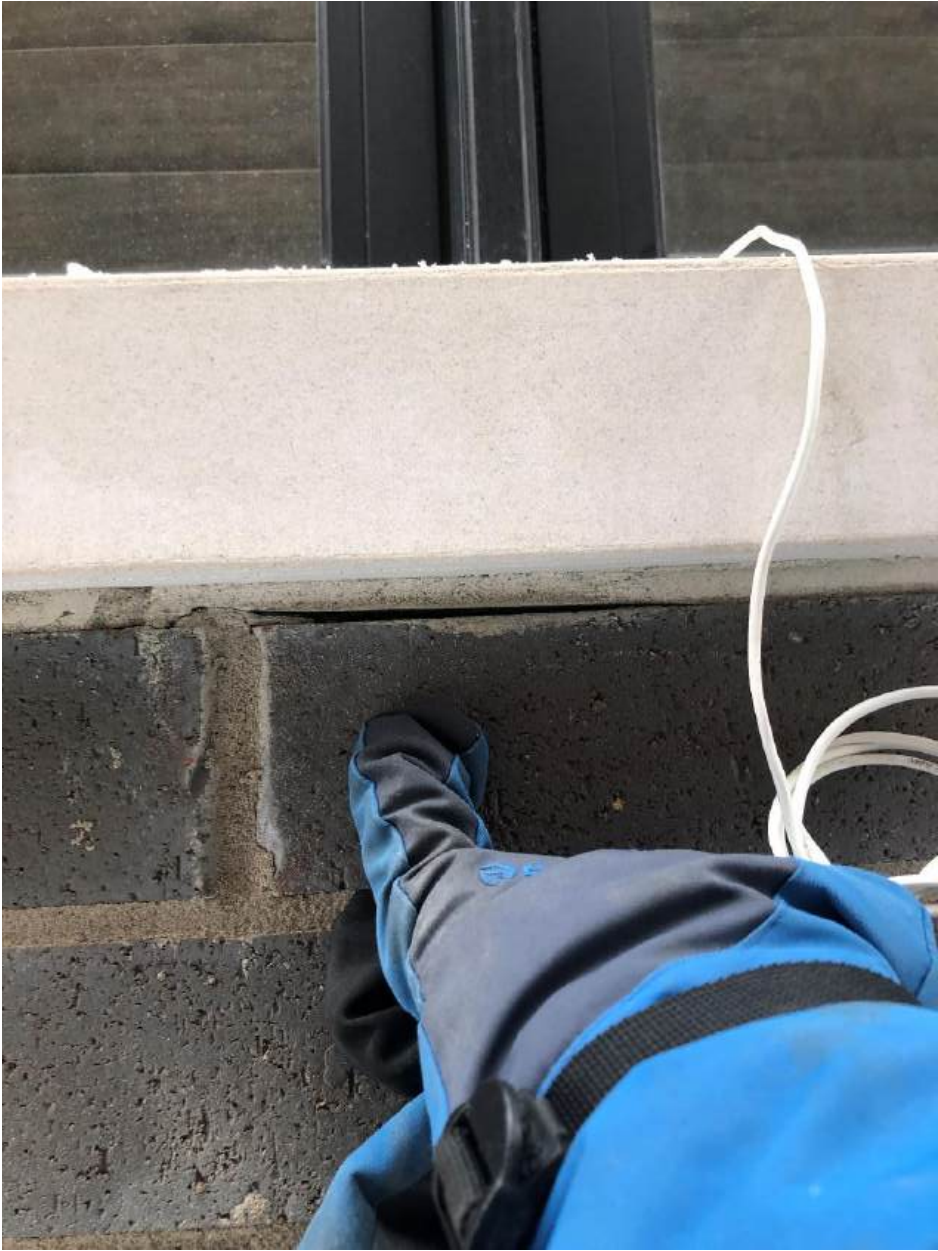
Sealant work is required under one of the window sills.

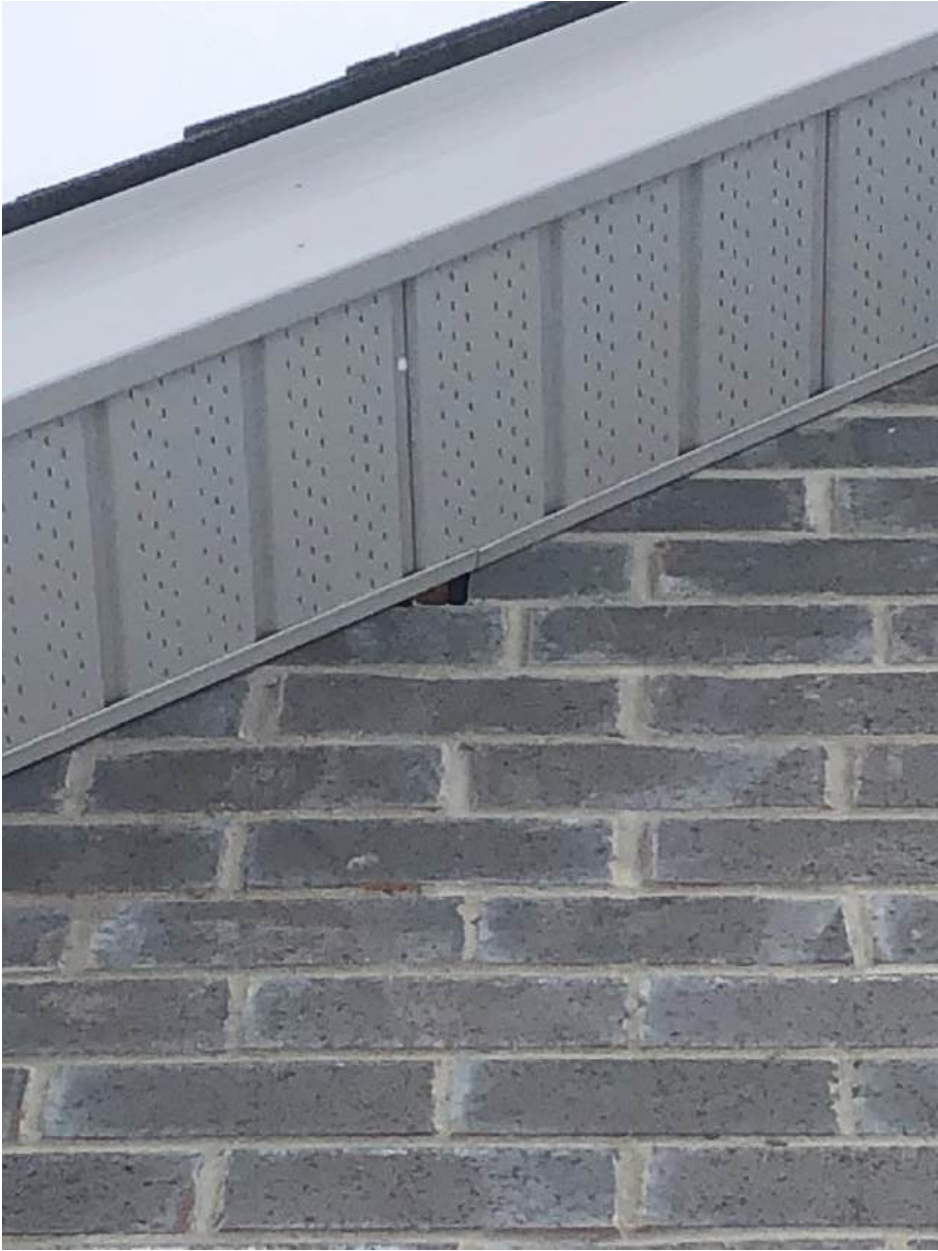
**A repair is required where the brick system meets the gable soffit assembly.**
