# SAFE HOMES CANADA HOME INSPECTION REPORT

## Tarion Inspection – First Year

**ADDRESS:** xx Mumberson Street, Cookstown, ON

**This inspection is a Tarion Warranty inspection for a new home.**

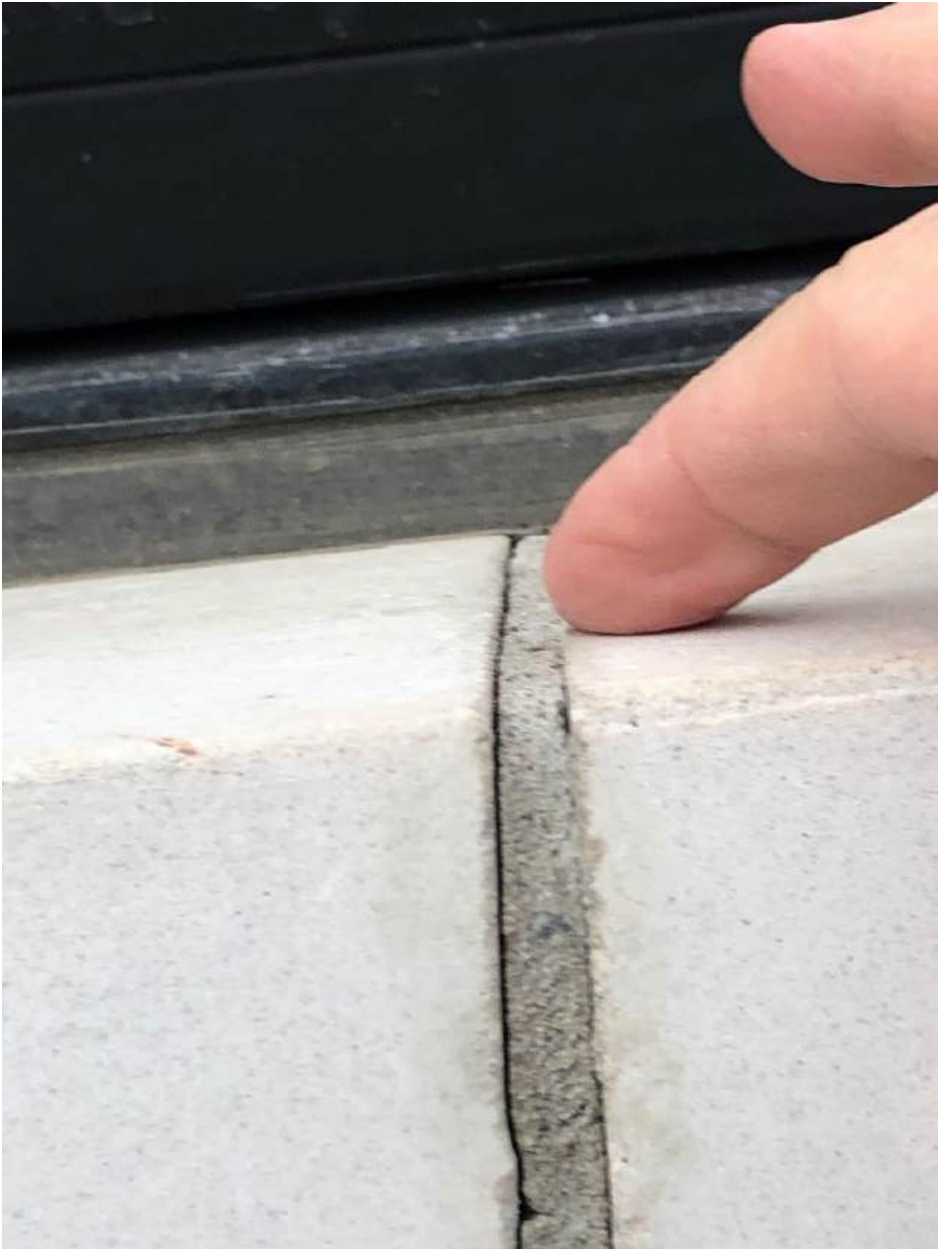
All horizontally-aligned mortar joints within window and door sills must be caulked.

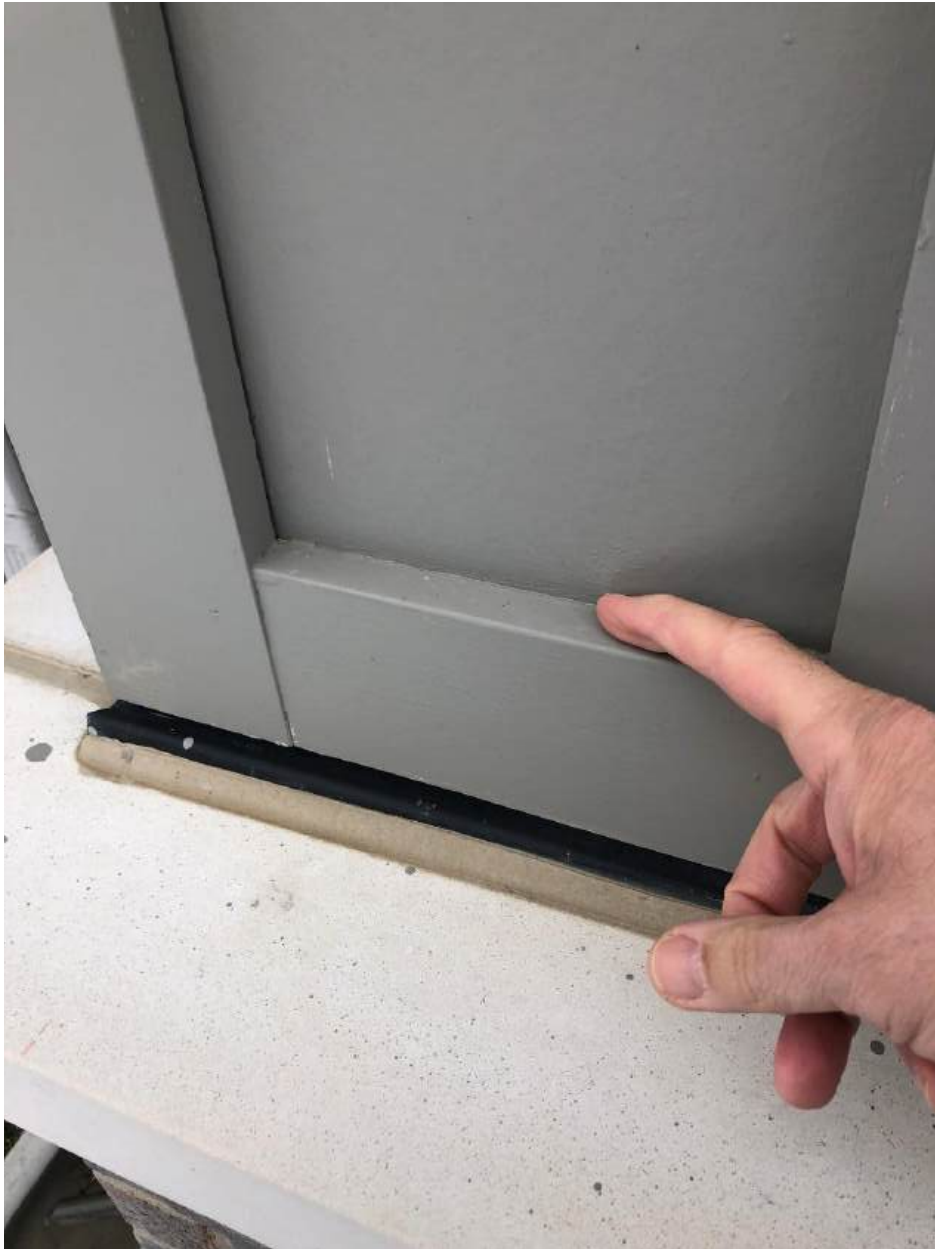
**Open joints at the decorative mouldings should be waterproof or they should be caulked.**

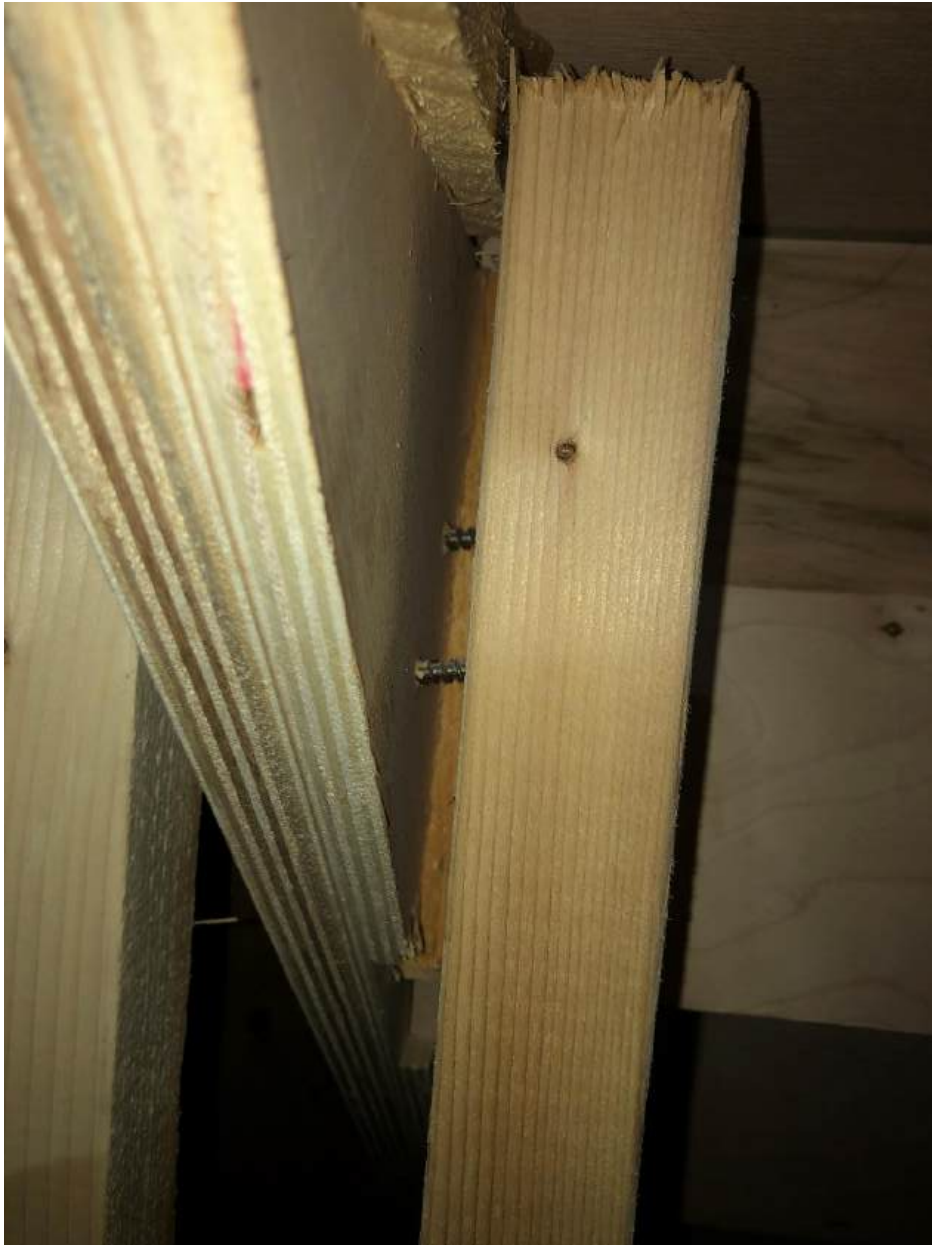
**Significant gaps are observable between the basement stair stringers and the members that support them for stability. Further, those added support members are informal. Vertical posts are recommended under the middle parts of the stringers.**

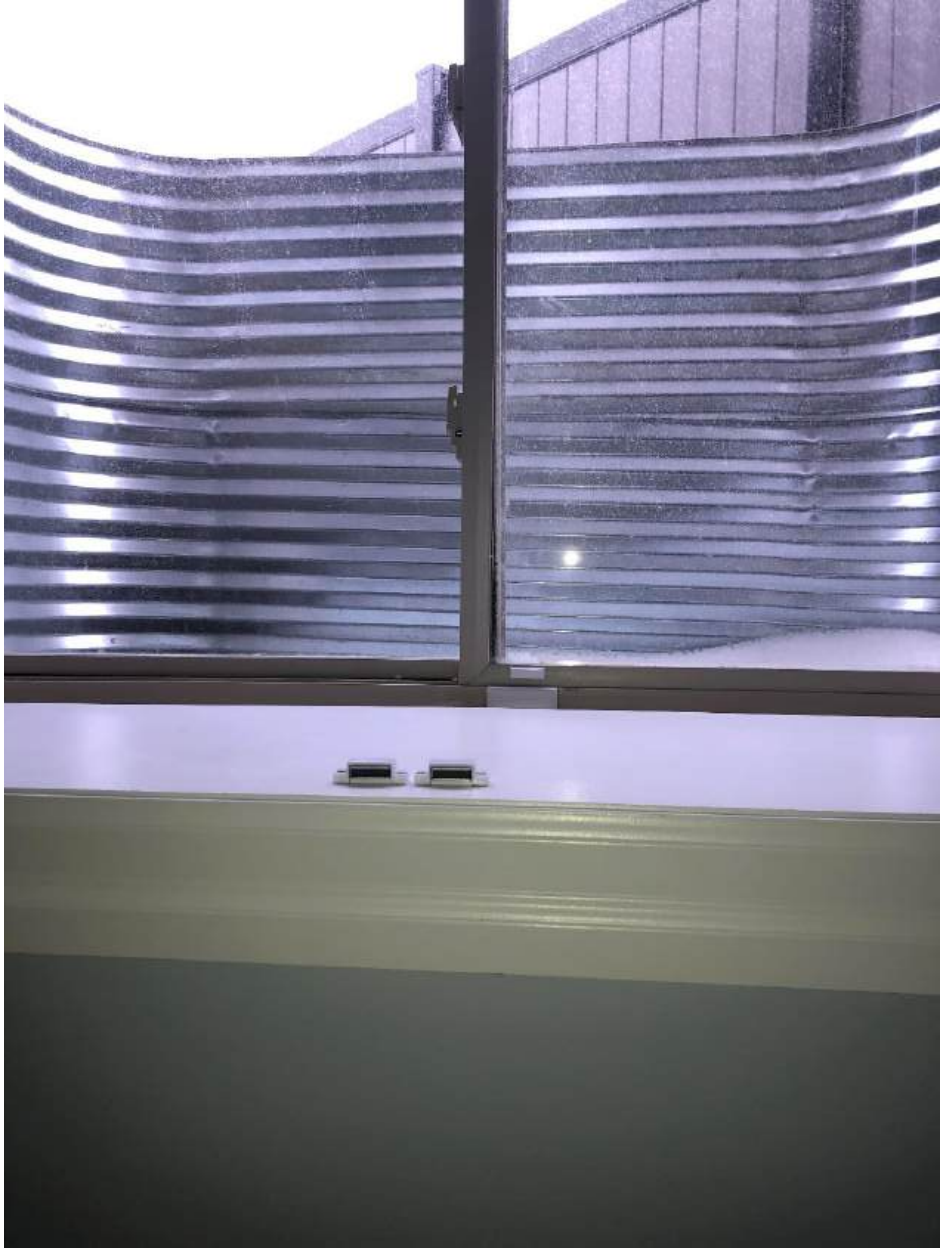
**However, the window in the back right basement bedroom is bowed, and the vinyl track at the sill is not fully connected to the framing below. The bow in the window track has not affected function or thermal resistance significantly, but it should be noted as a deficiency.**

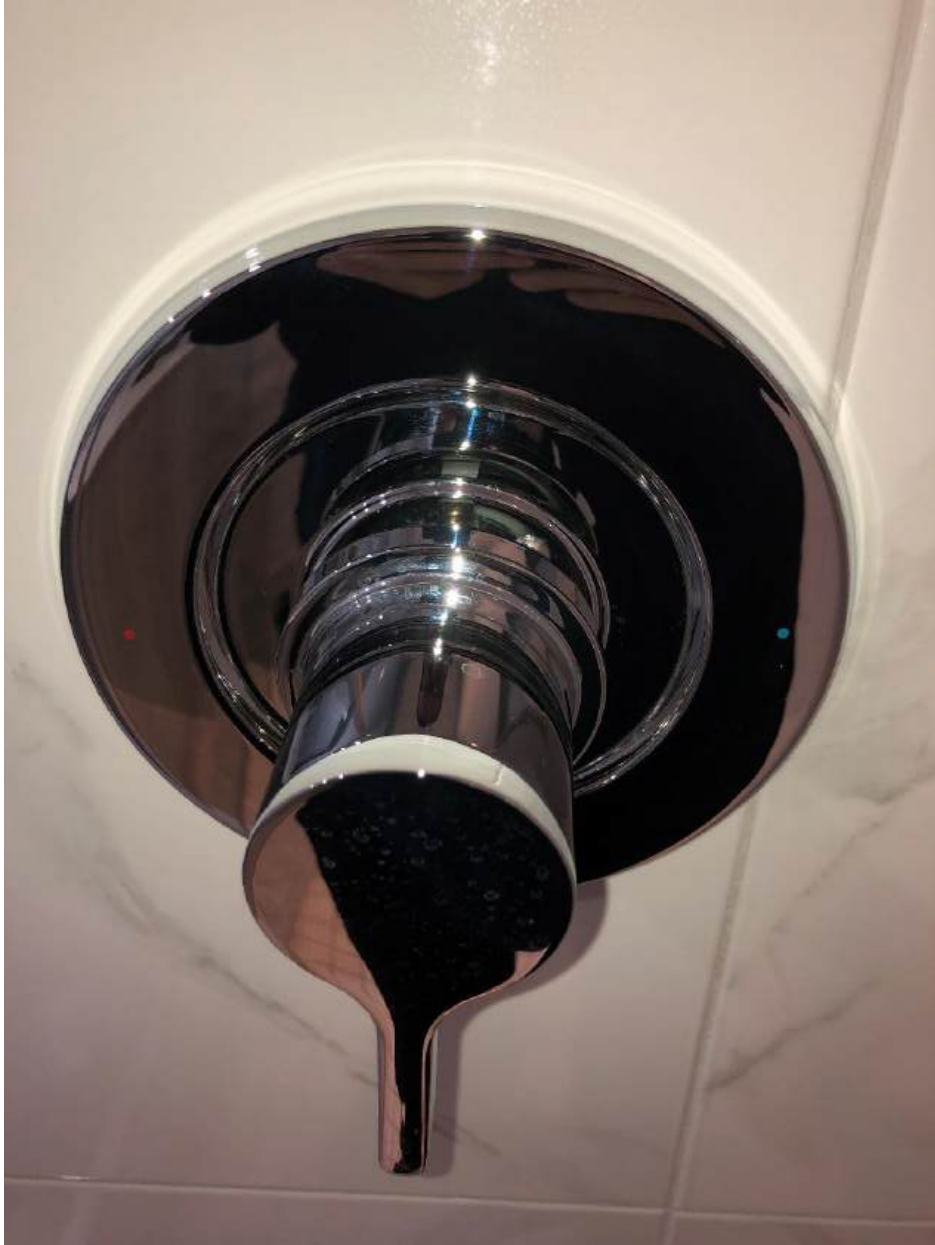
Caulking is incomplete at fixture junctions and escutcheon plates.

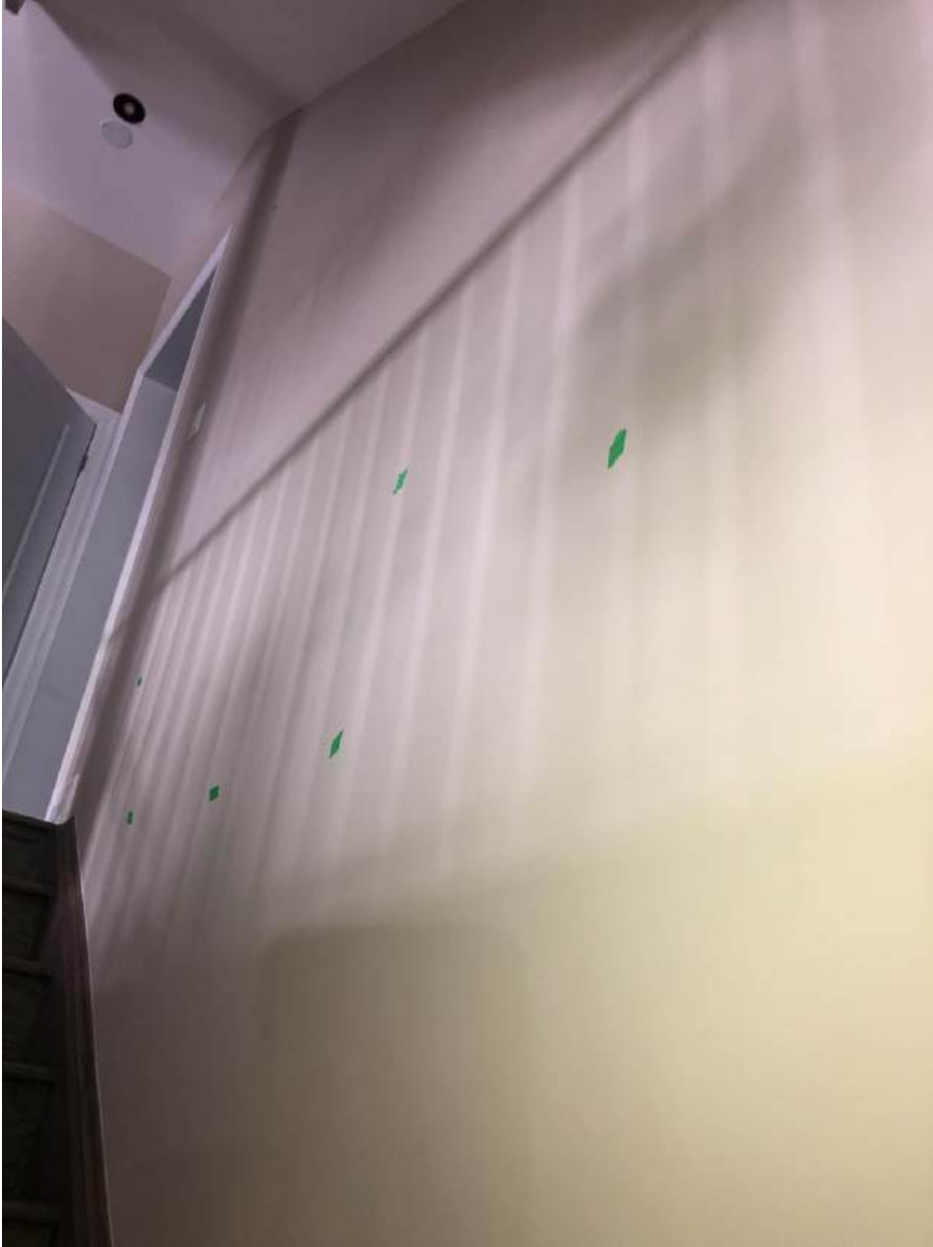
Drywall imperfections are observable at various locations.

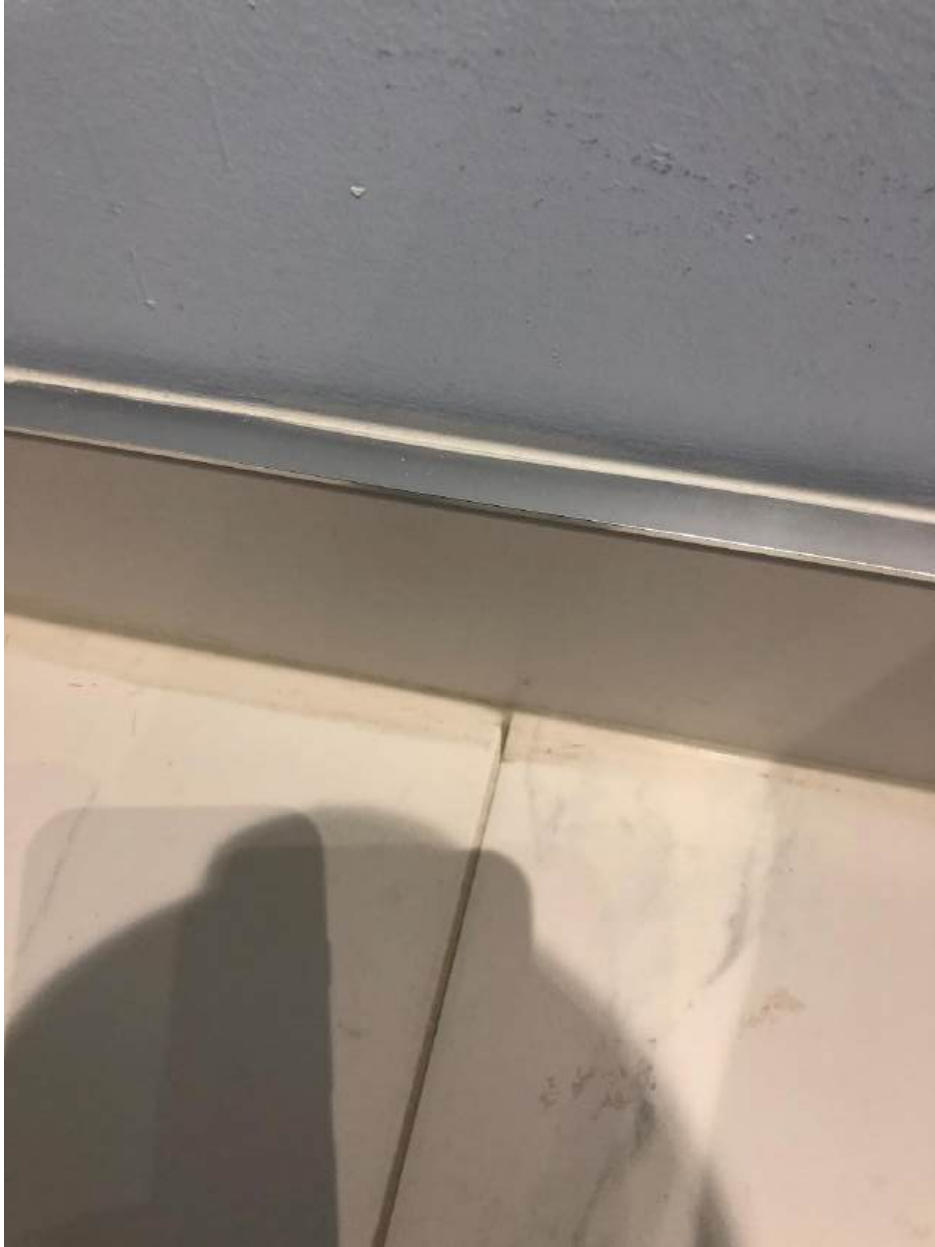
**Final caulking is incomplete at the open joints at the junctions where the windows meet interior finishes.**

**The kickplates in the main floor powder room and under the kitchen sink are loose.**

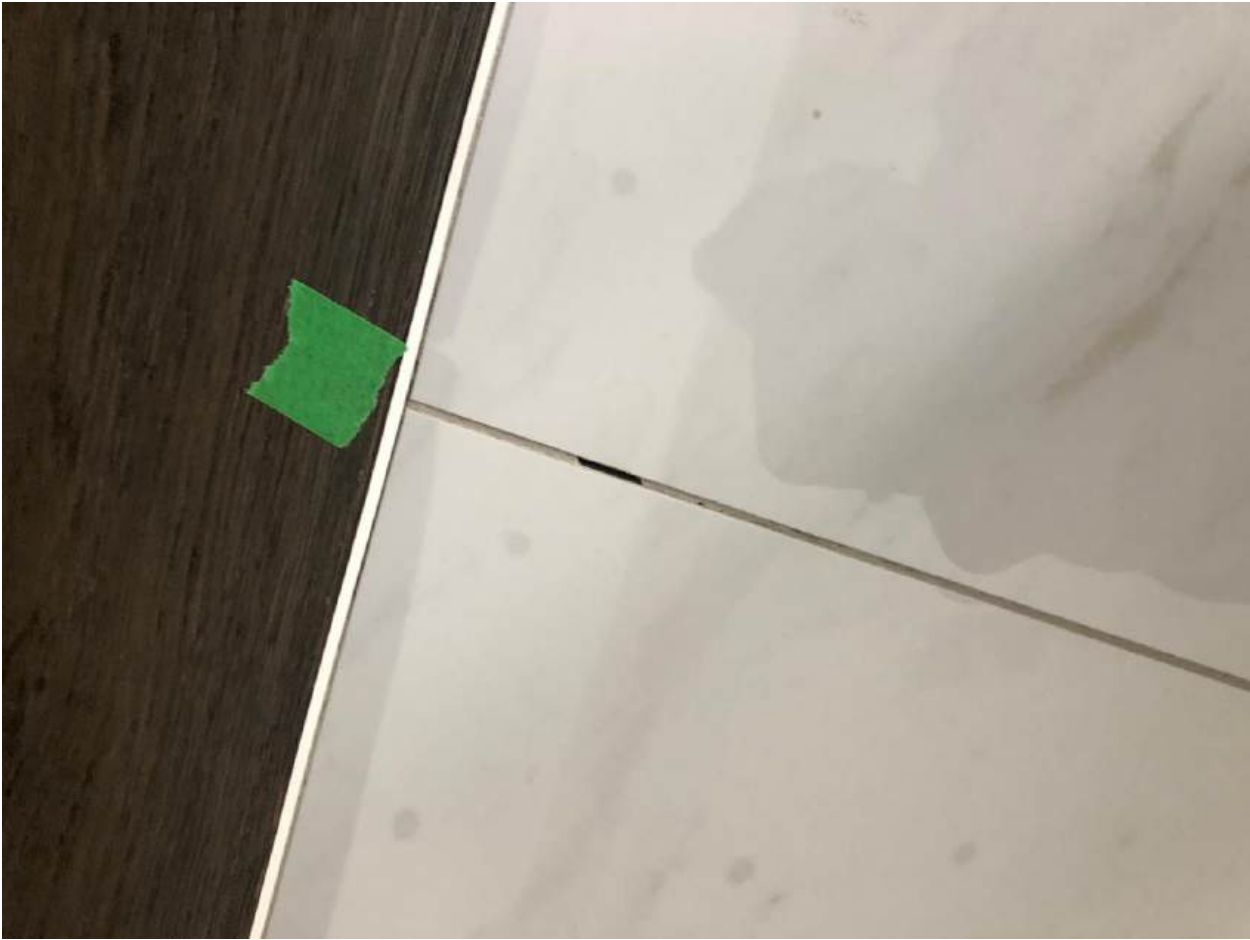
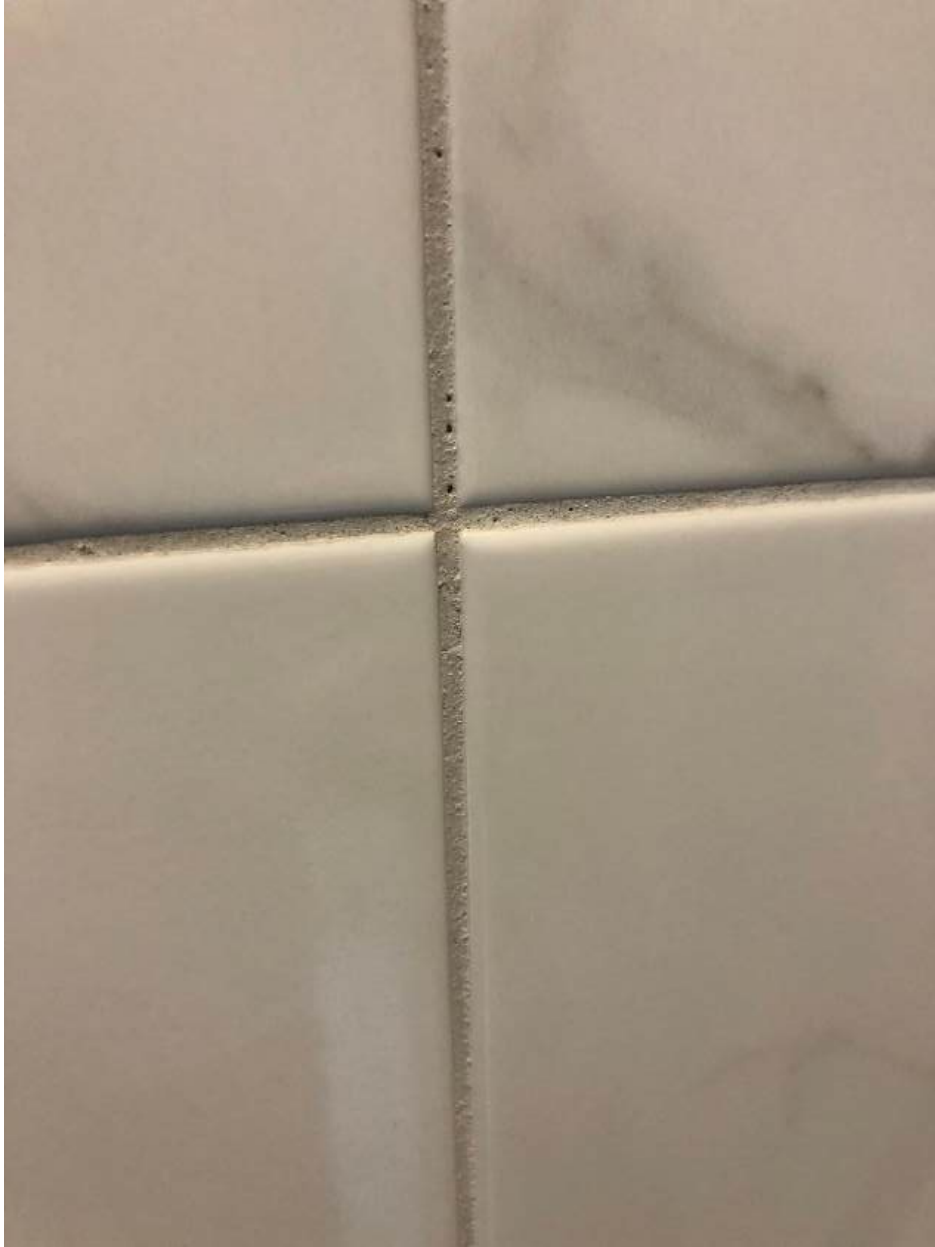
**The floor tiles in the main floor powder room are mis-aligned with reference to the home's design; they should be perpendicular to the as-built configuration.**

**Grout imperfections were observed at the floor times in the breakfast nook and at one of the showers.**

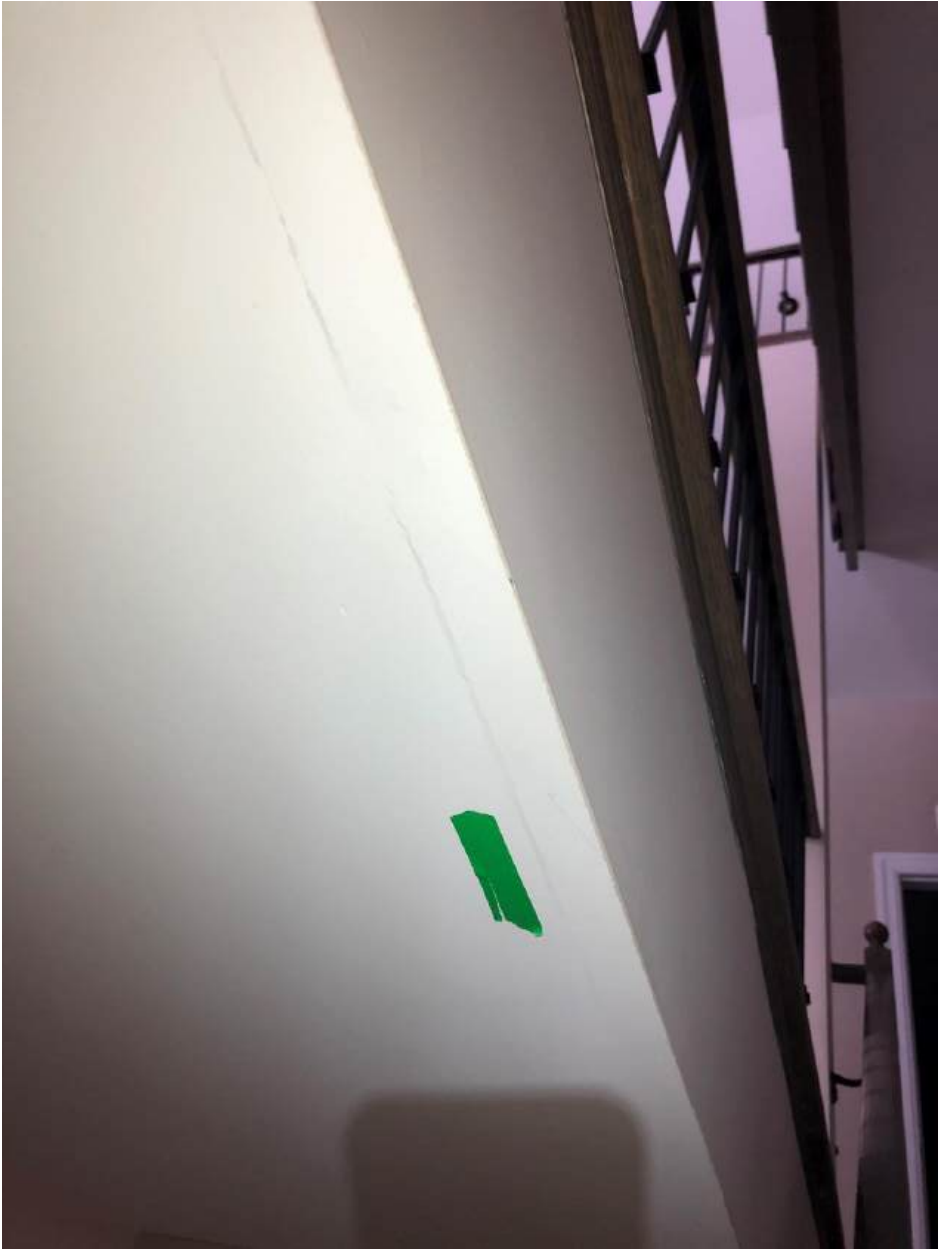
Work is required at corner beads. (See photo below.)

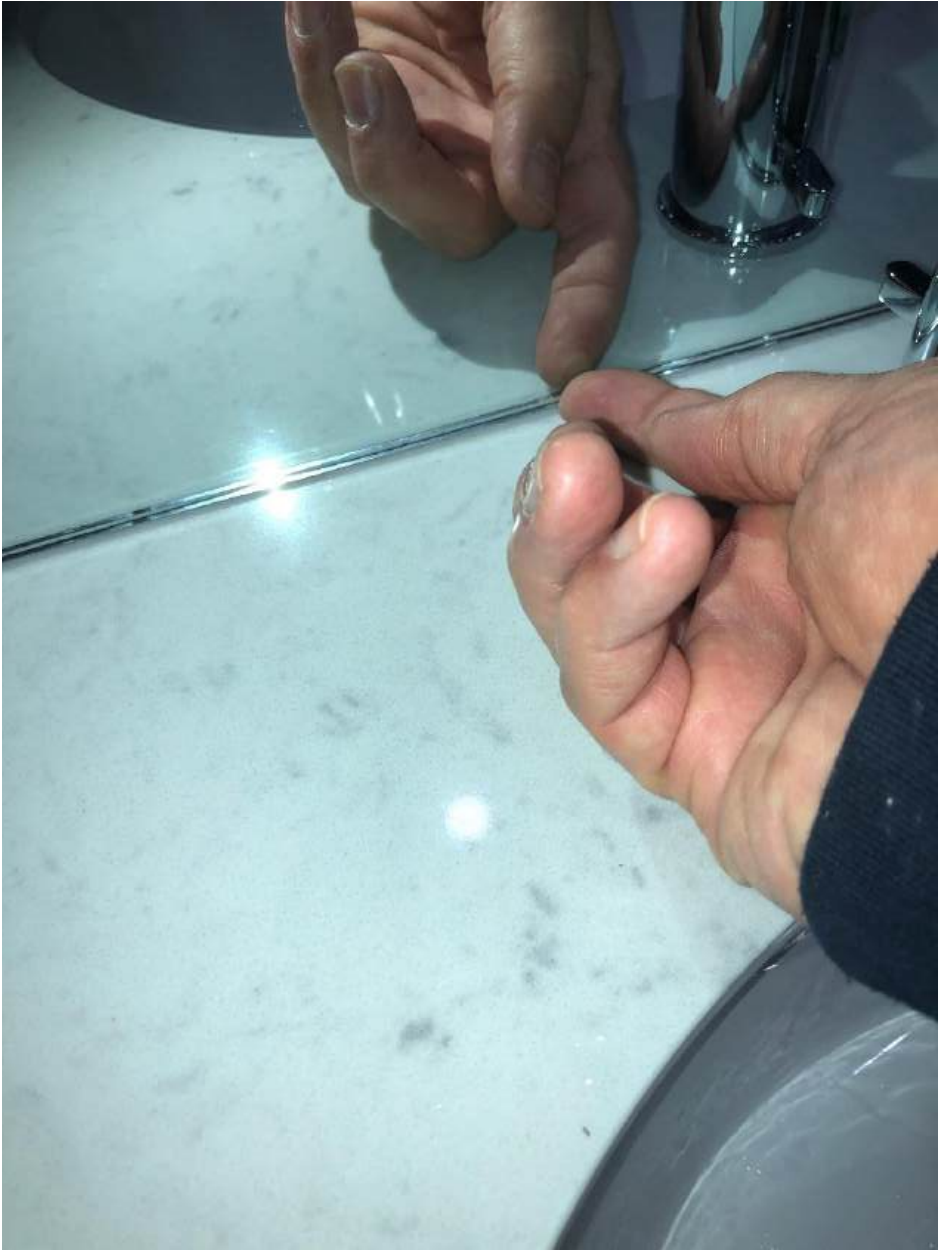
Sealant should be added where mirrors meet countertops.

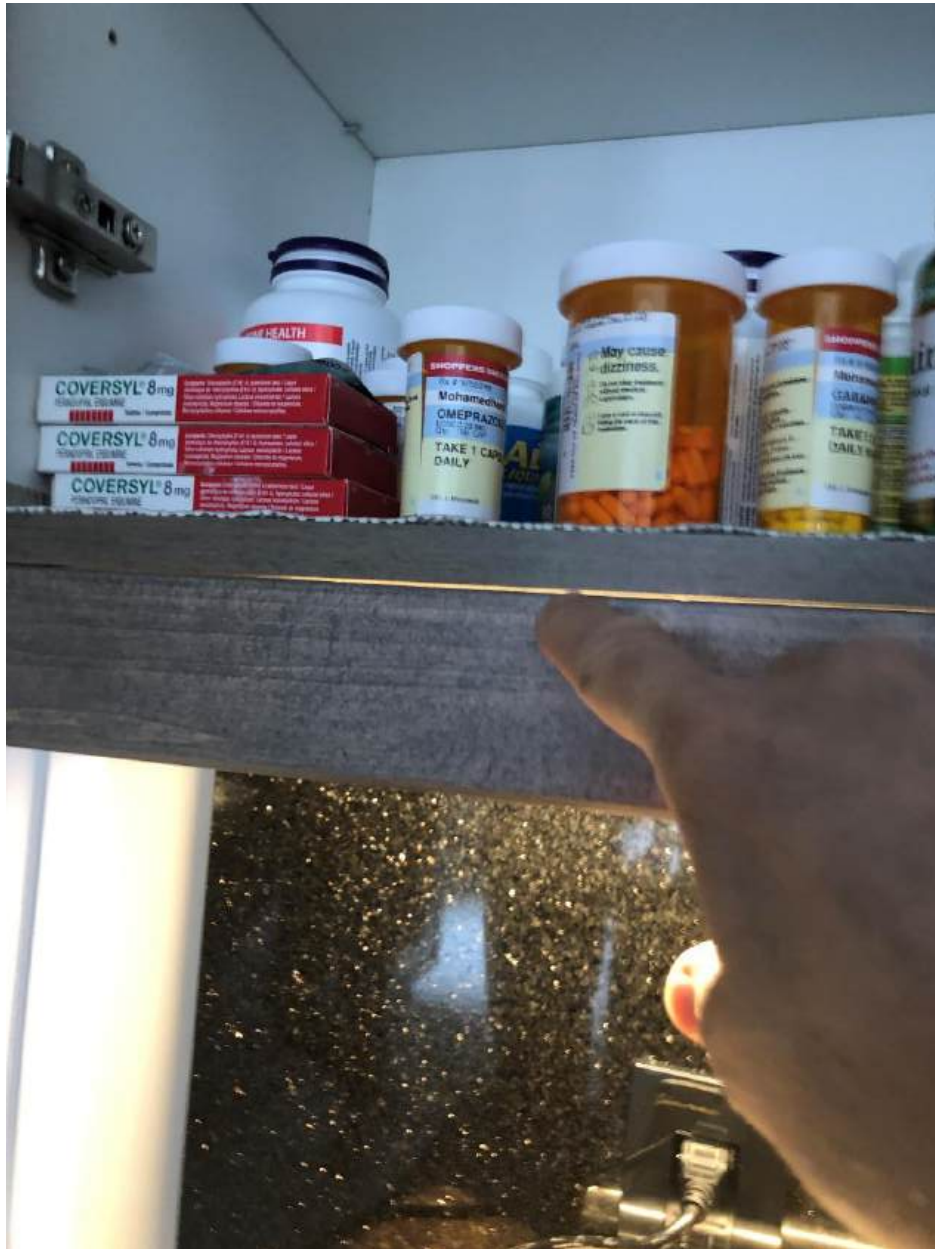
Significant gaps are observable at horizontal joints at the bottom of cabinets; they are unsightly. Perhaps the visible light can be eliminated by caulking from the insides of the cabinets (underneath).

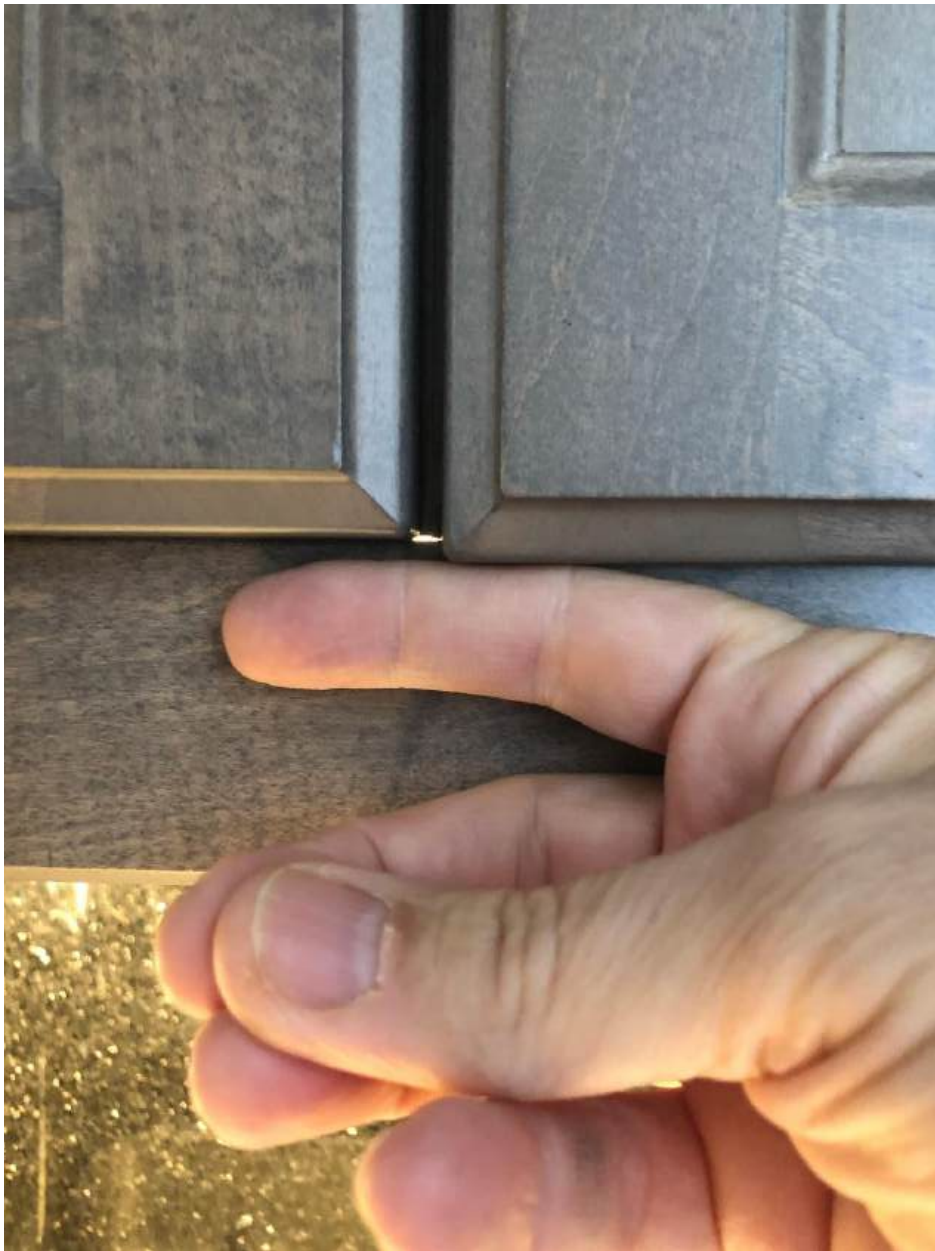
**Adjacent doors do not line up in elevation at the right side of the pantry and to the rear of the stove.**

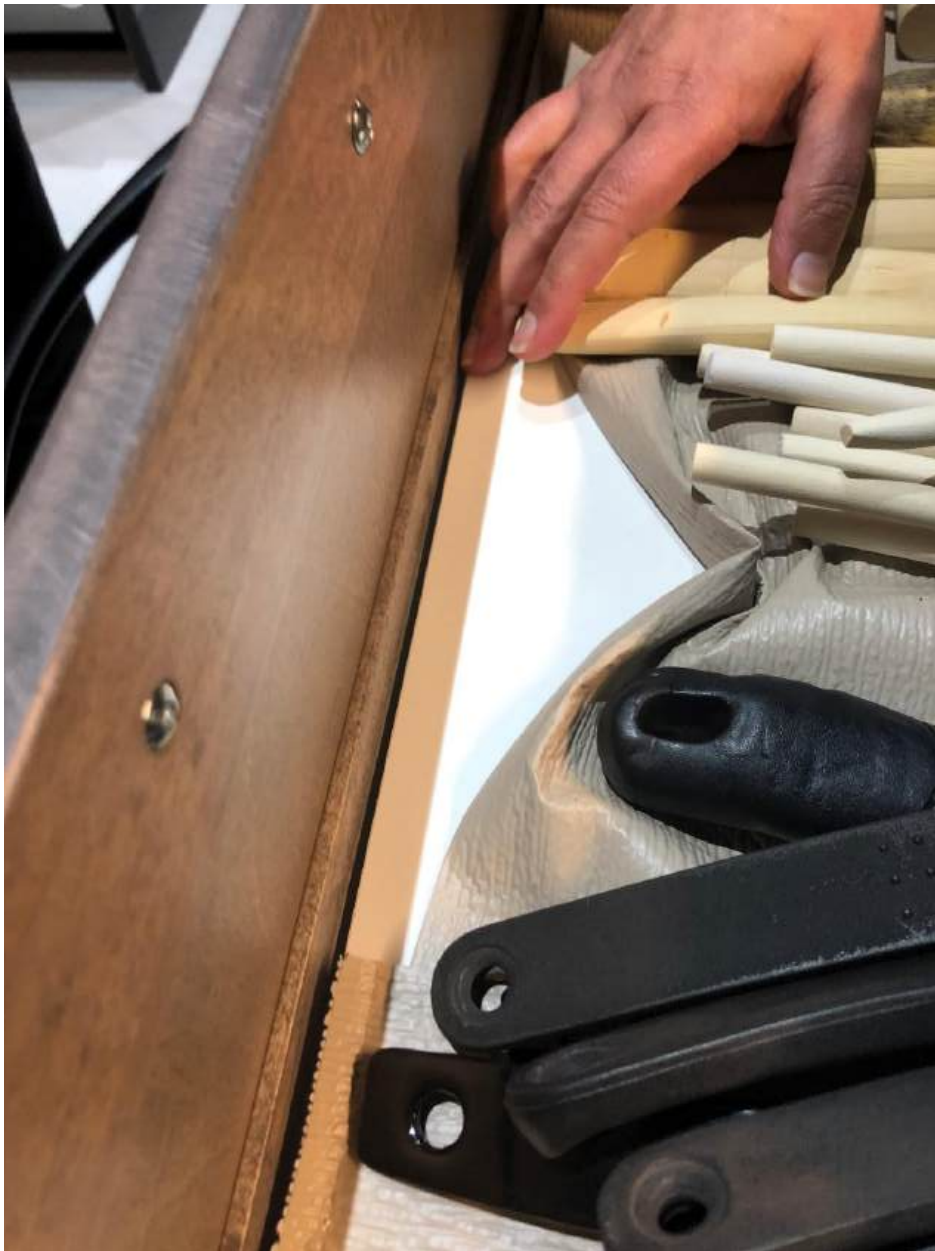
**A gap is observable inside the kitchen drawers where the face piece meets the bottom section.**

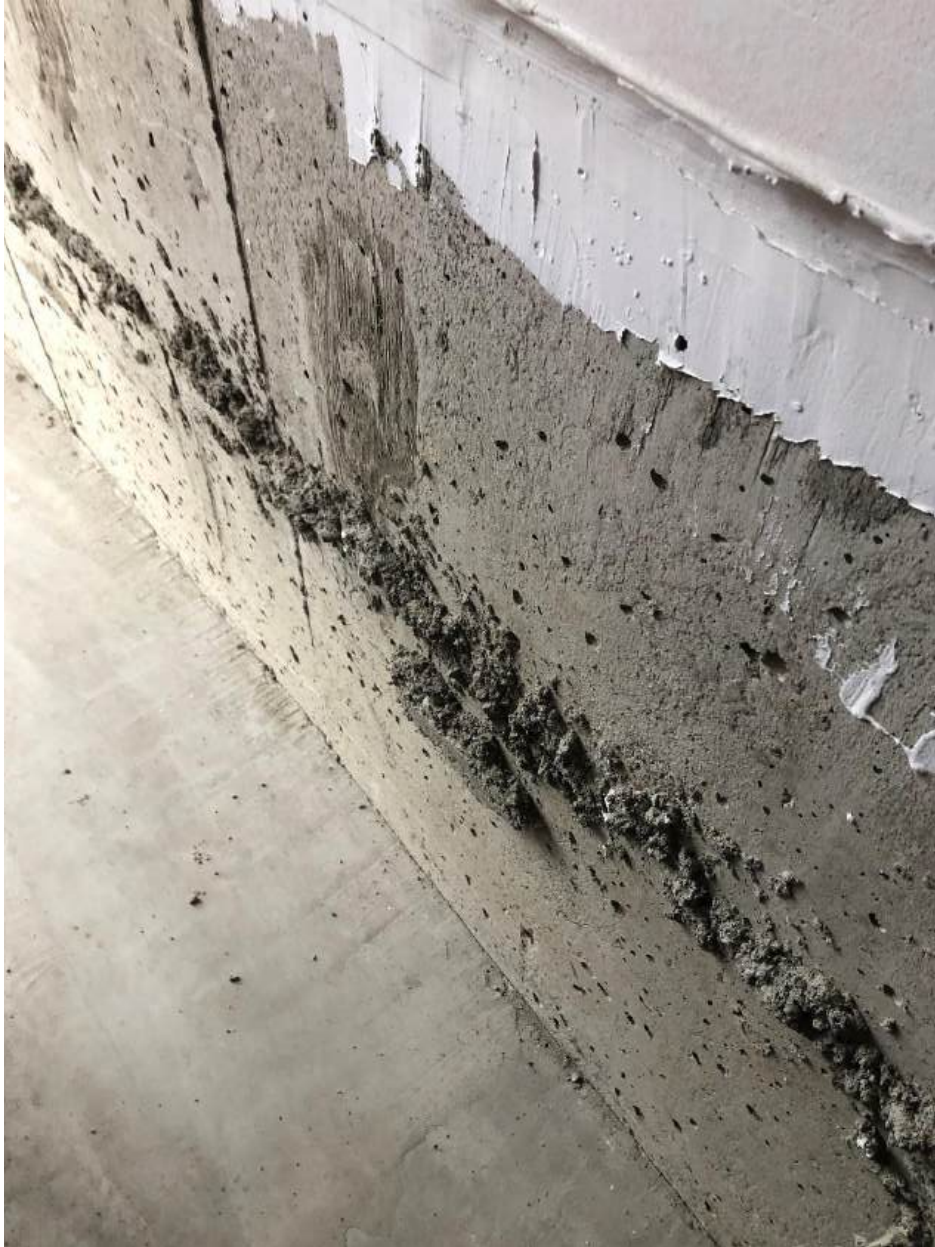
**The concrete surface inside the garage has not been formally finished.**

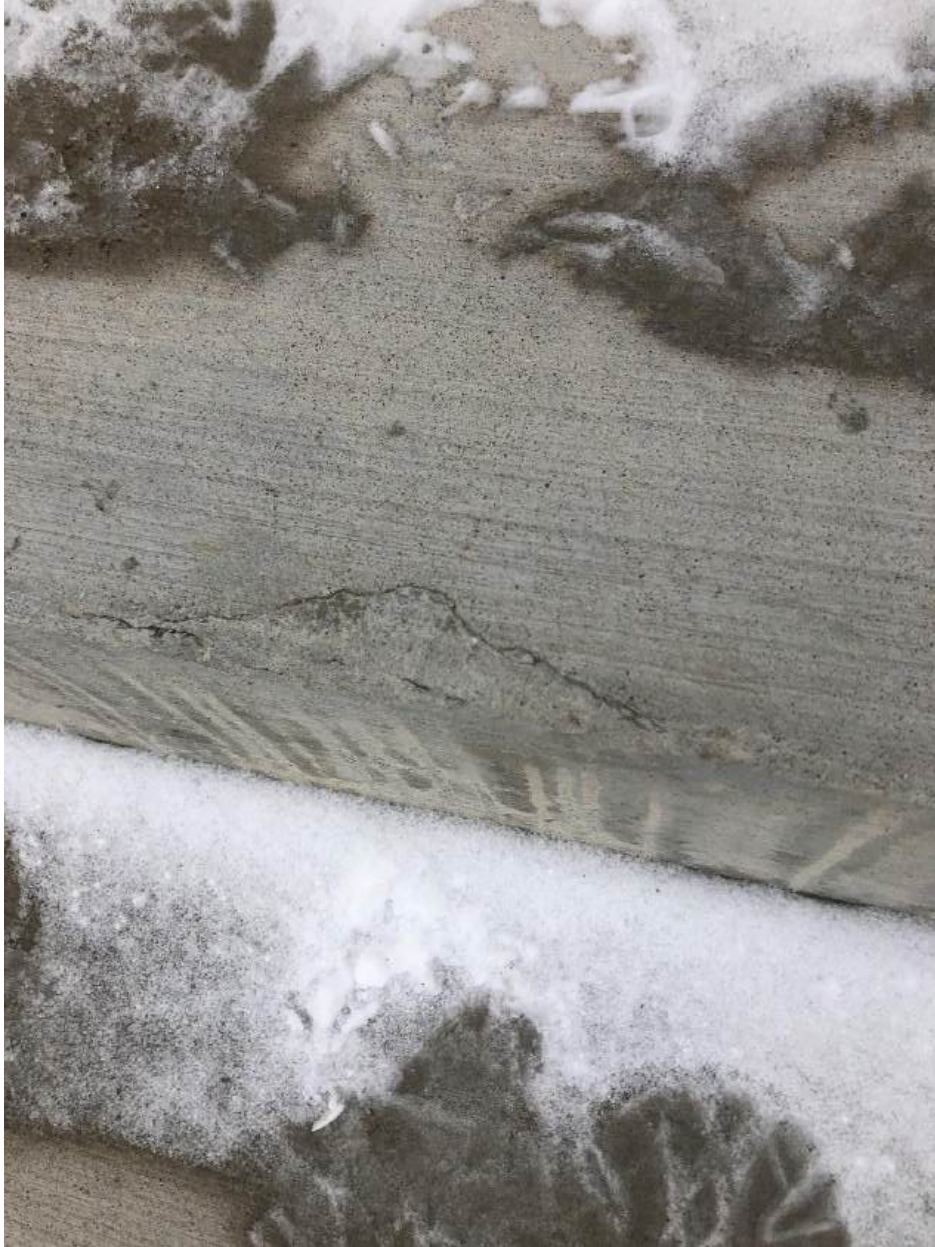
Some patching is required at the front exterior stairs.
