# **SAFE HOMES CANADA HOME INSPECTION REPORT**

**ADDRESS:** x Lavender Hill Road, Dunedin, ON

**DATE:** December 12, 2022

**AGE OF HOME:** 120 years (approximately)

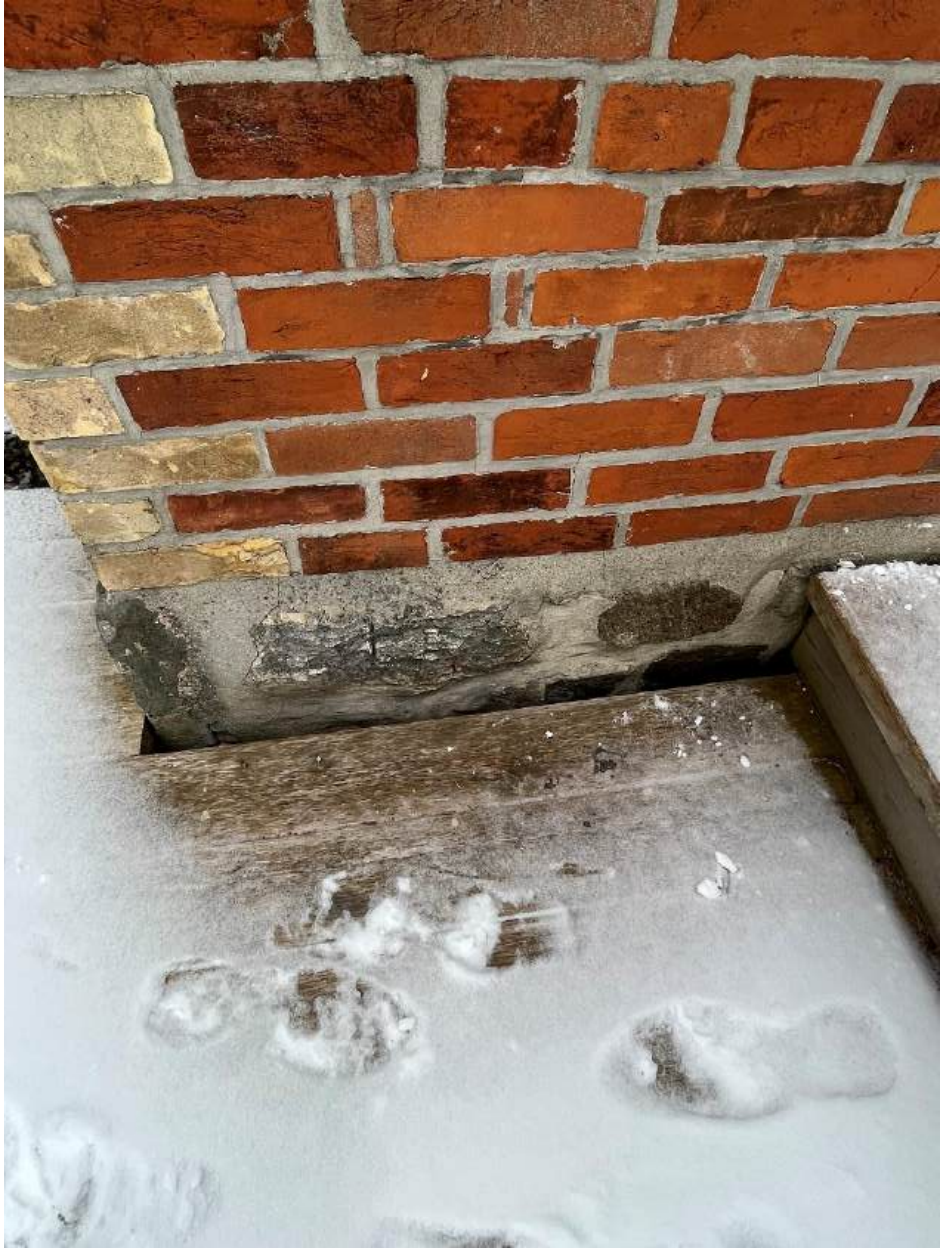
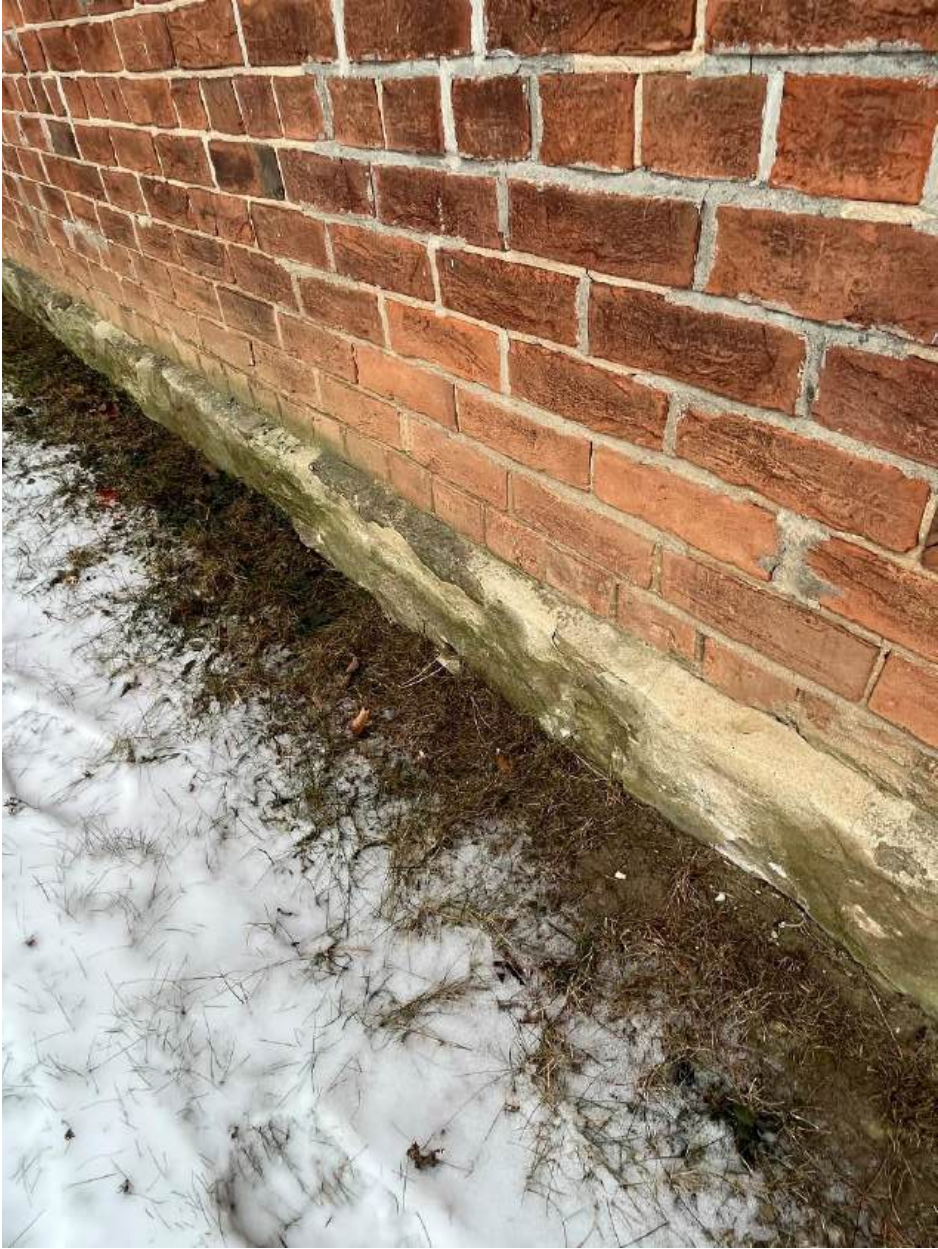
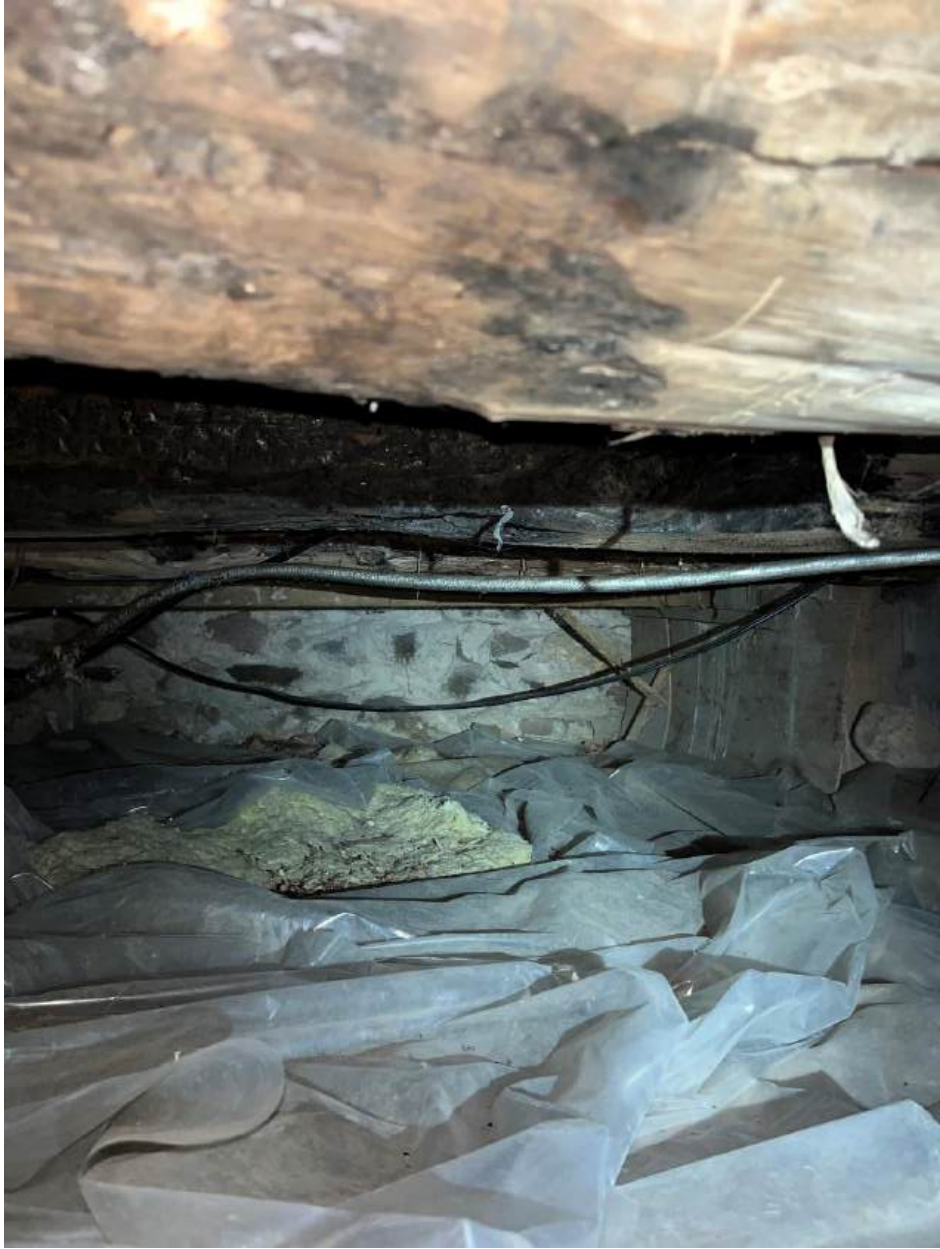
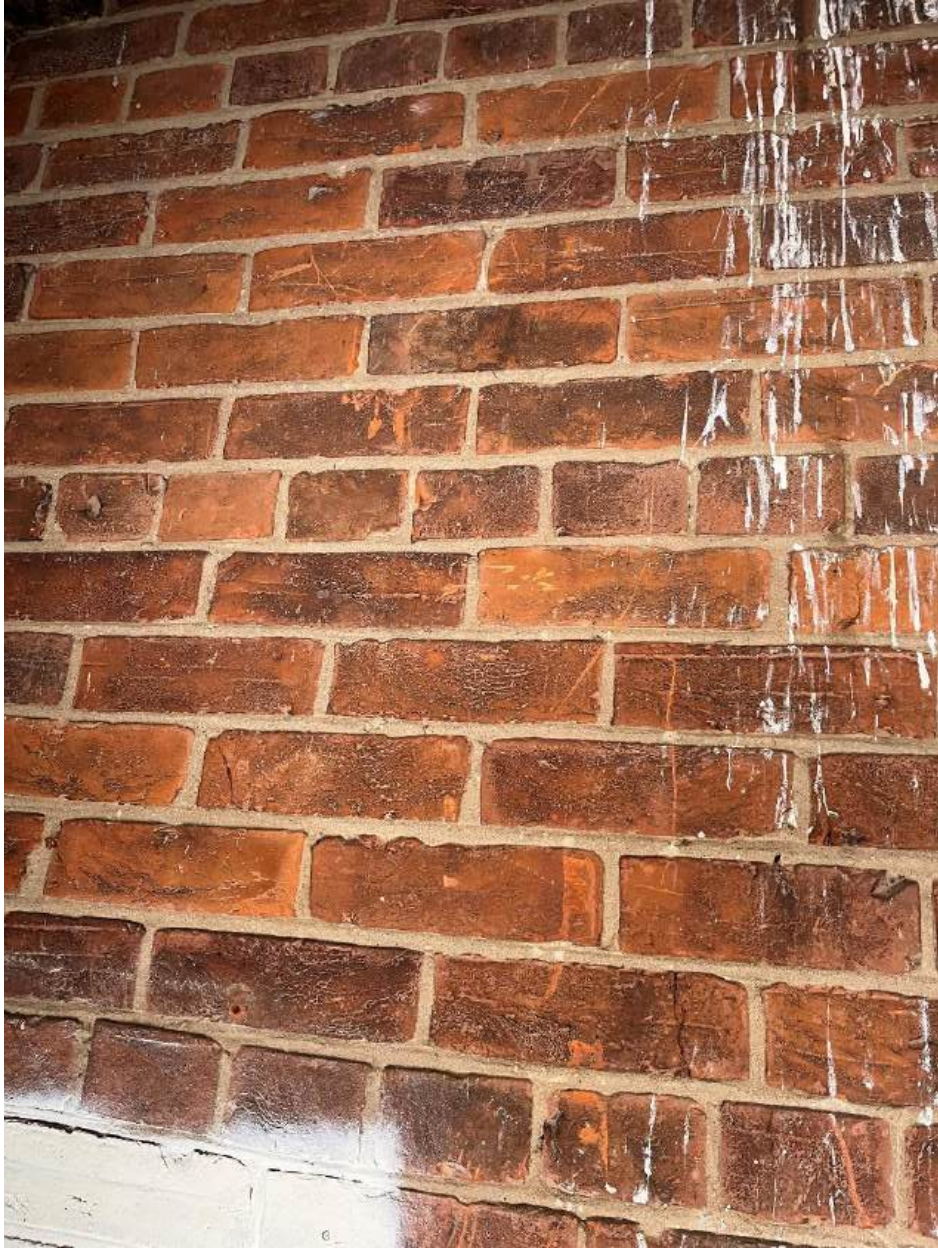
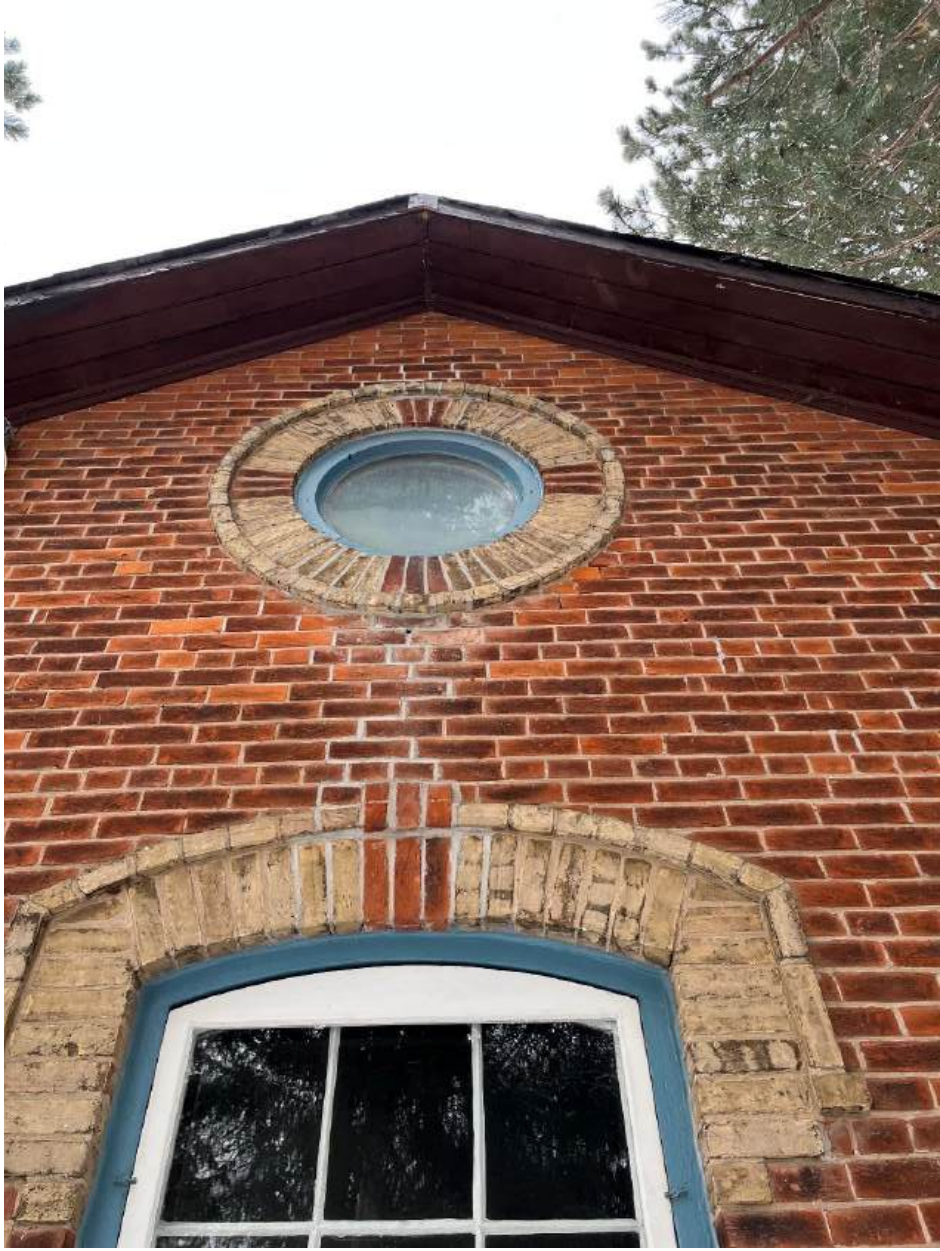
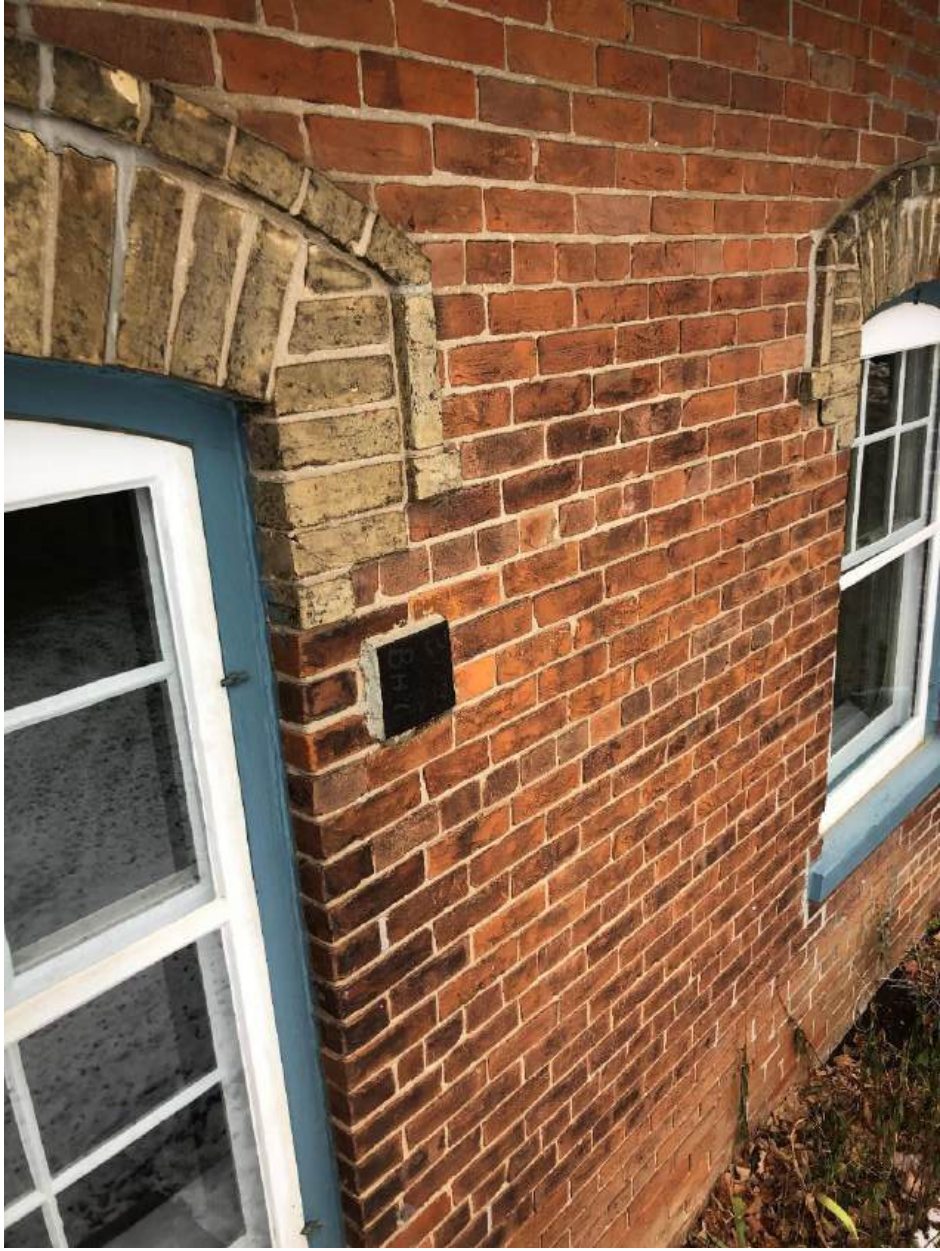
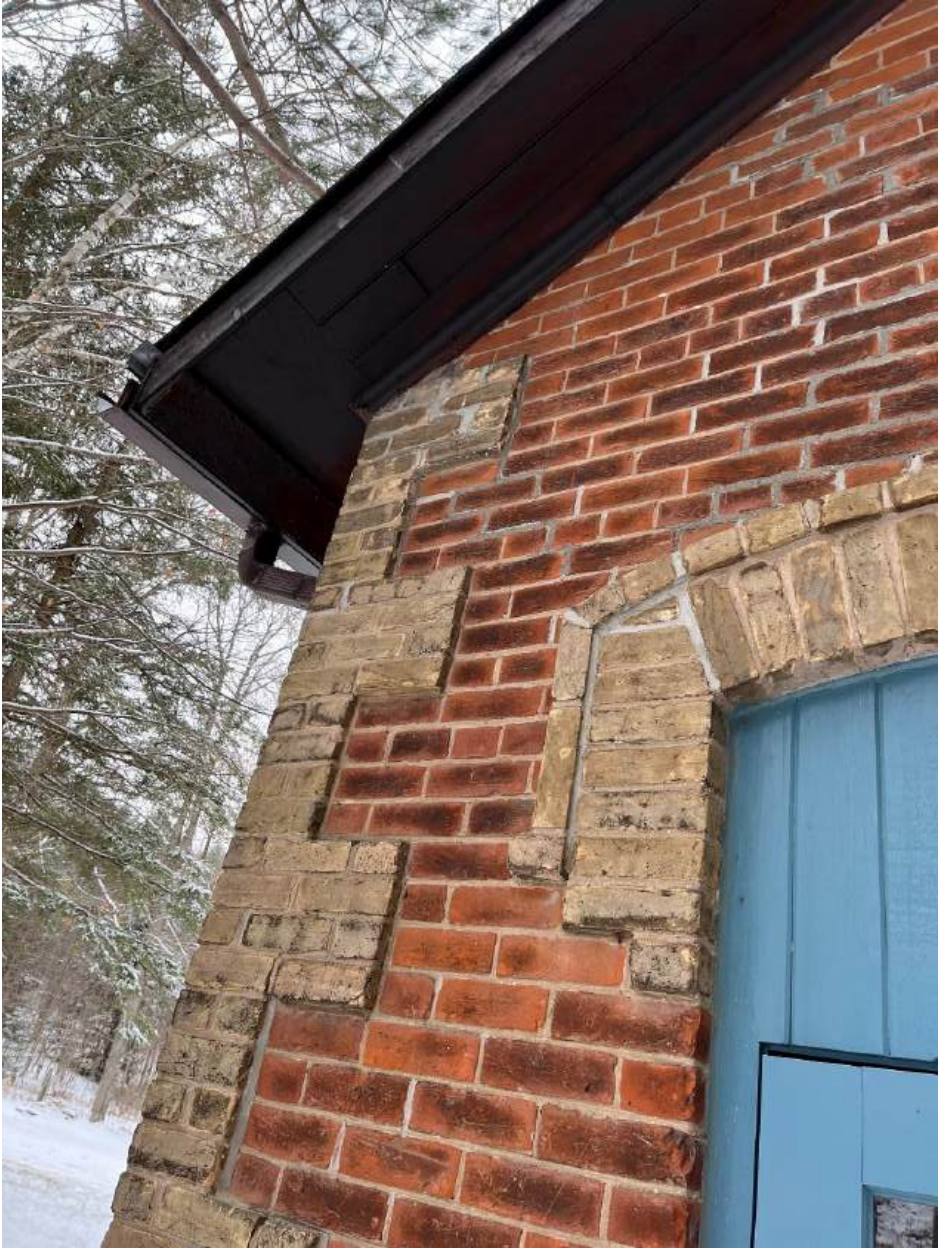
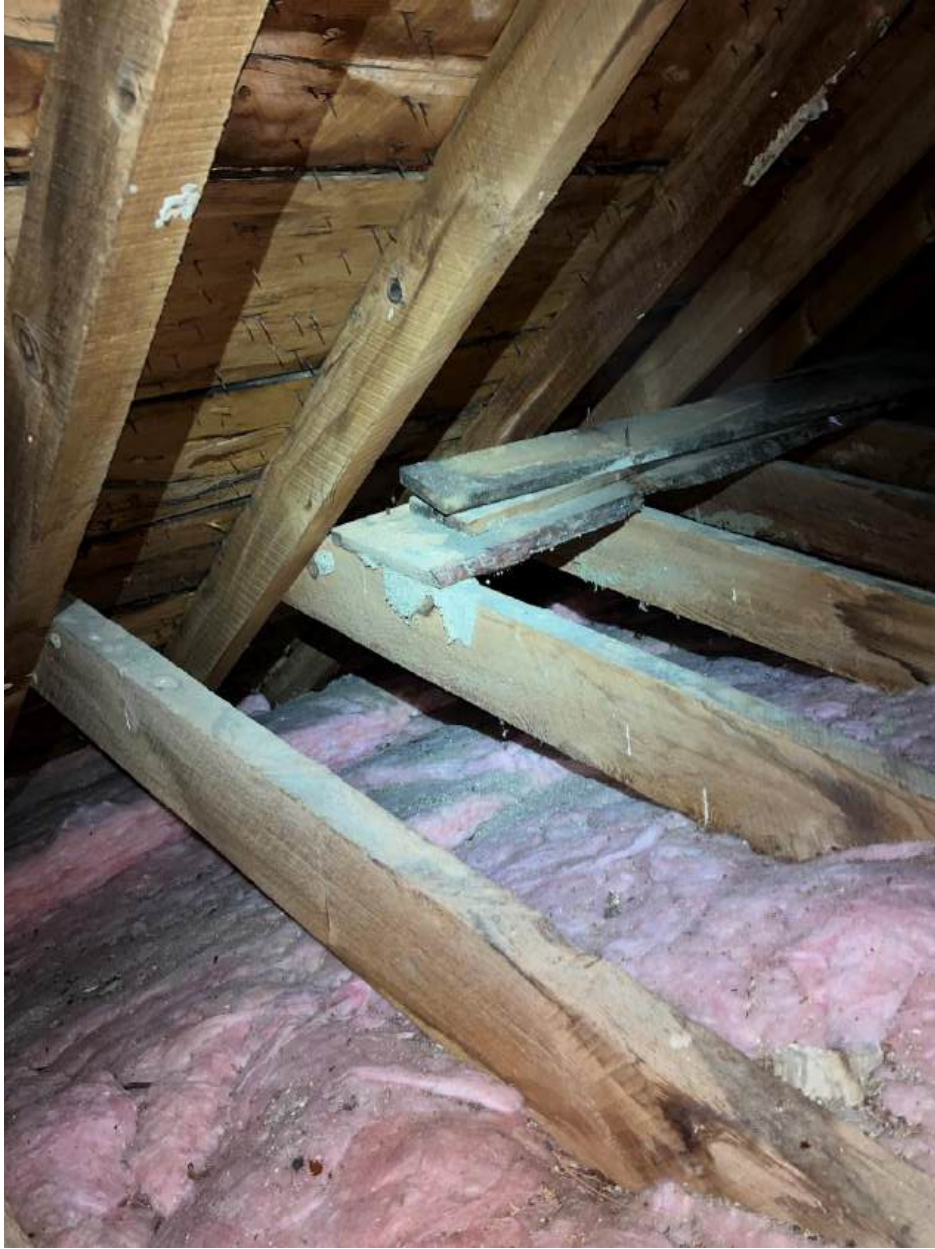
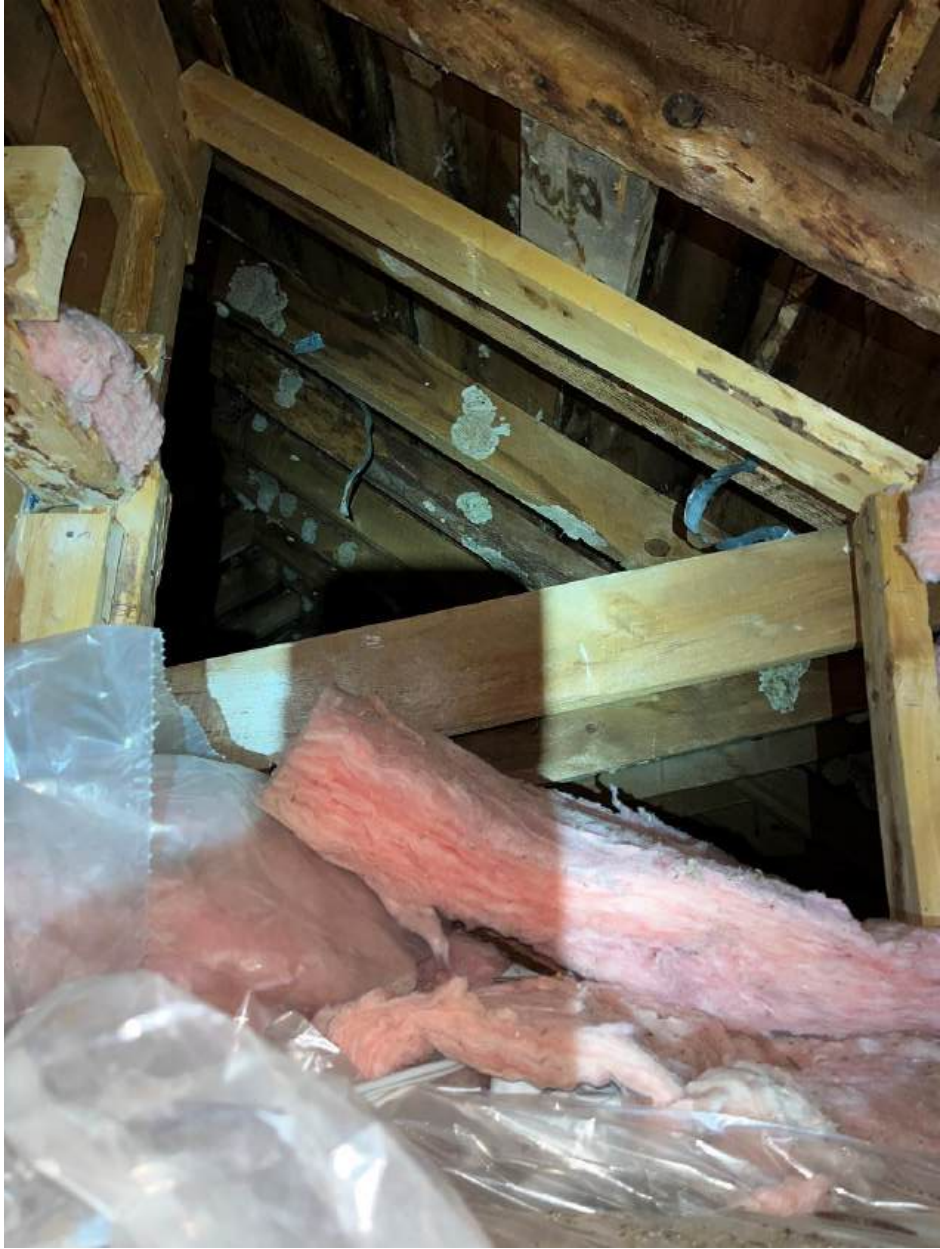
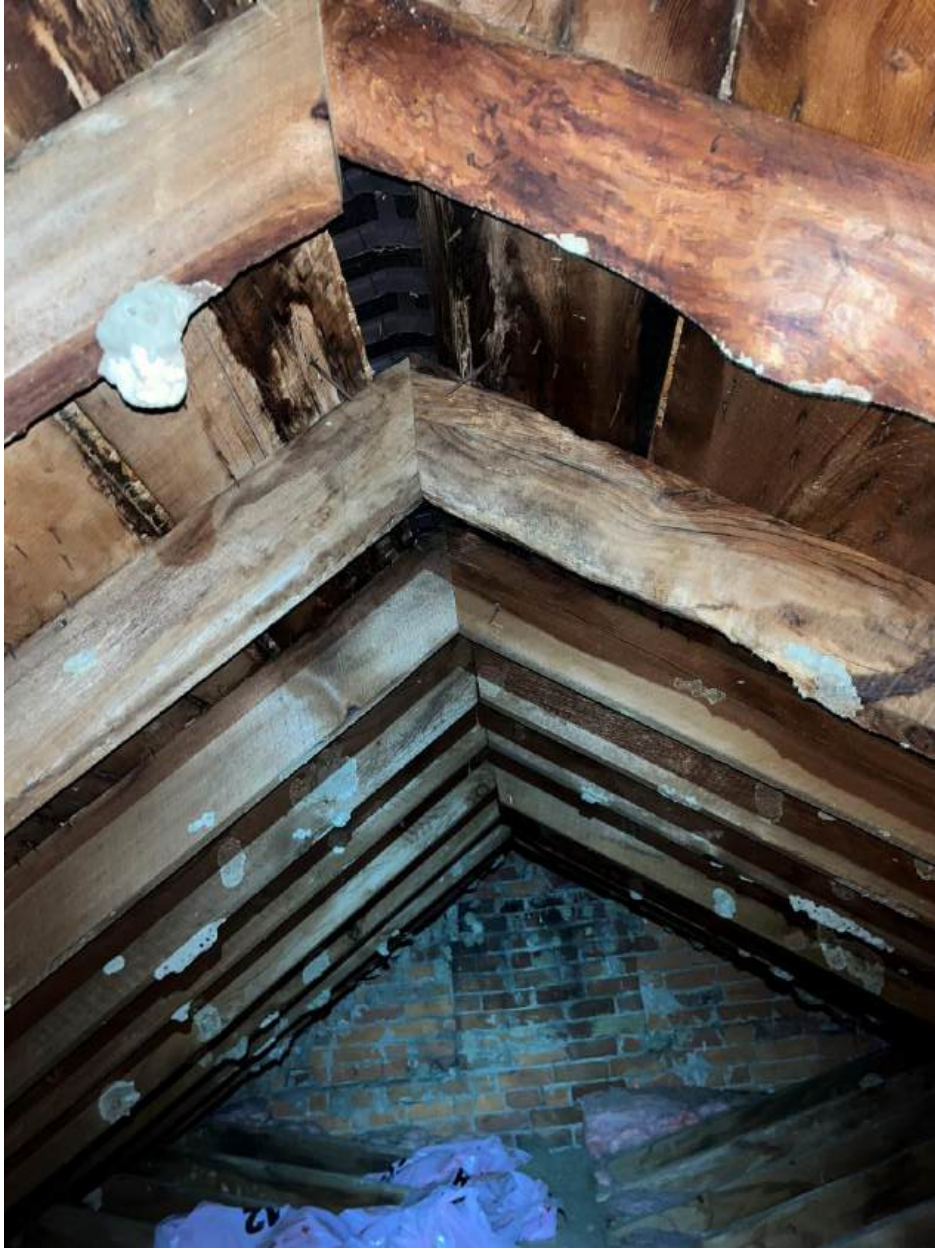
The Structural Elements, including foundation walls, wall assemblies and roof structure are all stable and free from significant damage and degradation, as observable.

\*Minor moisture decay is observable at a few locations; see Key Issues.

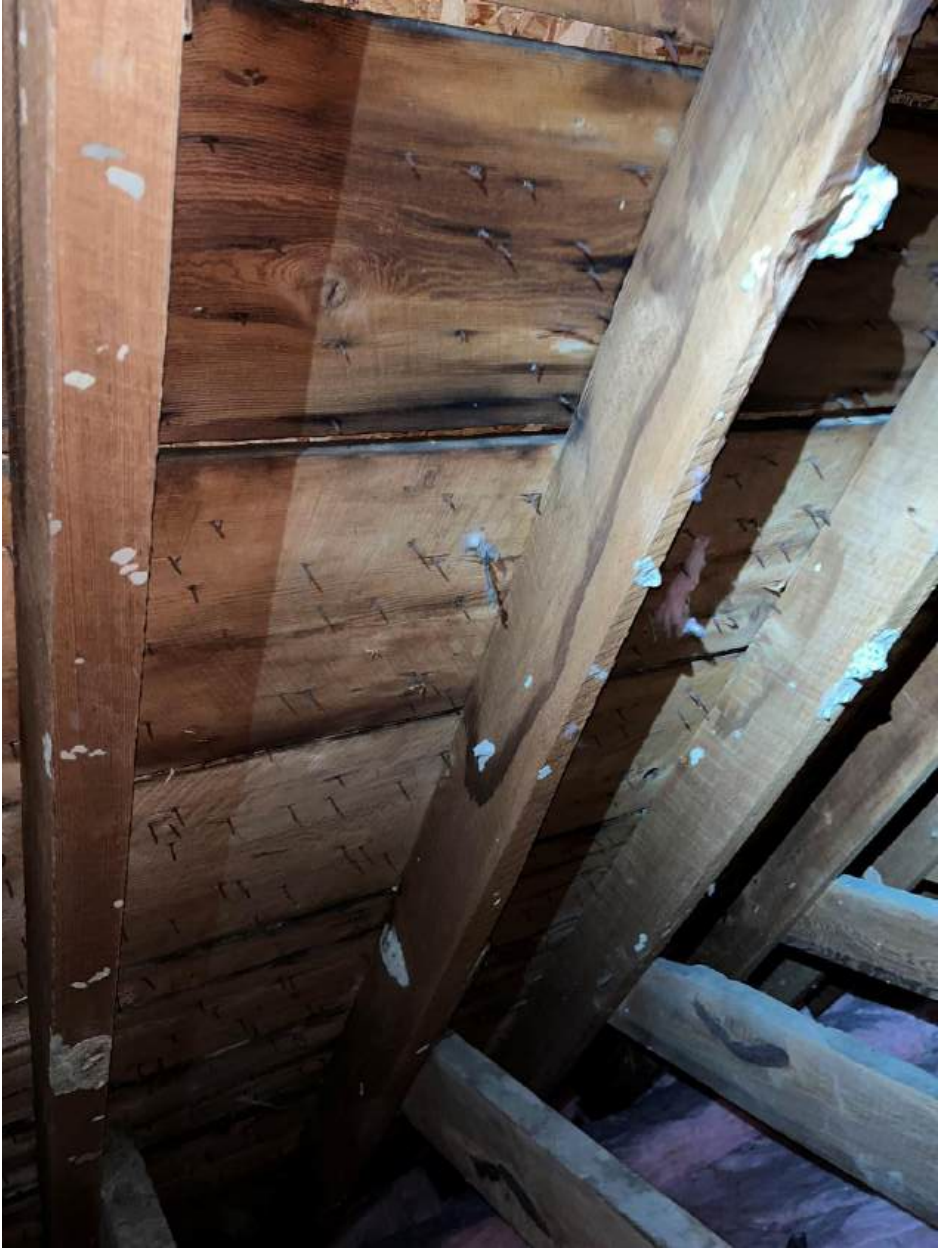
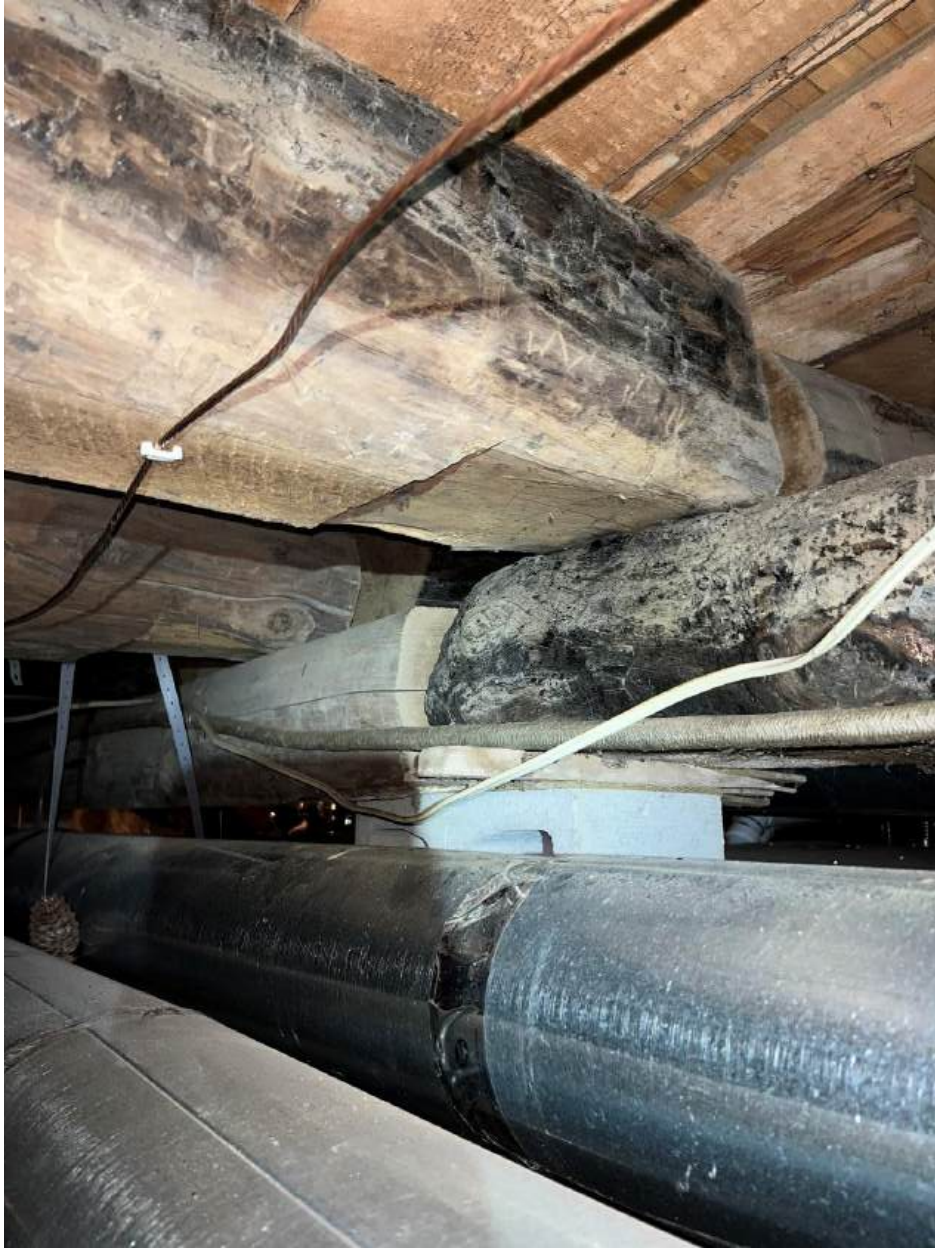
Waferboard has been added over the planks, which can be seen in the following photo; it is likely a benefit.

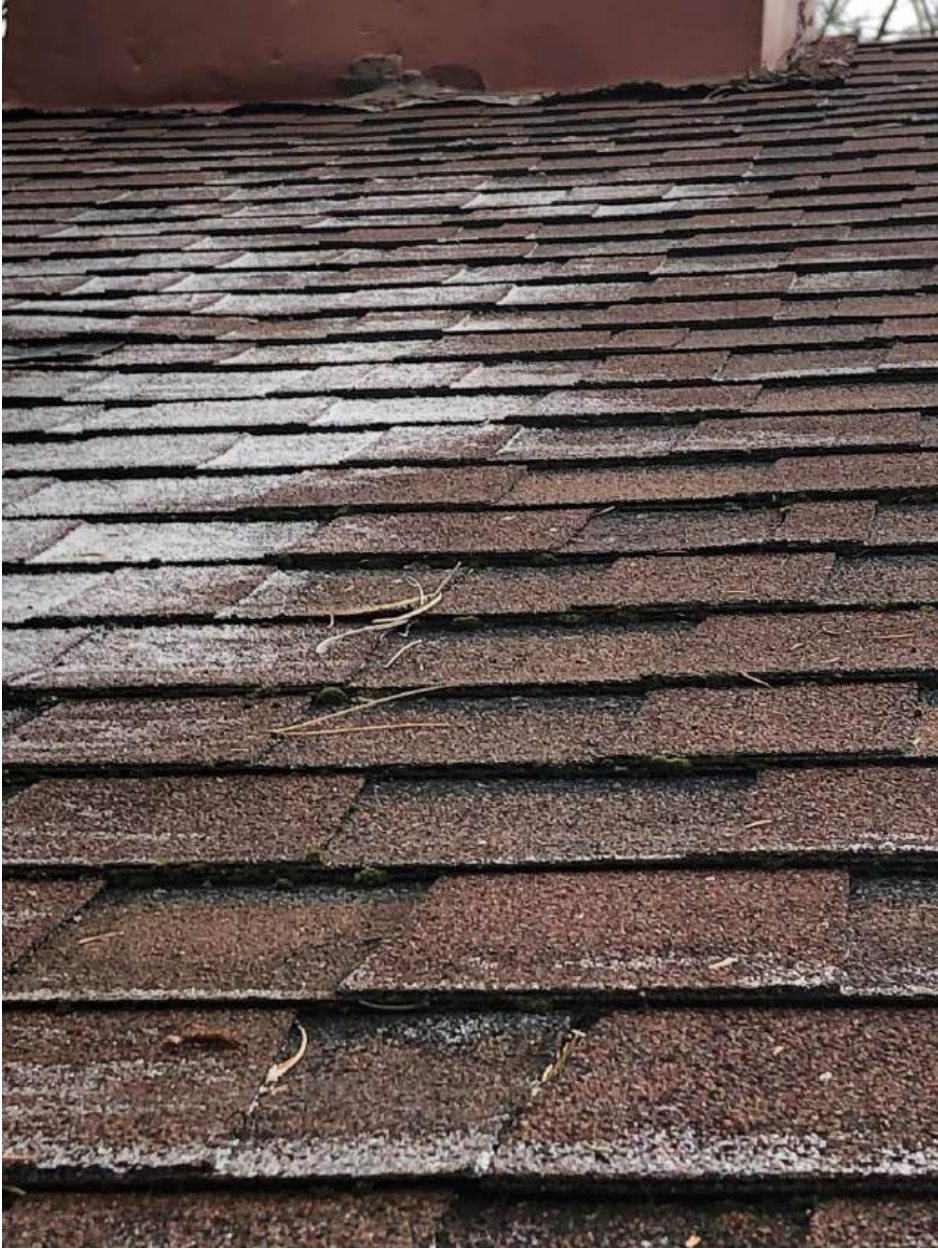
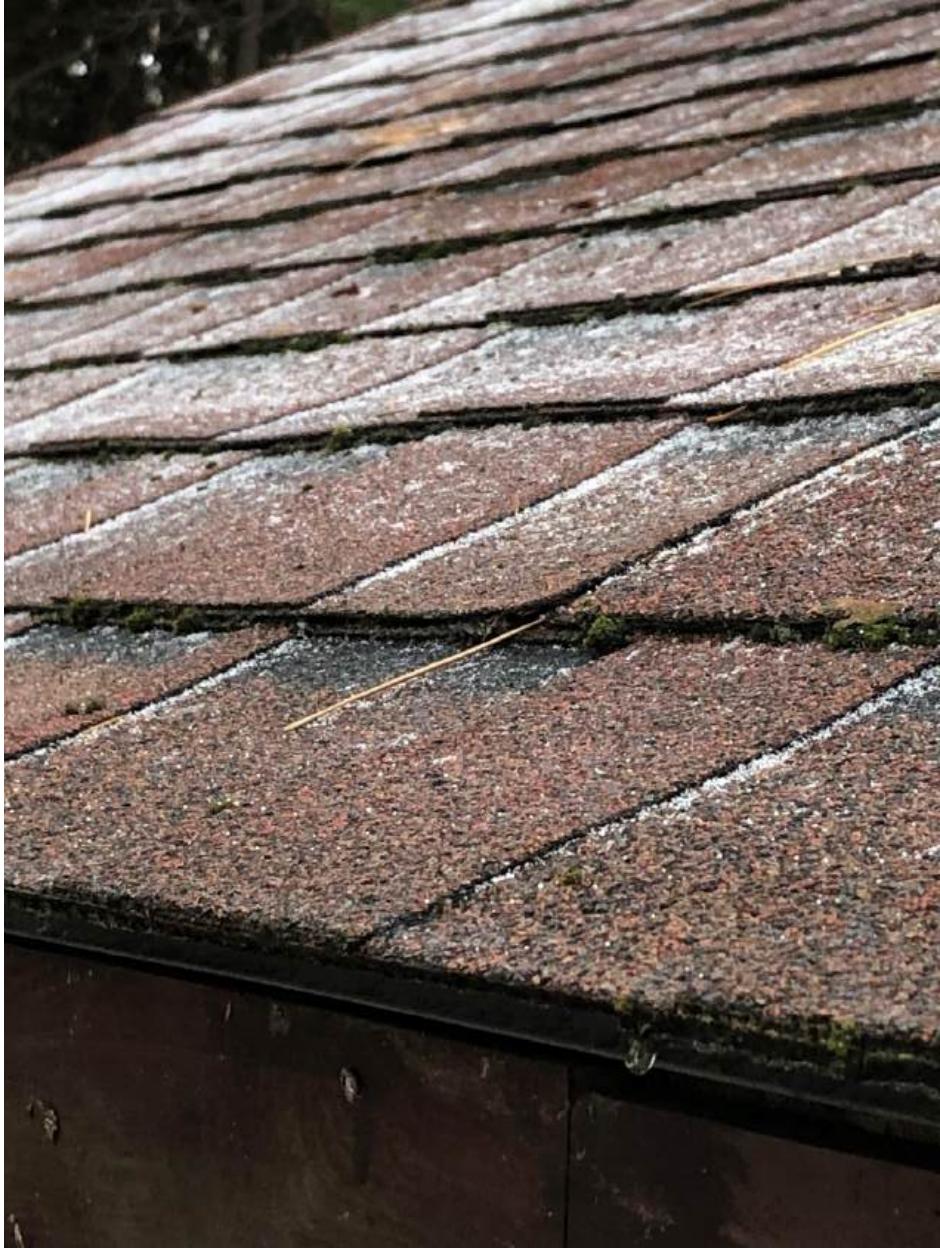
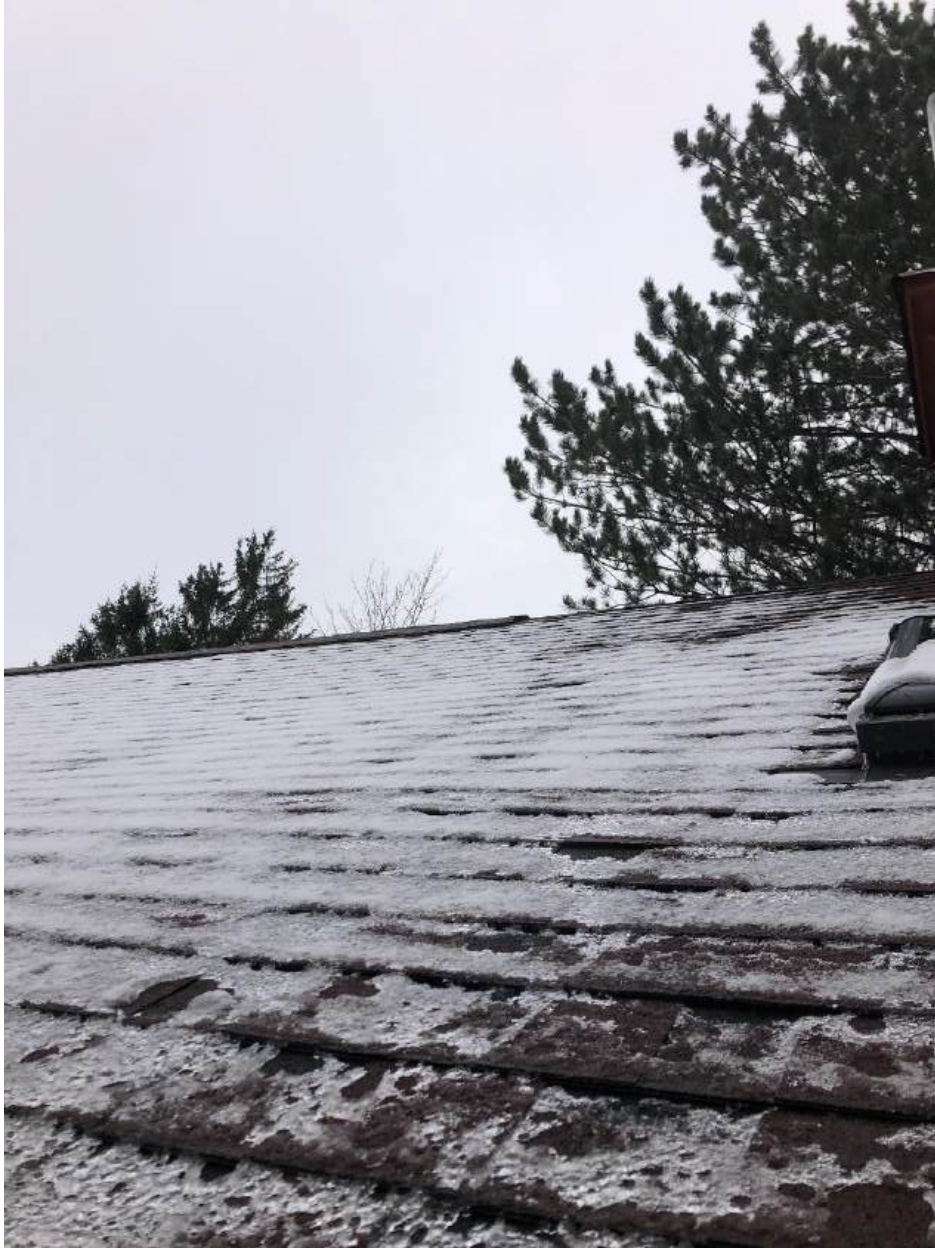
Based upon partial observation, the shingles are newer and were well-nailed; re-shingling will not likely be necessary for between 14 and 18 years, best estimate.

As seen above, much of the roof surface was not observable due to snow and ice. That includes the shed roof. Note that the shed is to be removed by the buyer anyway.

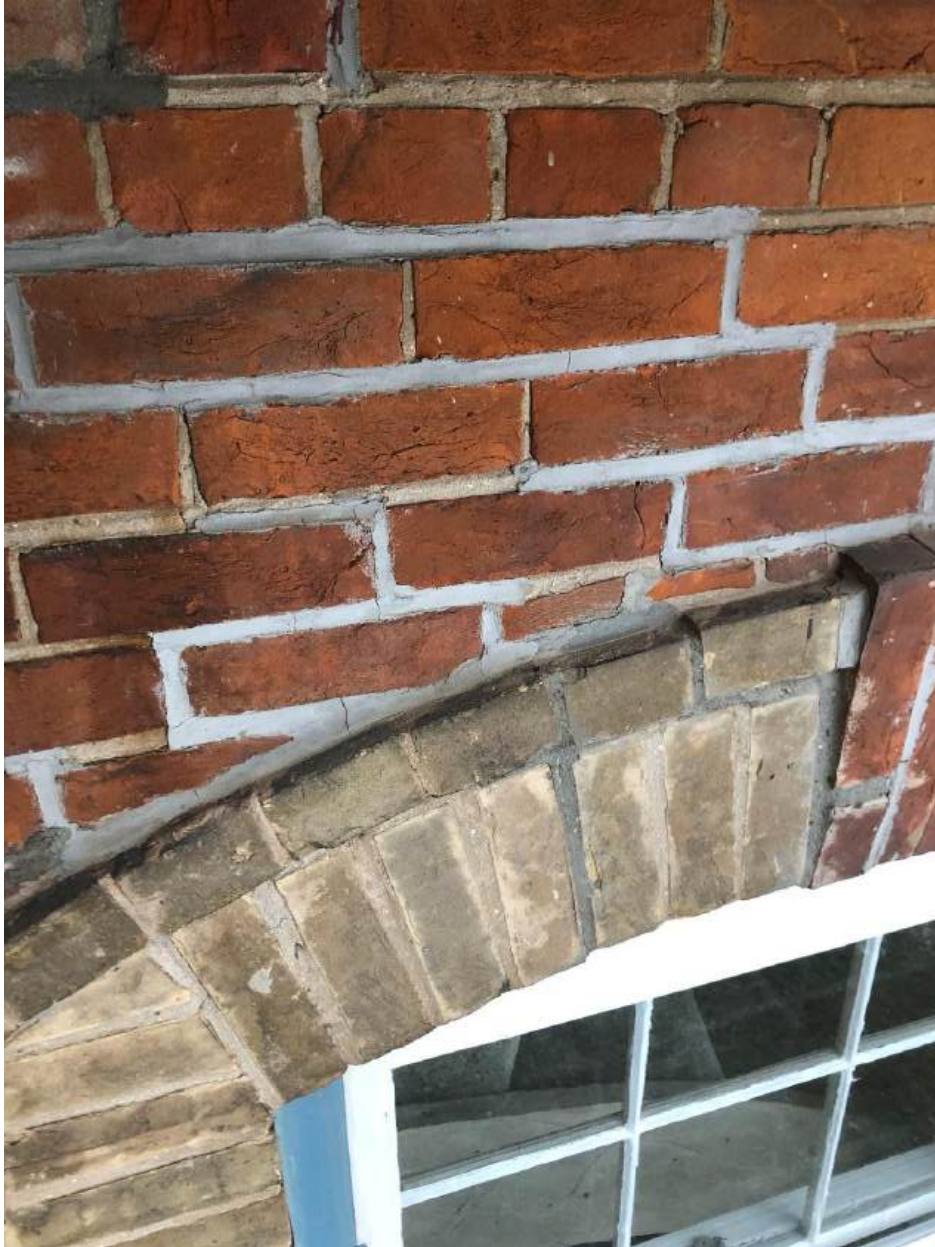
The repair work that has been executed at the brick masonry system appears to have been very well-executed.
