# **SAFE HOMES CANADA HOME INSPECTION REPORT**

**ADDRESS:** x Lavender Hill Road, Dunedin, ON

**DATE:** December 12, 2022

**AGE OF HOME:** 120 years (approximately)

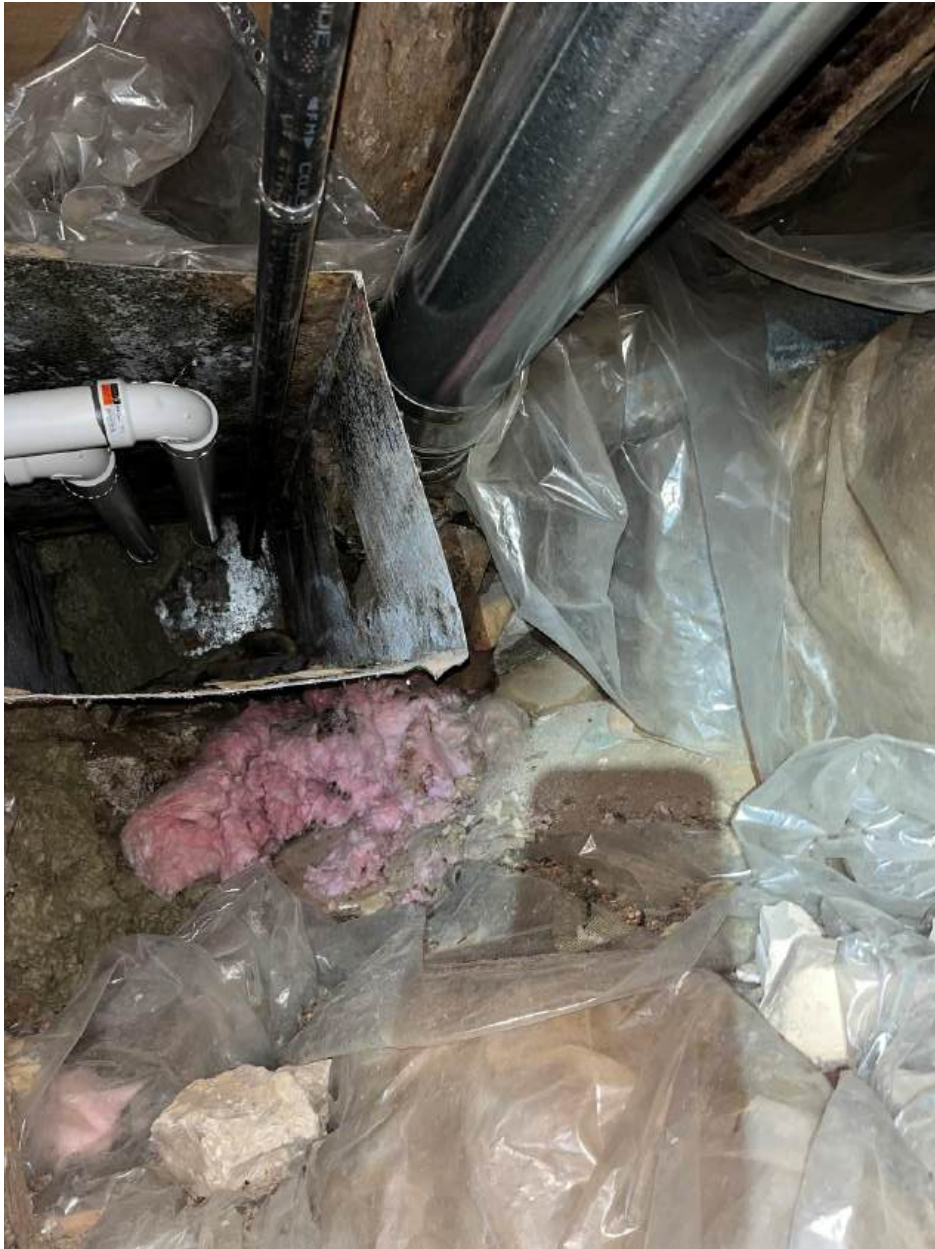
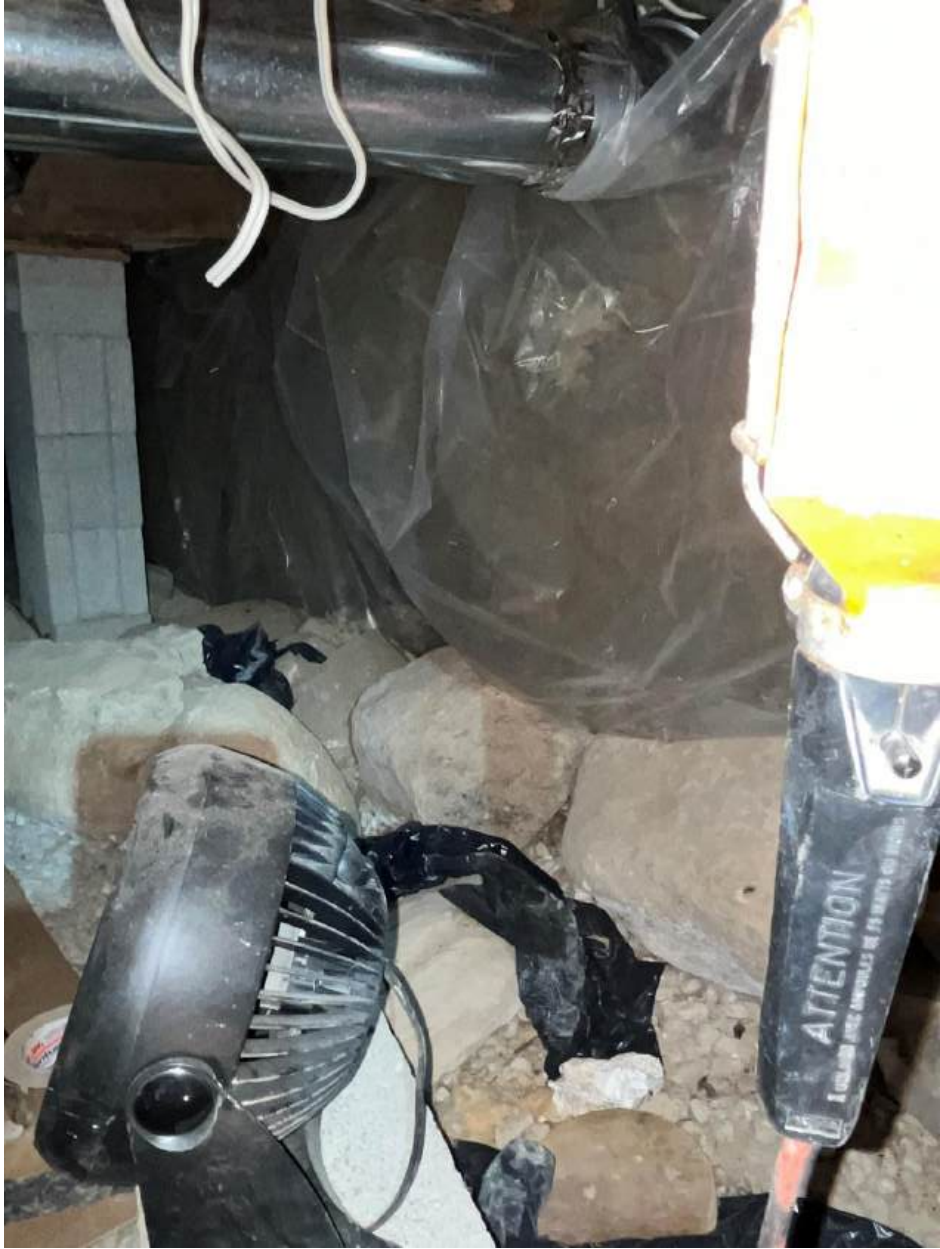
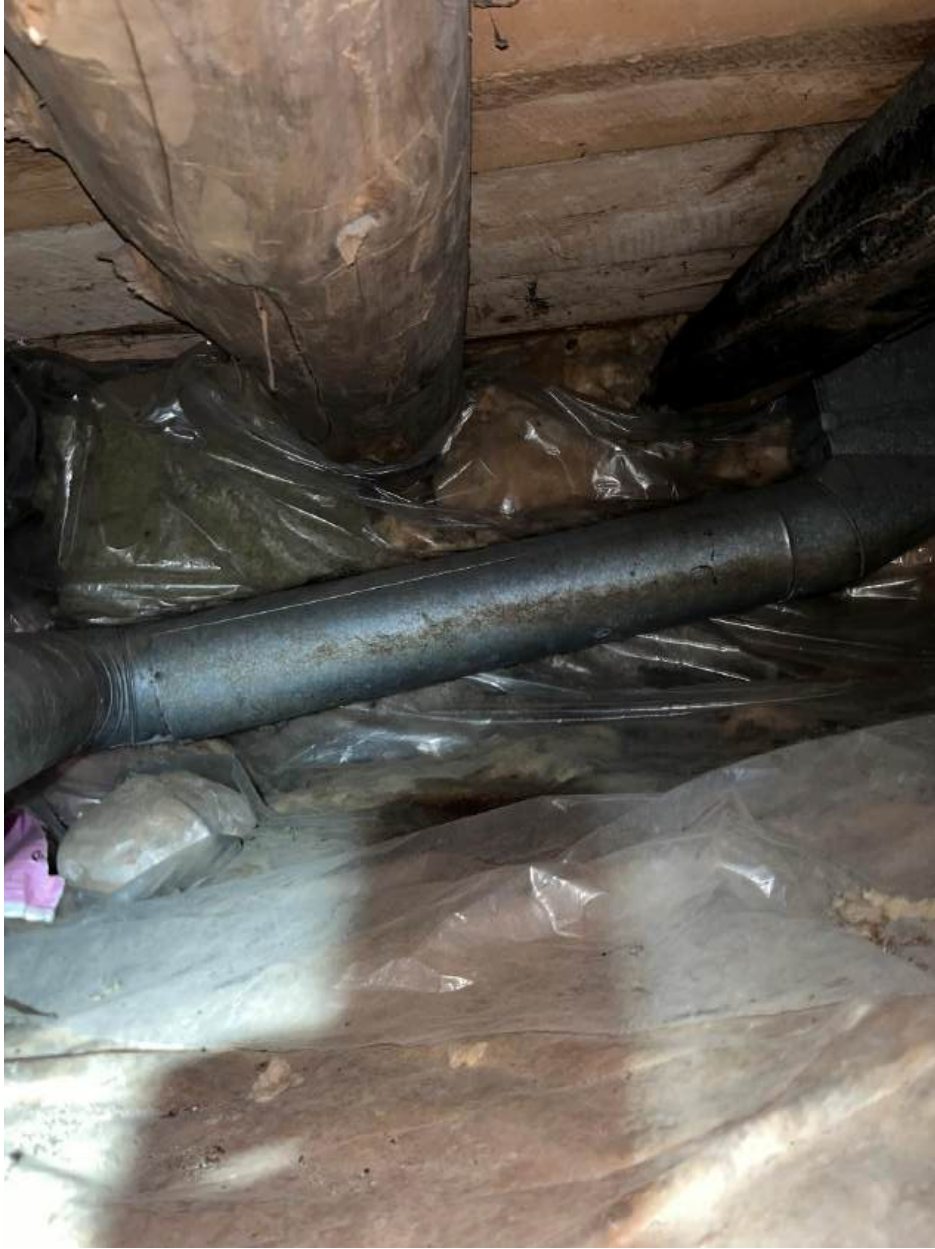
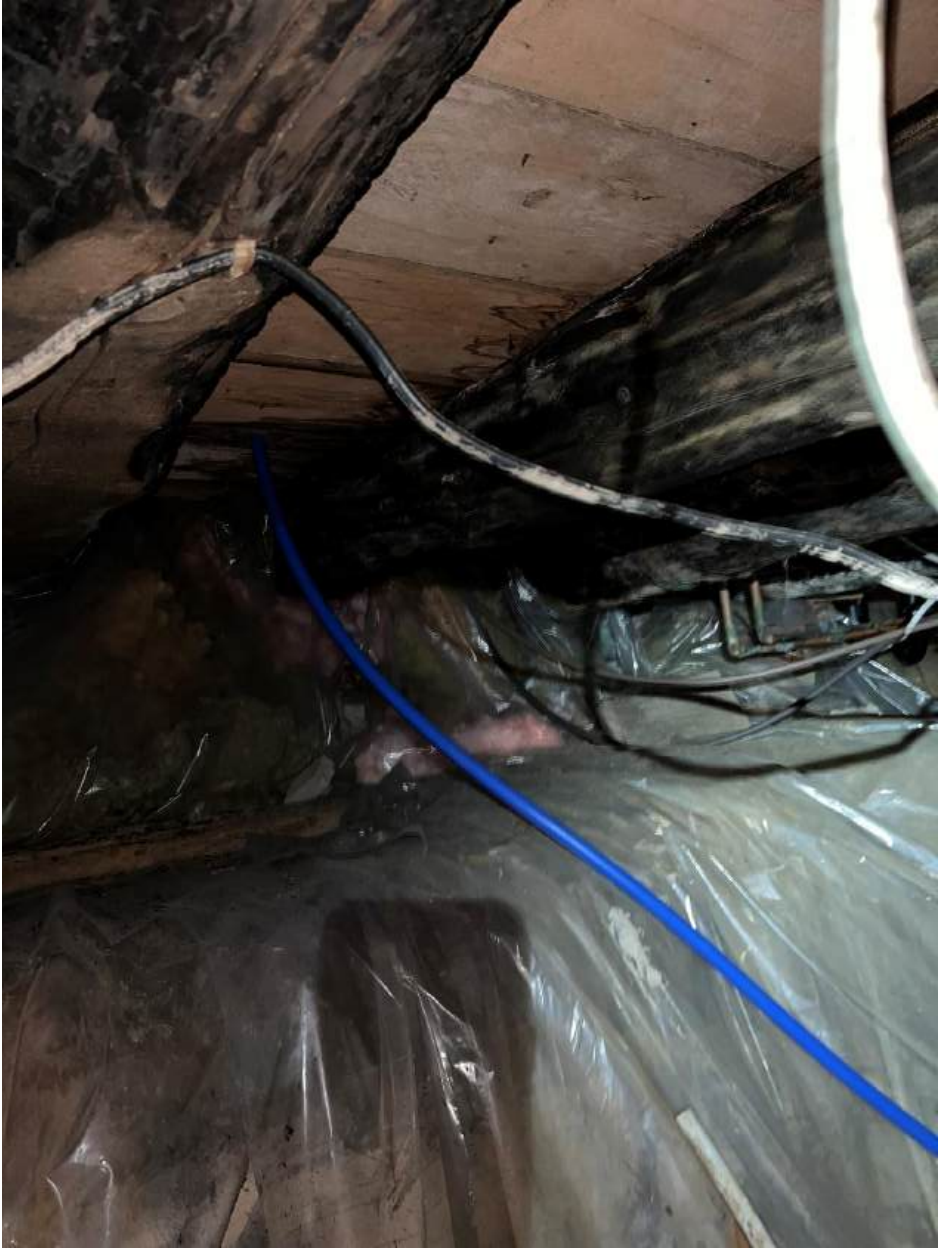
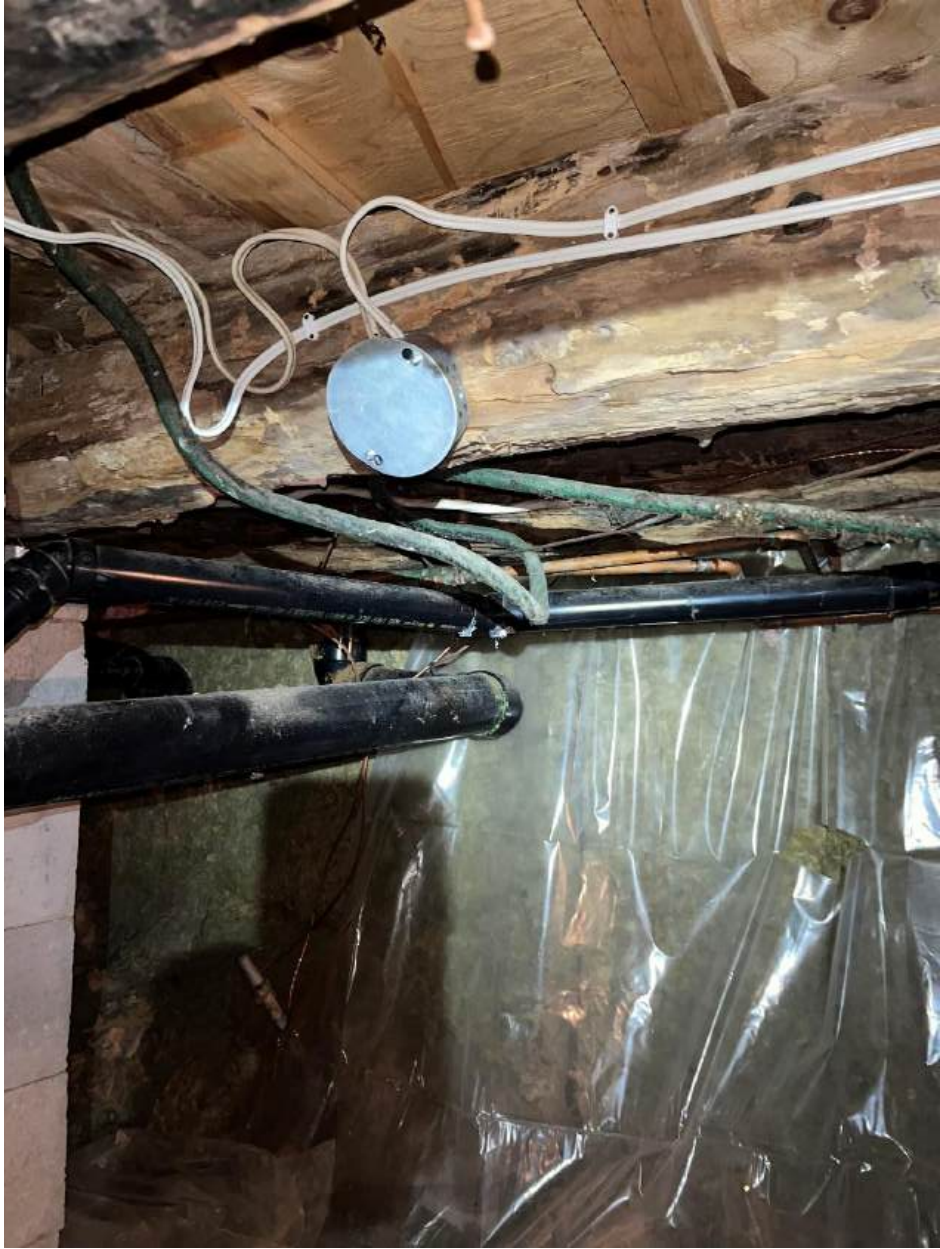
The inside face of the foundation walls is not observable due to insulation and poly plastic. As noted, the foundations are stable, as observable. Loose stones are observable, at a few locations, at the bottom of the foundation, on the ground. This inspector feels the insulation system provides a home for insects and

rodents. Long term, it would likely be most practical to replace that system with a high-quality poly urethane insulation, which is moisture, wildlife and insect-resistant. If the existing system is removed at some point, that would provide an opportunity for a full assessment of the inside face of the foundation walls. Some patching of the stone system may well be required.

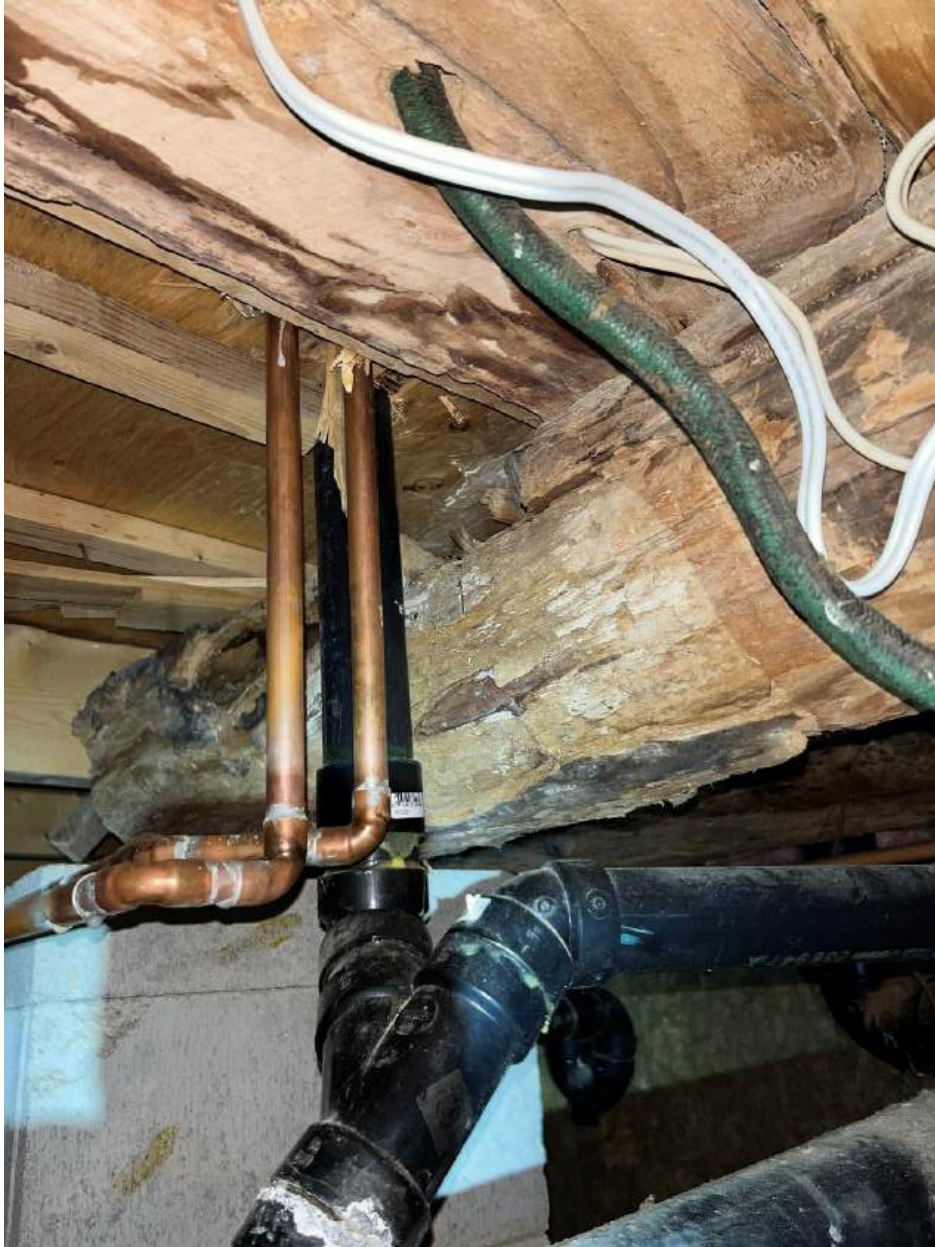
The right end of a log near the front of the building has rotted significantly, and exhibits a crack. While repairing it is an option, it may be most practical to add a pier just left of the damaged area.

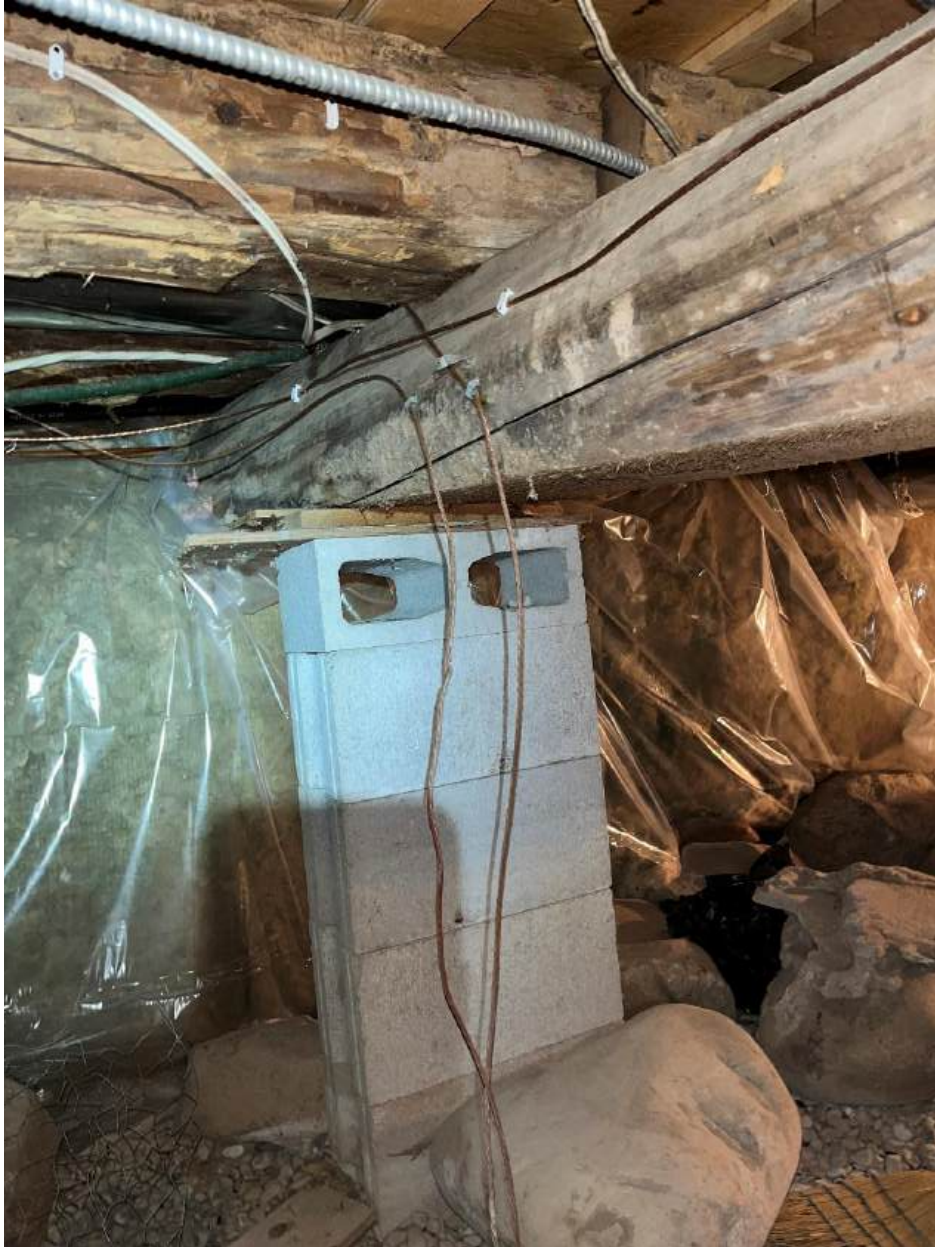
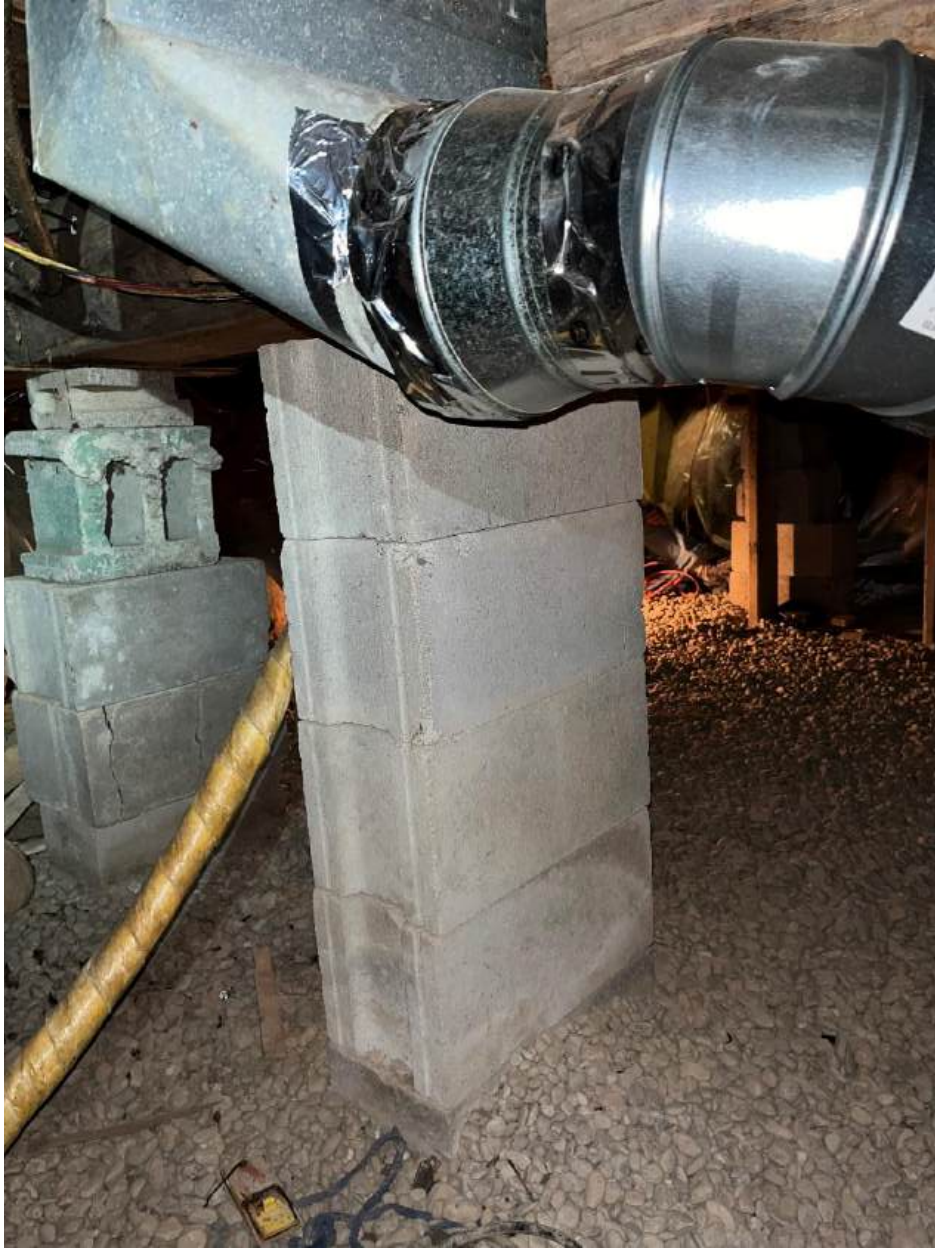
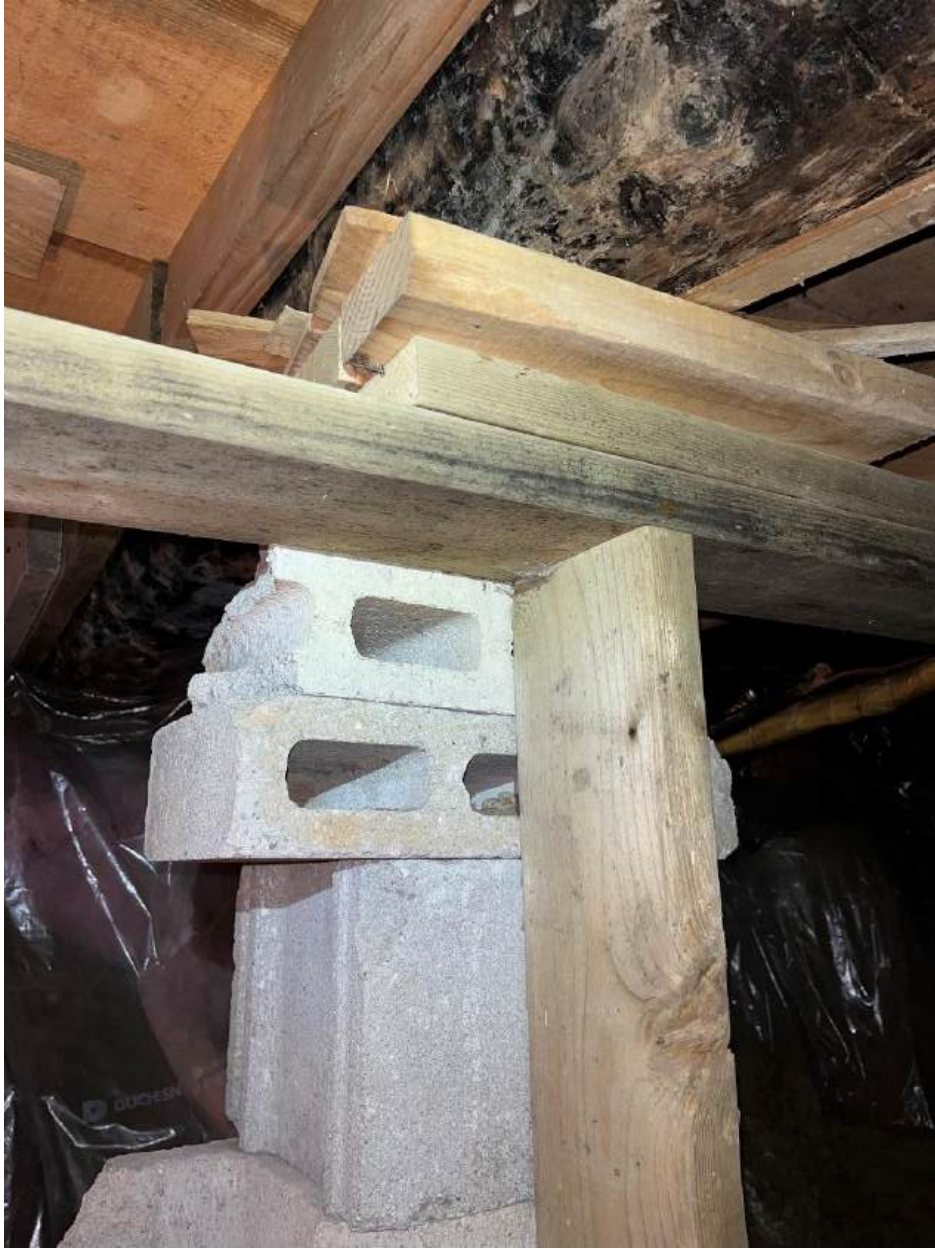
Concrete blocks have been aligned incorrectly at multiple locations. The cavities within blocks must be aligned vertically when blocks are significantly loaded. While the piers appear stable, the future structural performance of the piers cannot be confidently predicted. It is recommended that the piers be improved/formalized to prevent possible failure.

As seen in the photo above, wood components have been used informally at a number of locations. Work will be necessary to stabilize/improve/maintain the assemblies over time.

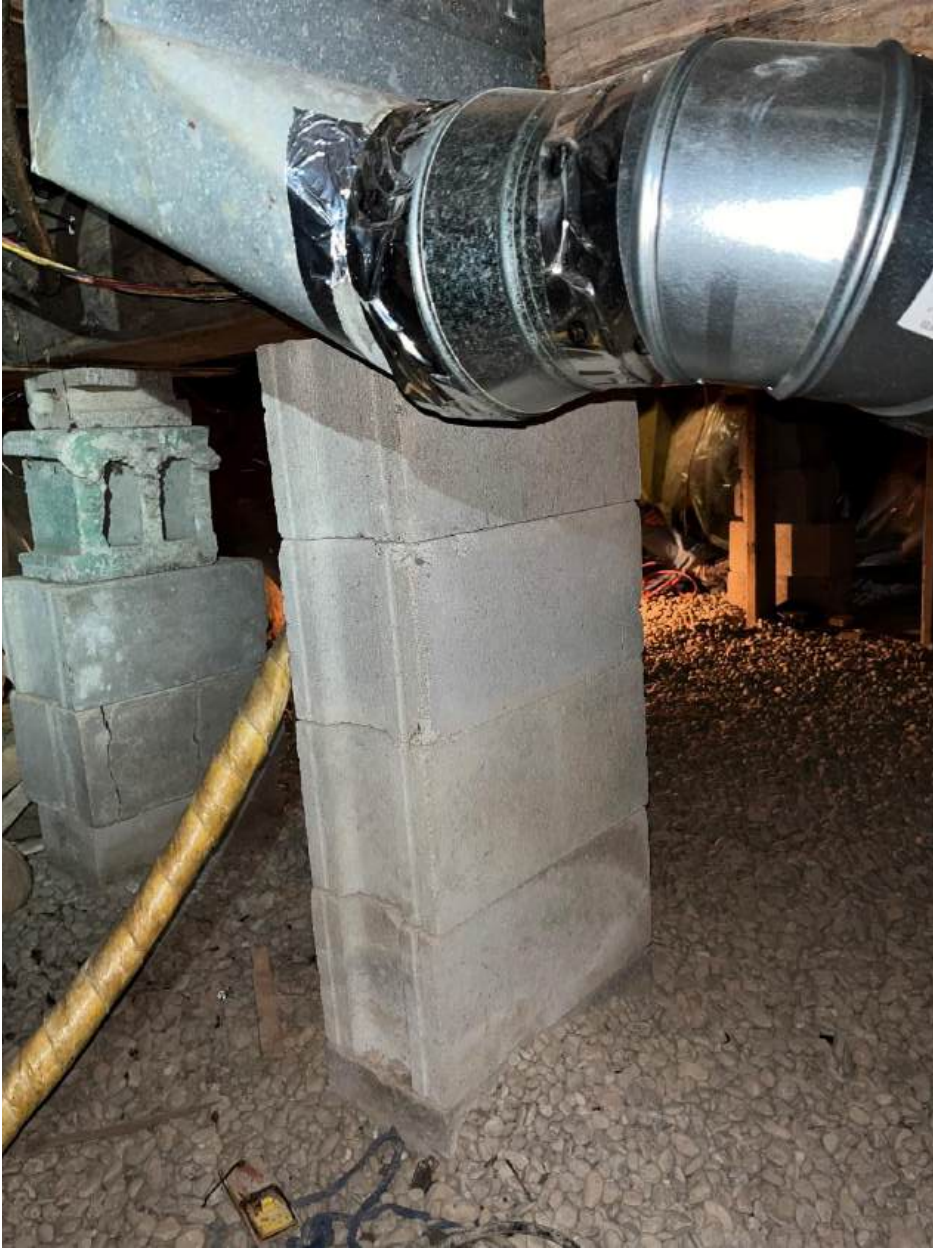
Some cracking was observed at the piers also. Again, it is difficult to assess whether the cracked blocks will fail.

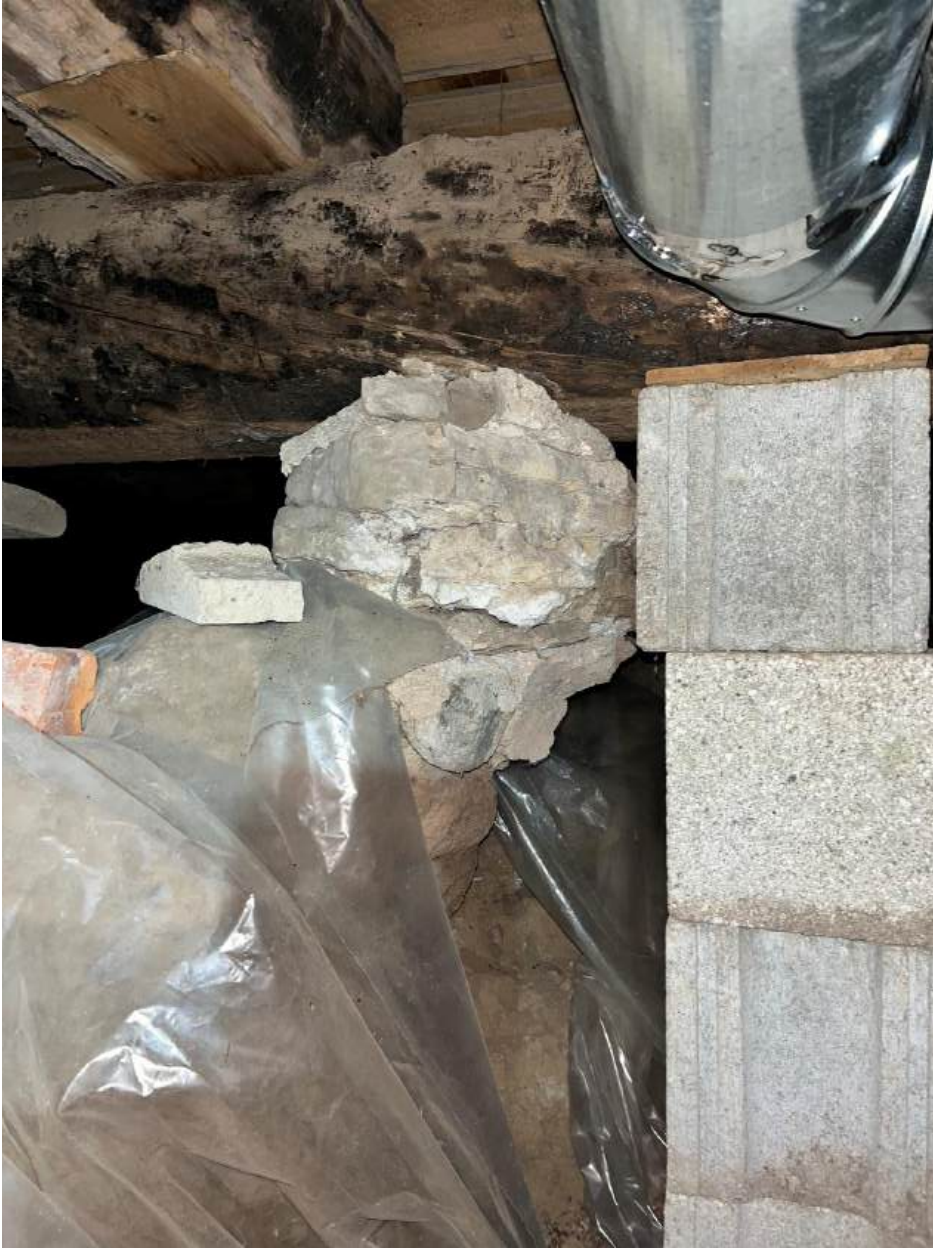
One stone pier – which appears precarious – will require work to stabilize.

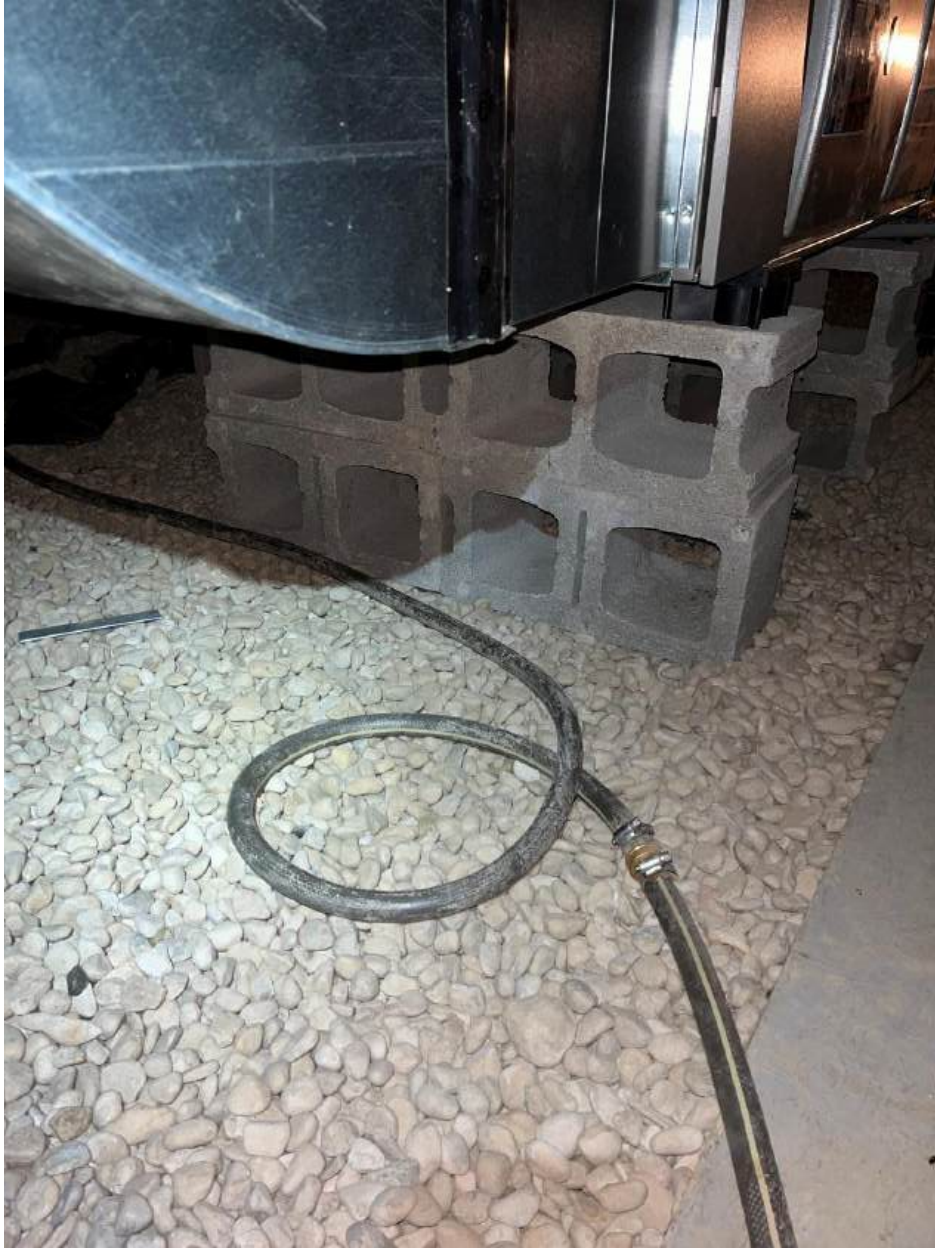
The mis-aligned blocks that are supporting the furnace are not likely a problem, as the load is fairly minimal.

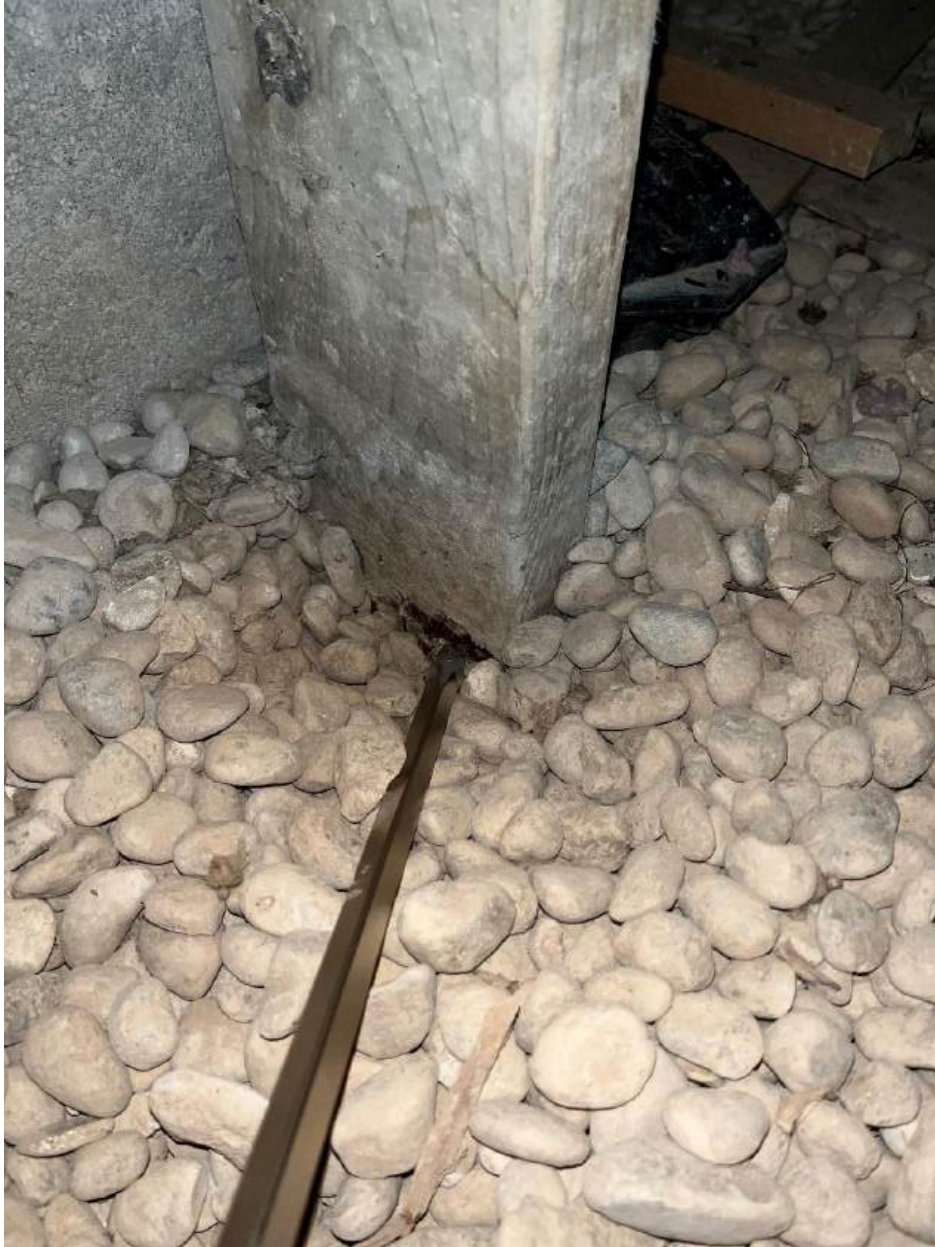
The wood frame bearing wall at the right side of the crawlspace access cover exhibits moisture decay at its base pieces. It should be re-constructed so the bottom is not susceptible to moisture decay.

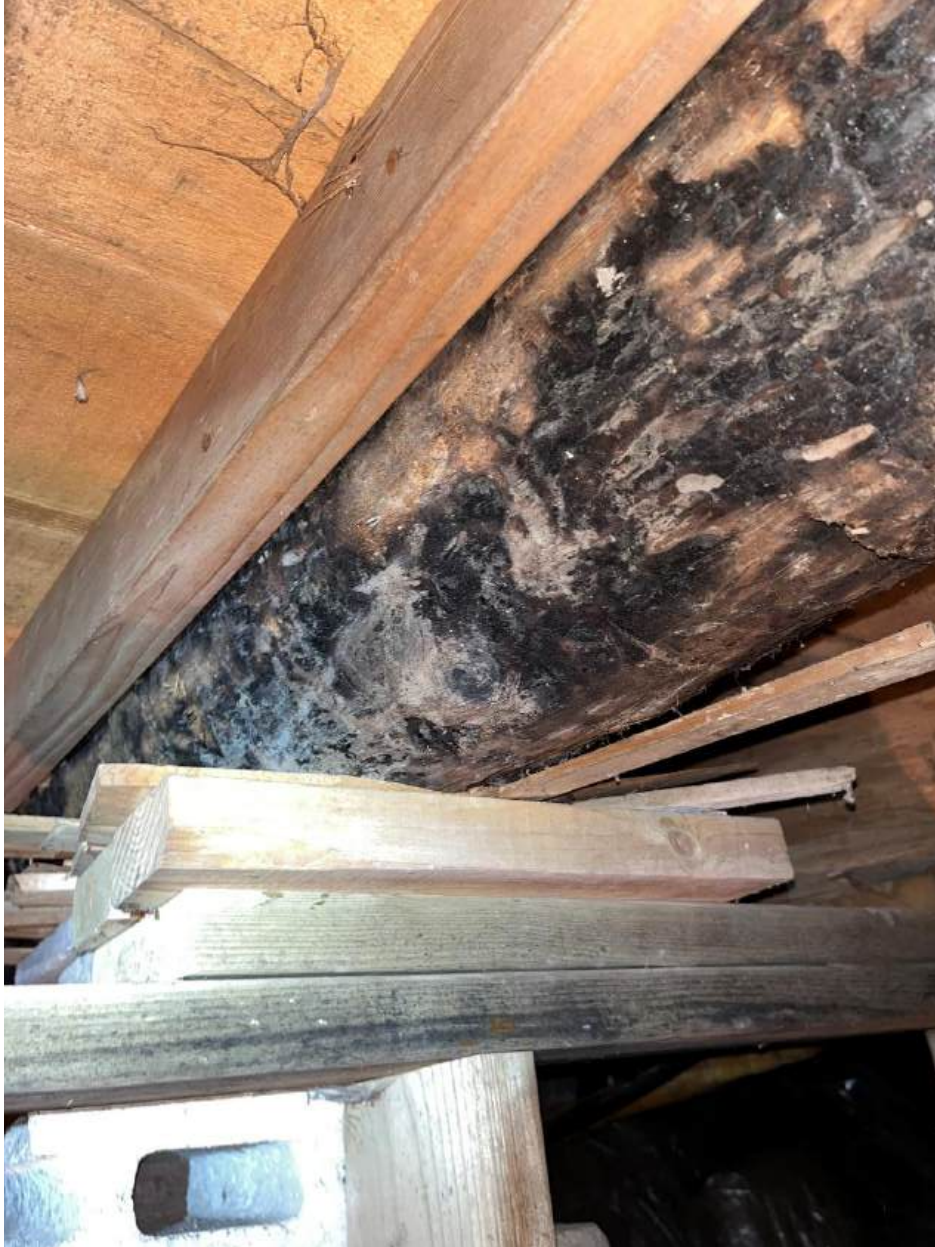
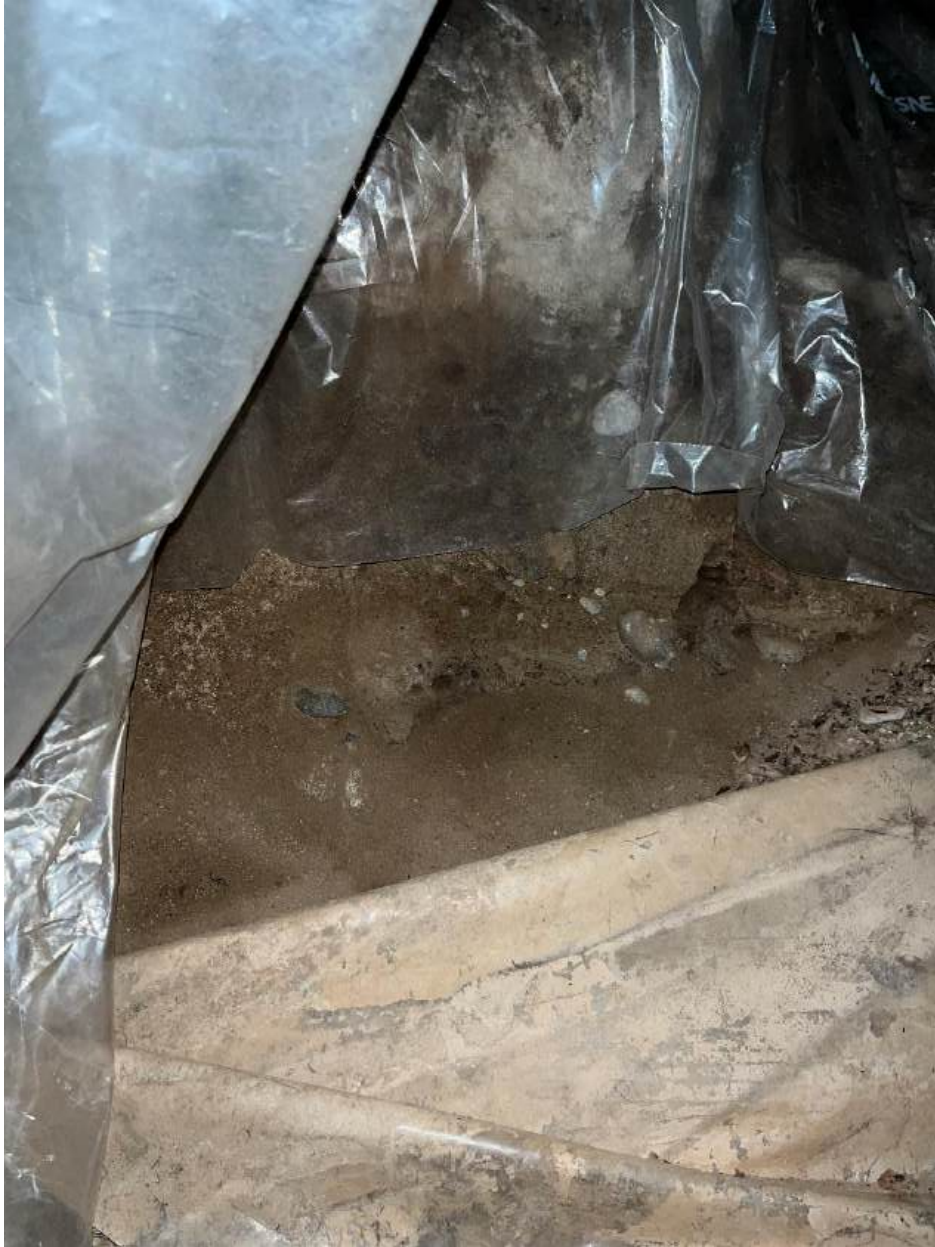
**Some minor moulds are observable at the bearing wall. Some dark earth is observable beyond and in between the plastic. There is a possible impact upon air quality, relating to moulds, organics, an earthy aroma, etc. It is recommended that a fully-sealed moisture barrier be installed to help maintain low relative humidity, and to**

help promote air quality. A heat recovery ventilator is strongly recommended. A mould-resistant primer can be painted over the (possible) moulds.

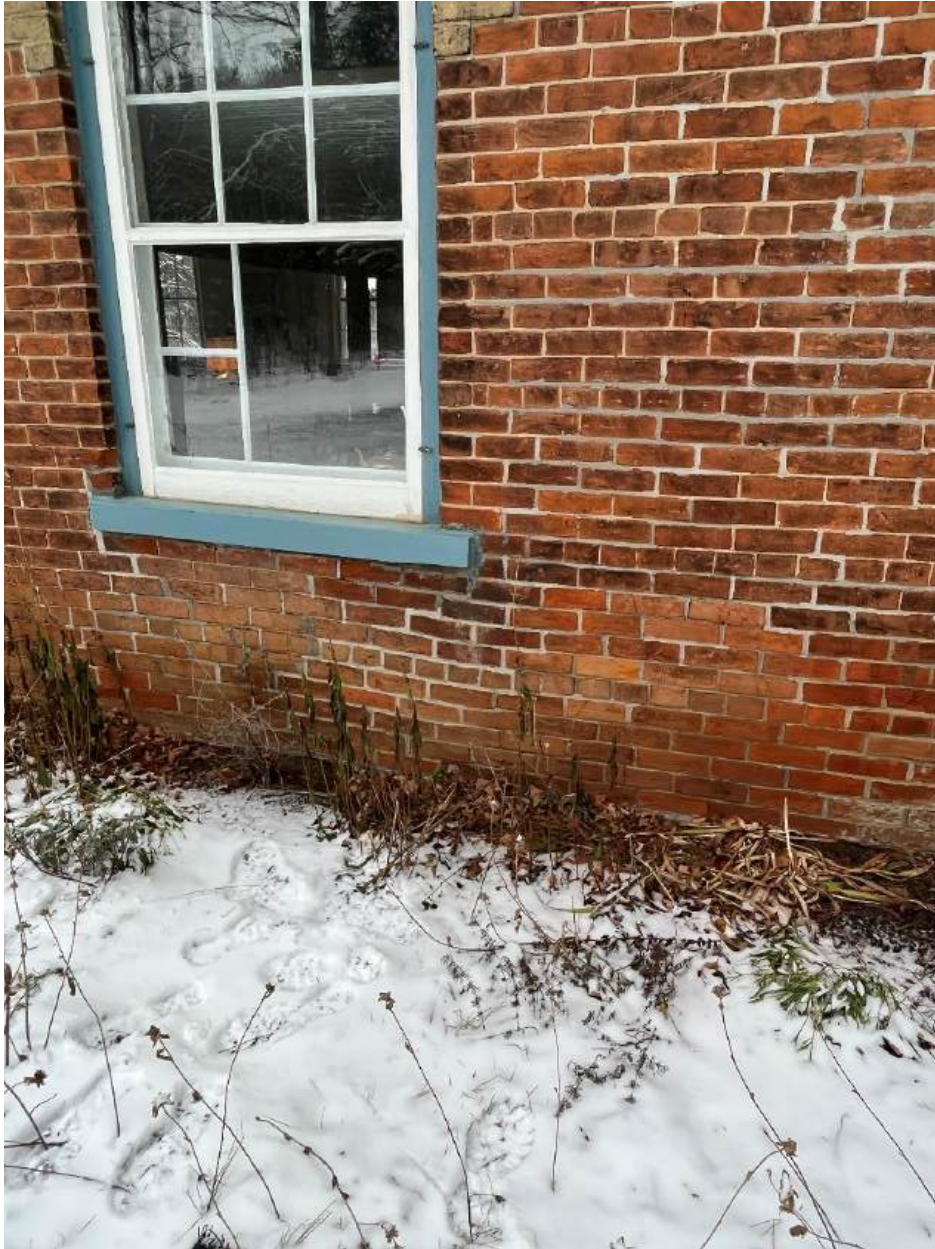
Although the masonry assembly is stable, it is out of plumb and level at the front part of the left wall. Further investigation is required at the inside face of the foundation. The keys to preventing further movement and failure of the brick system (and at the foundation level) are to transport all eaves trough water well away from the building, and eliminate all possible entry points for water. There might be a structural flaw at the foundation below this area, which might also

explain the floor being out of level rear of the crawlspace access. Further investigation will be necessary when the insulation is removed at the foundation wall.

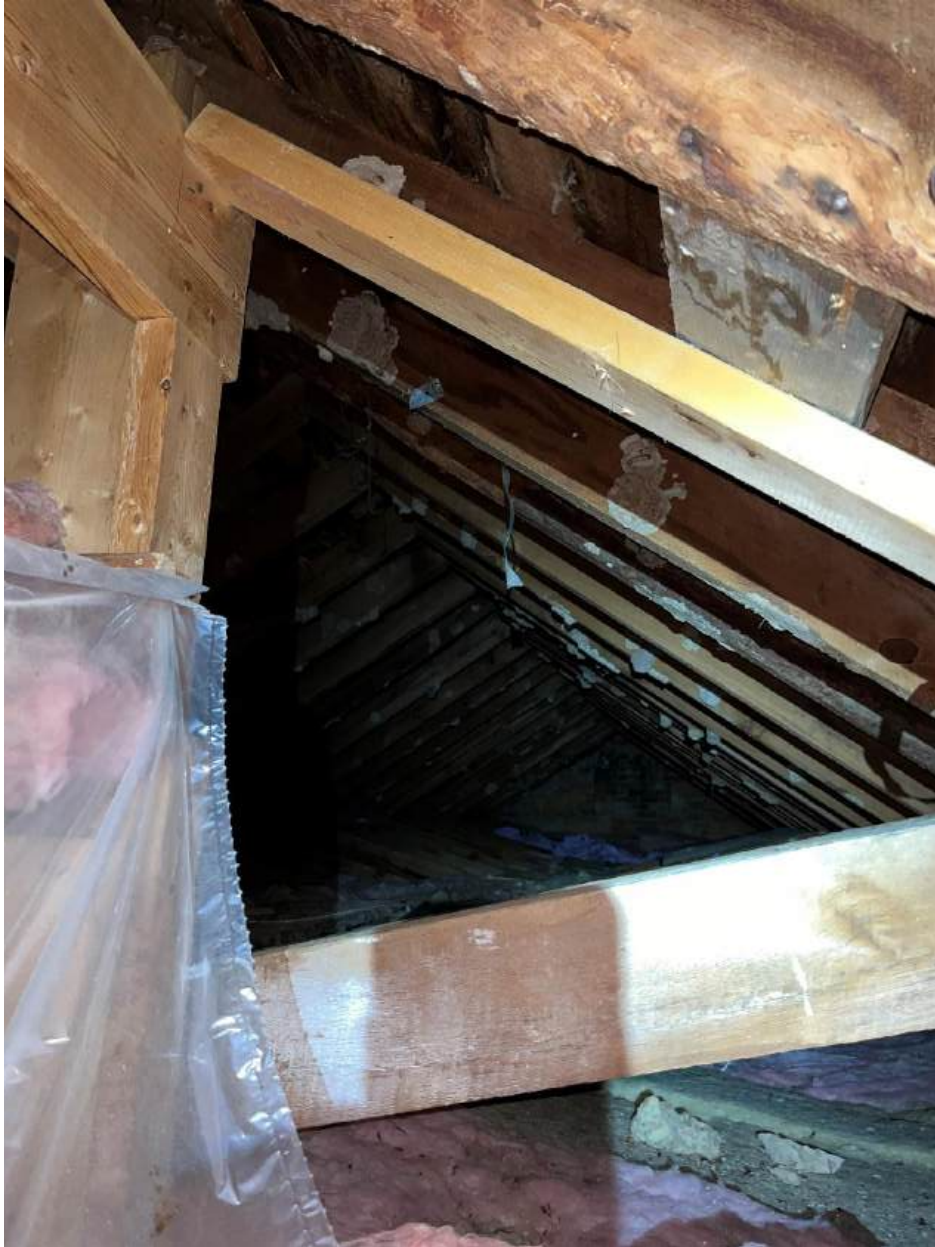
The access into the attic is informal; access is very difficult by crawling through a tight truss opening. It is recommended that a formal access be created further to the rear, at a practical location in the middle of the attic (left to right middle).

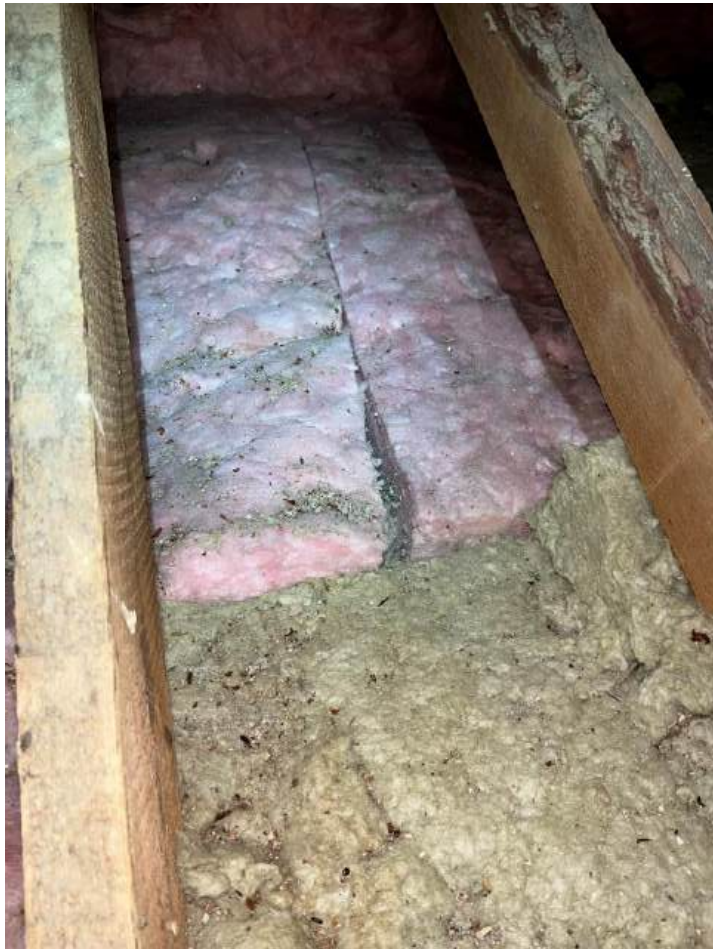
Existing insulation provides about R40. It includes glass fibre batts and loose cellulose. While not critical work, it would be a benefit to update the insulation to R60, which would match the current building code requirement.
