# **SAFE HOMES CANADA HOME INSPECTION REPORT**

**ADDRESS:** x Lavender Hill Road, Dunedin, ON

**DATE:** December 12, 2022

**AGE OF HOME:** 120 years (approximately)

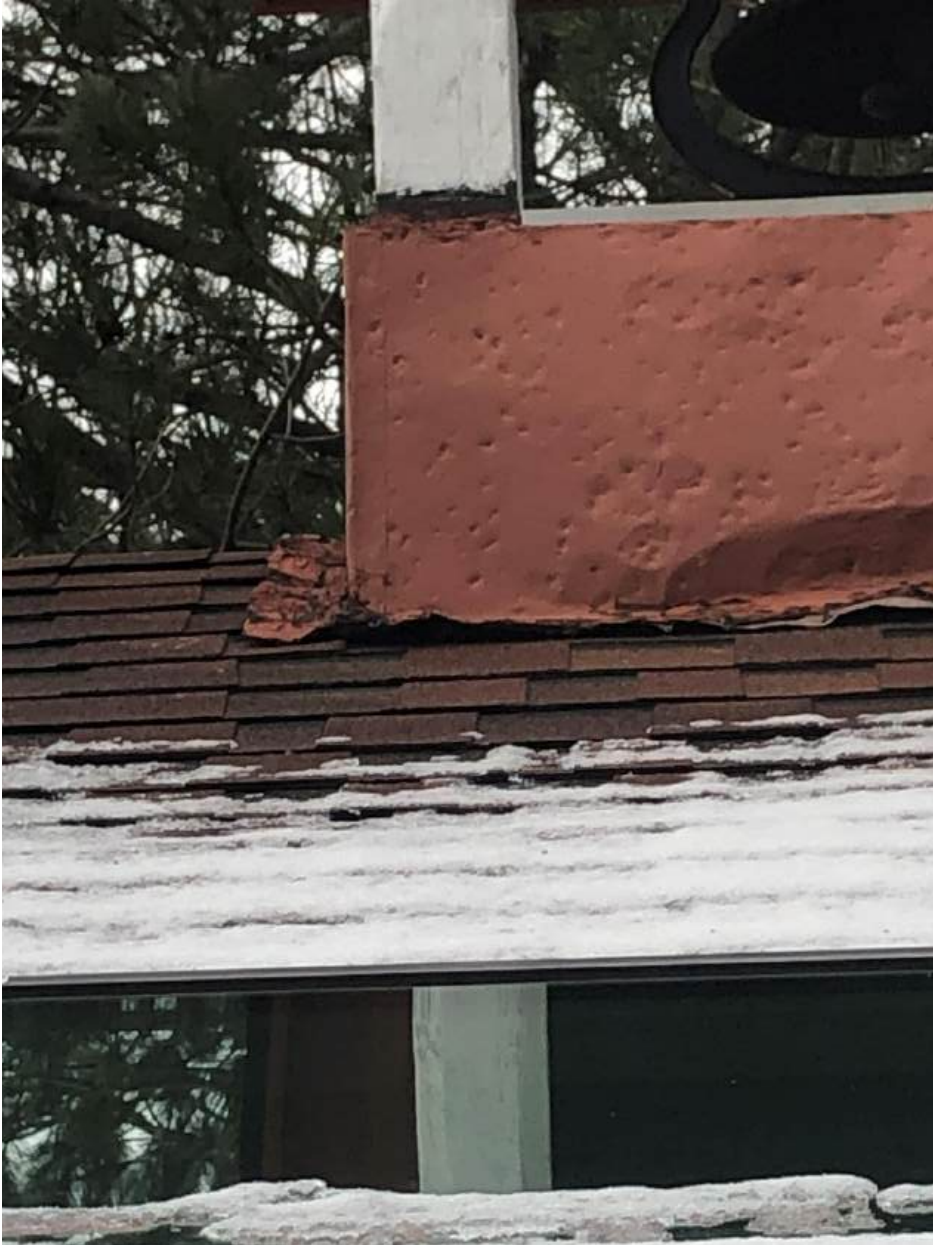
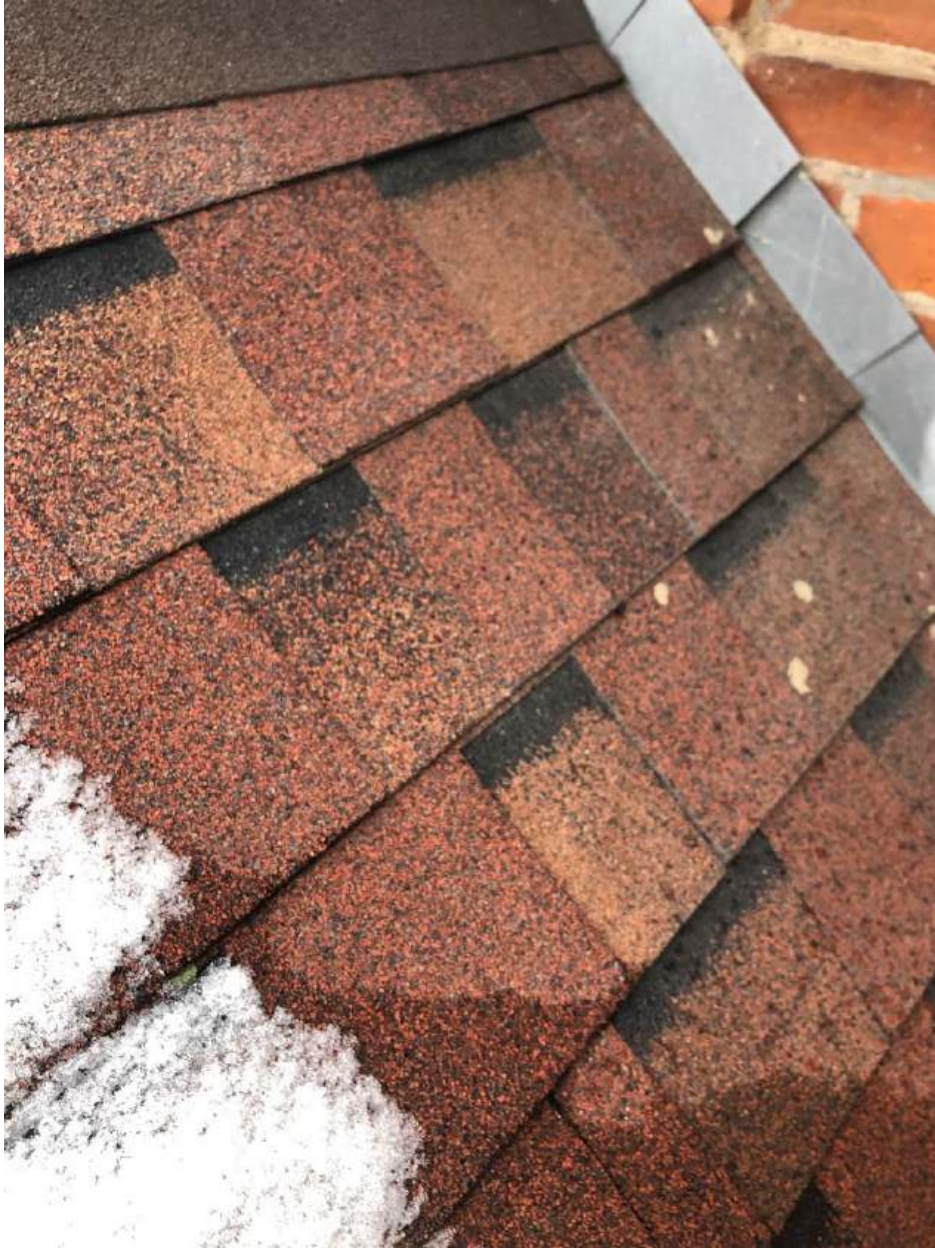
A number of junction flashings are open to water/insect/wildlife infiltration. They all should be fastened and fully sealed without delay.

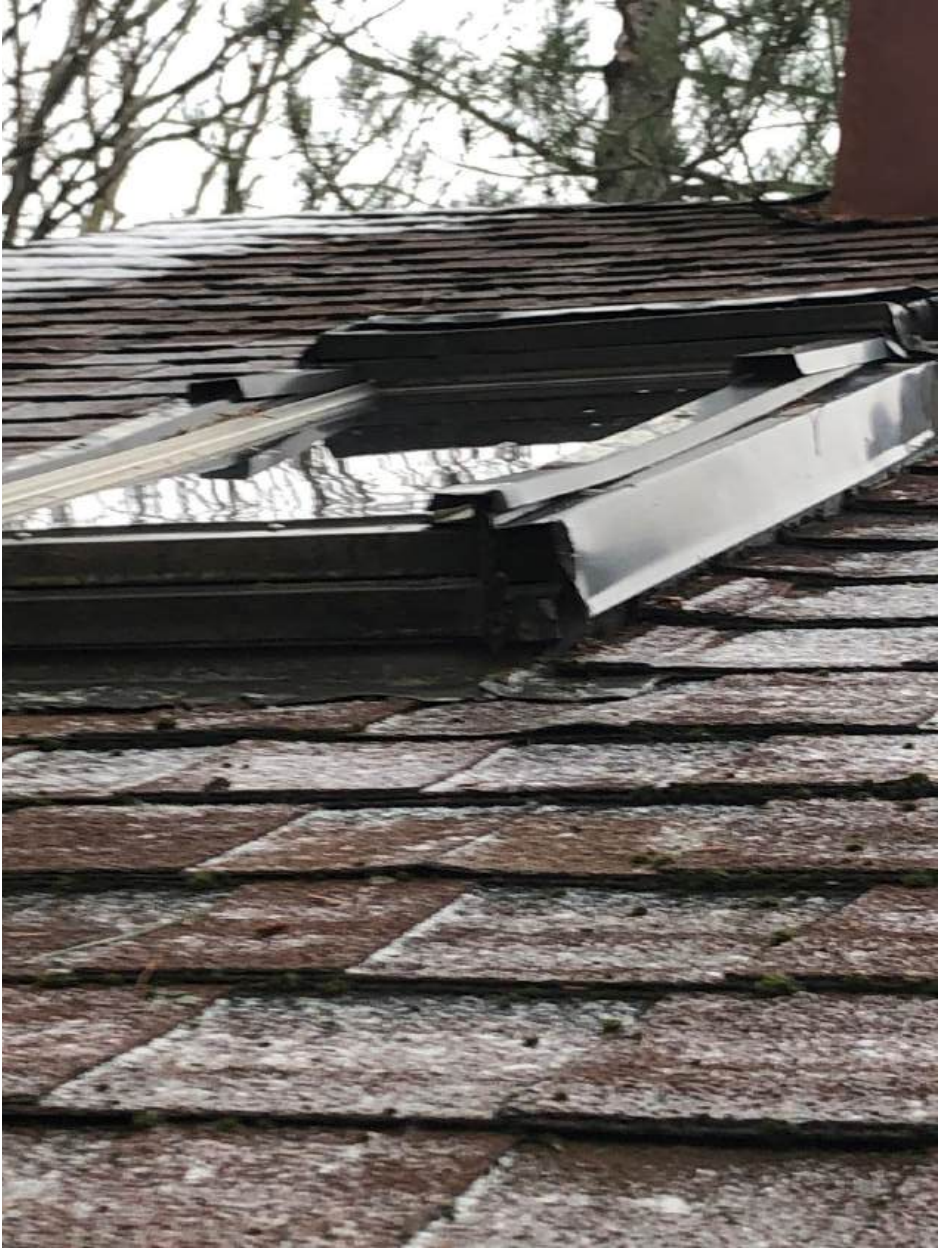
Work is also required at the metal caps at the skylights.

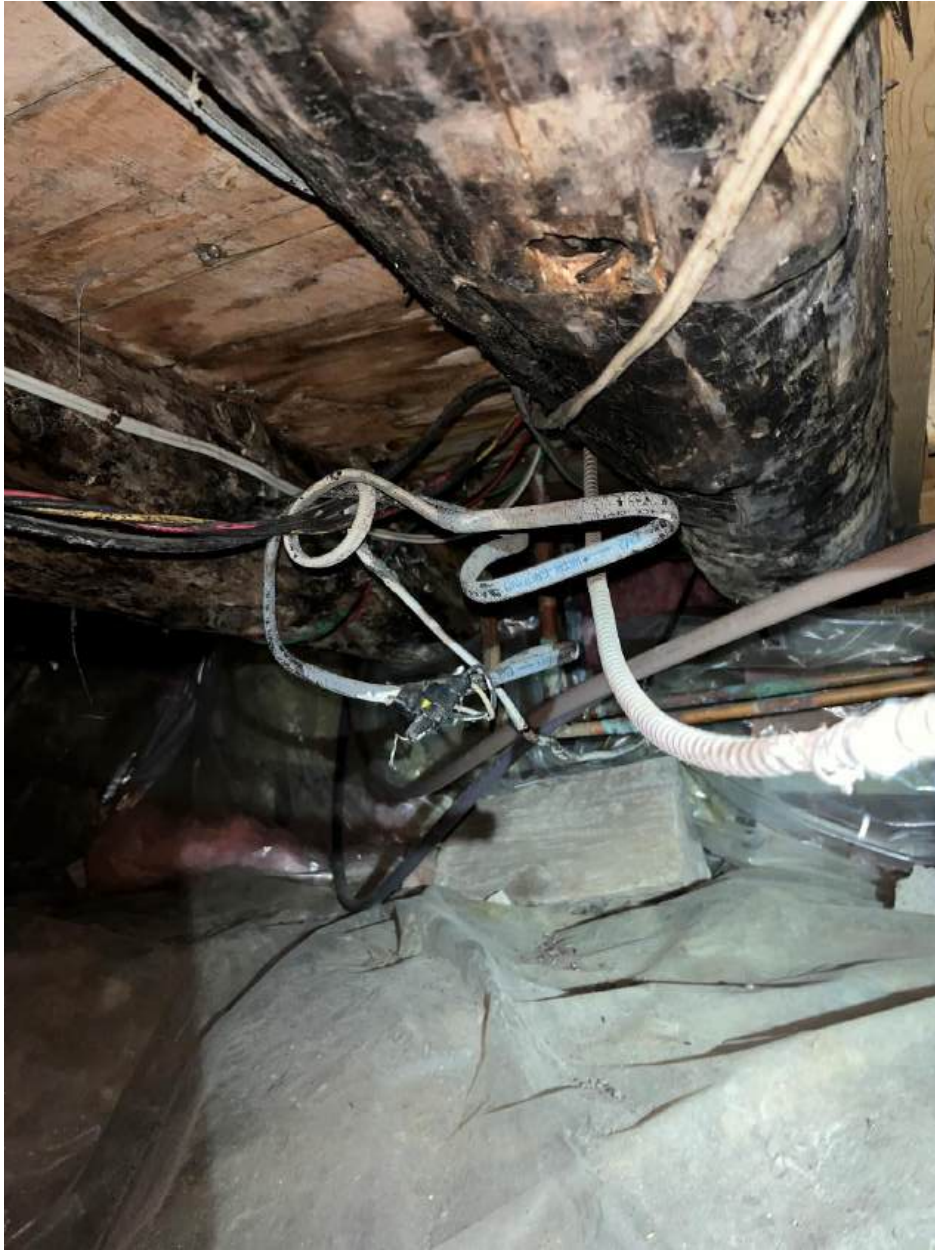
Some sloppy wiring requires checking/tidying in the crawlspace.

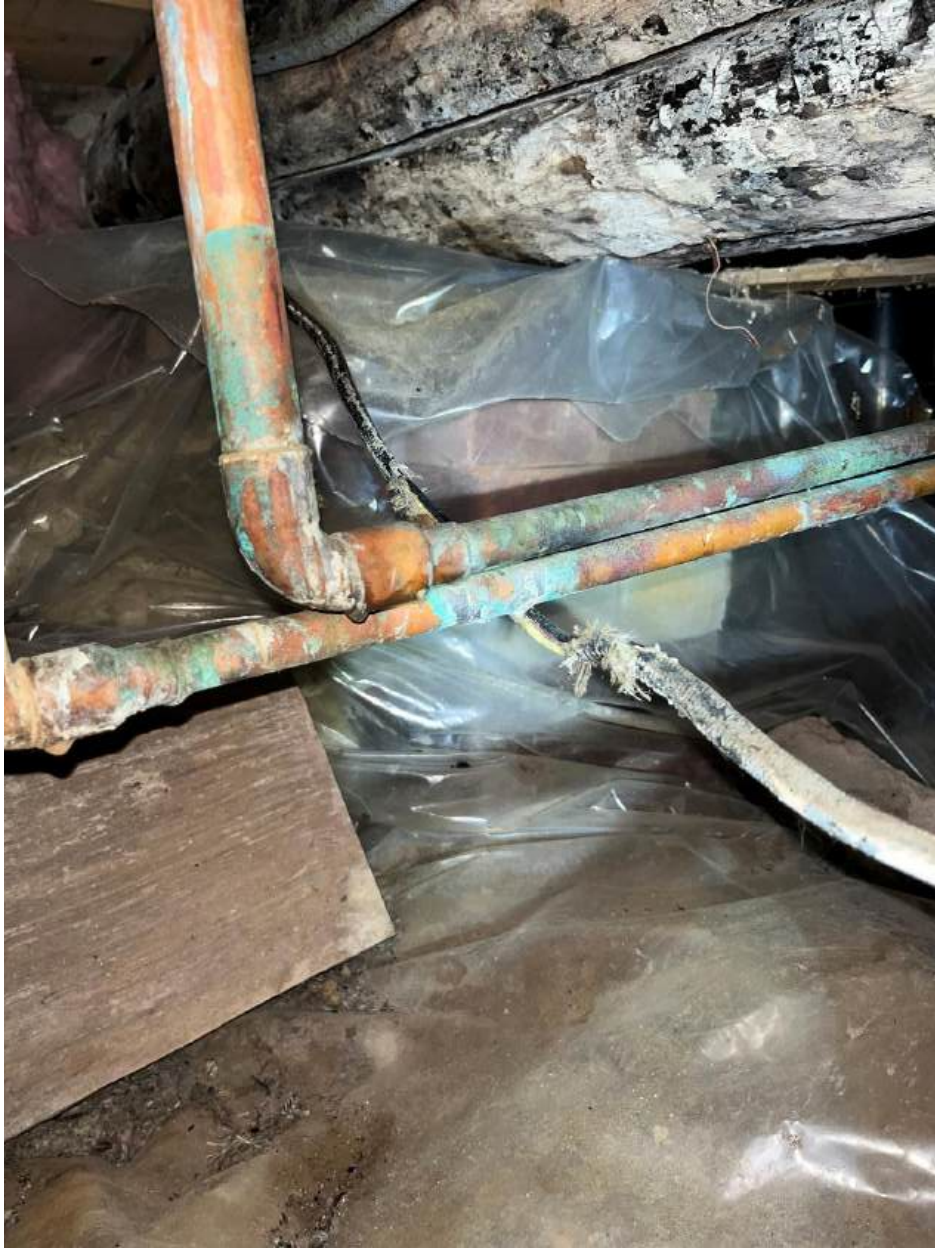
The sheathing at one location at a circuit at the front part of the right section of the crawlspace has failed due to contact with a hot water pipe. It should be repaired without delay. Also have all the older wiring inspected by the electrician when they are on site.

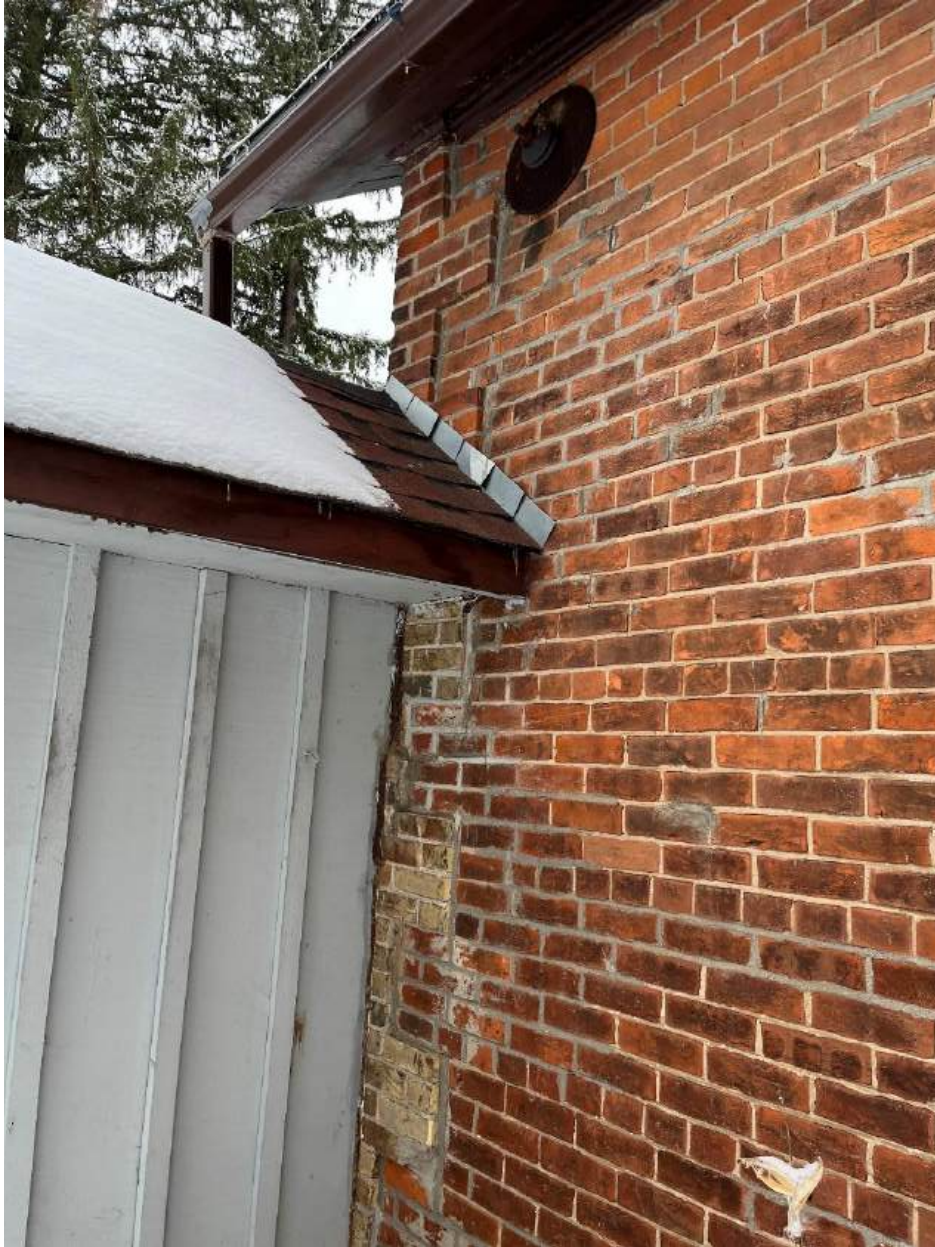
Various deficiencies were identified at the rear, attached shed, but it is to be removed anyway. It is important that all junctions where the shed meets the main structure be fully sealed without delay.

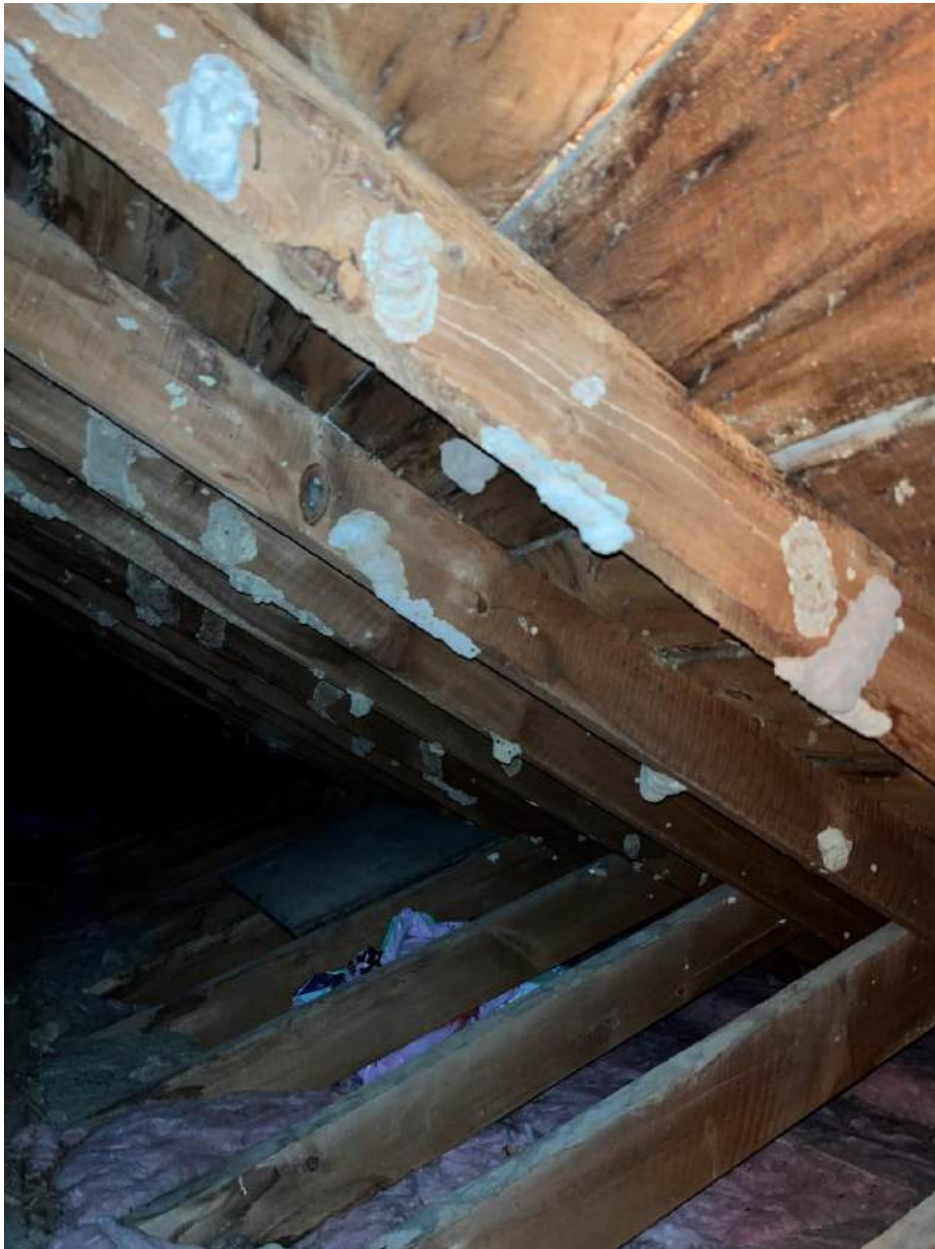
A plethora of bees nests were observed in the attic.

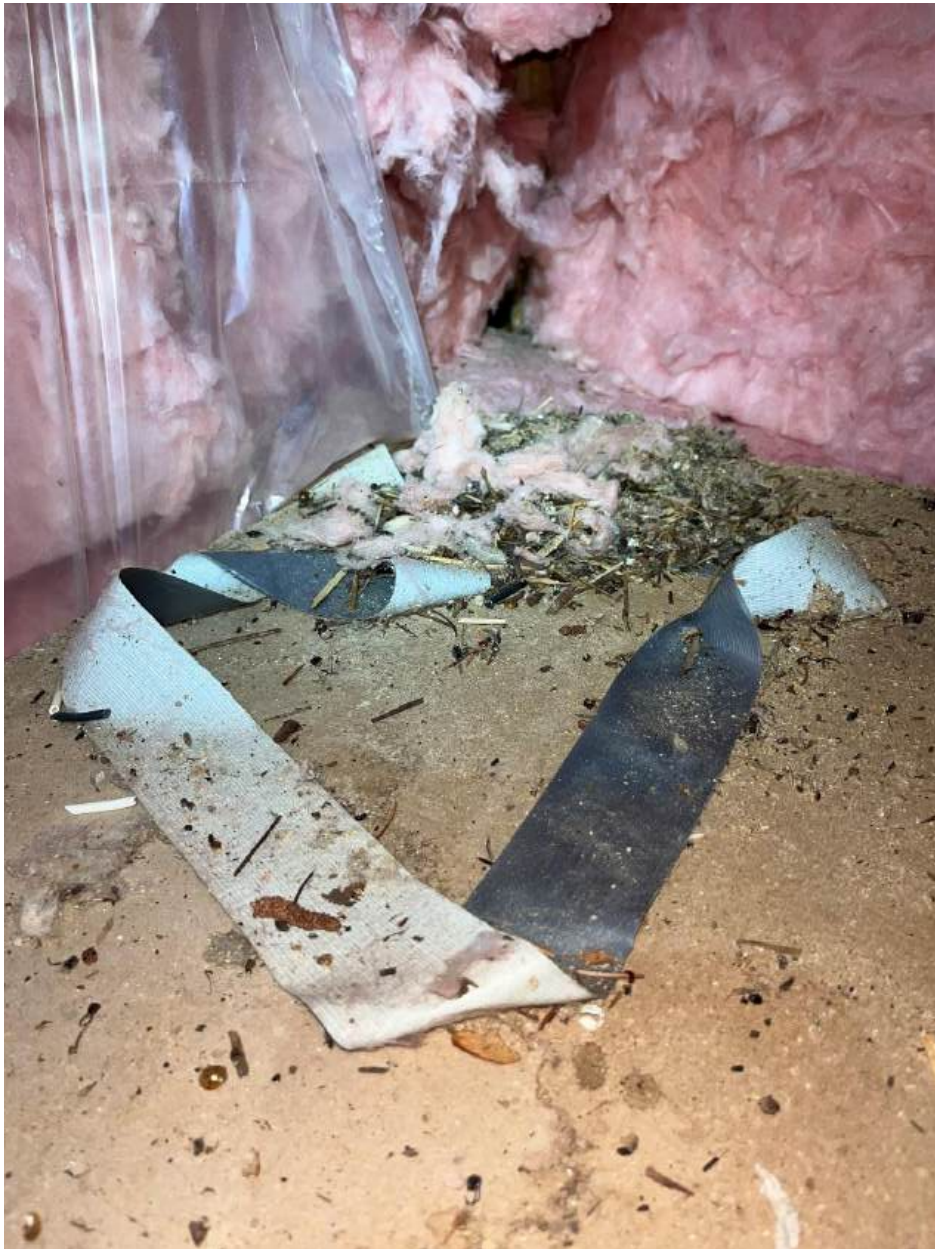
A small amount of bat guano was observed.

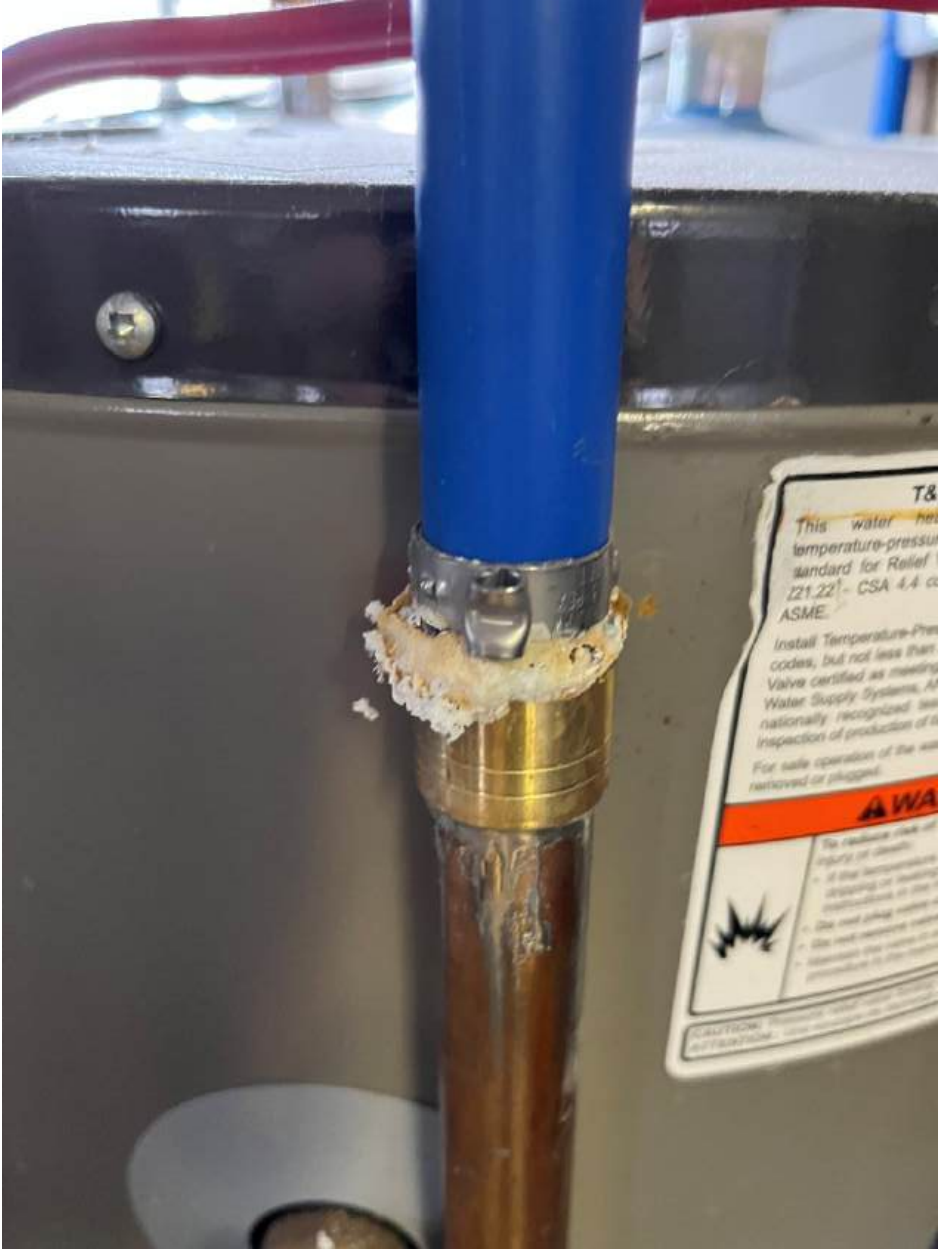
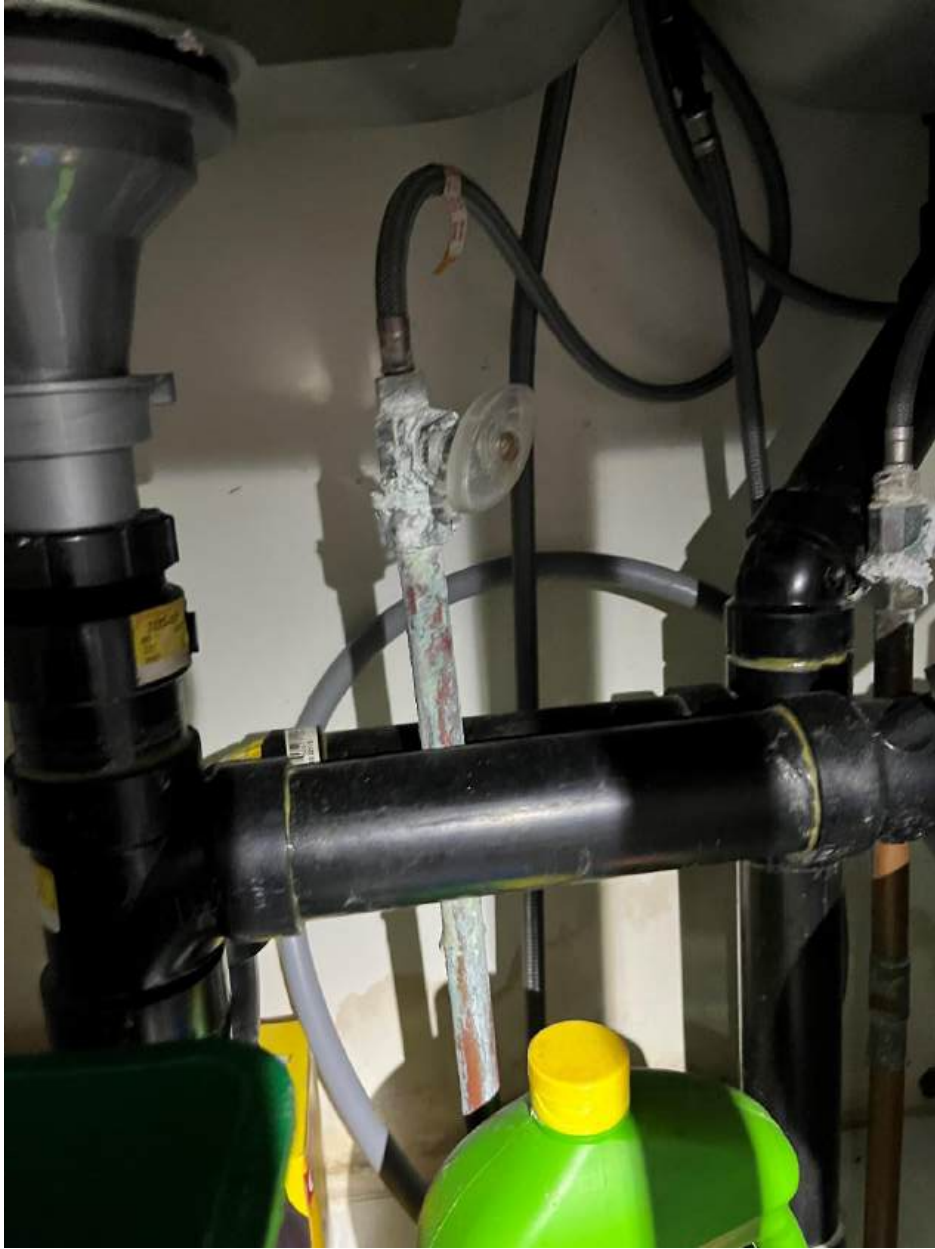
A couple of plumbing repairs are required, including at the main floor mechanical room, and under the kitchen sink.

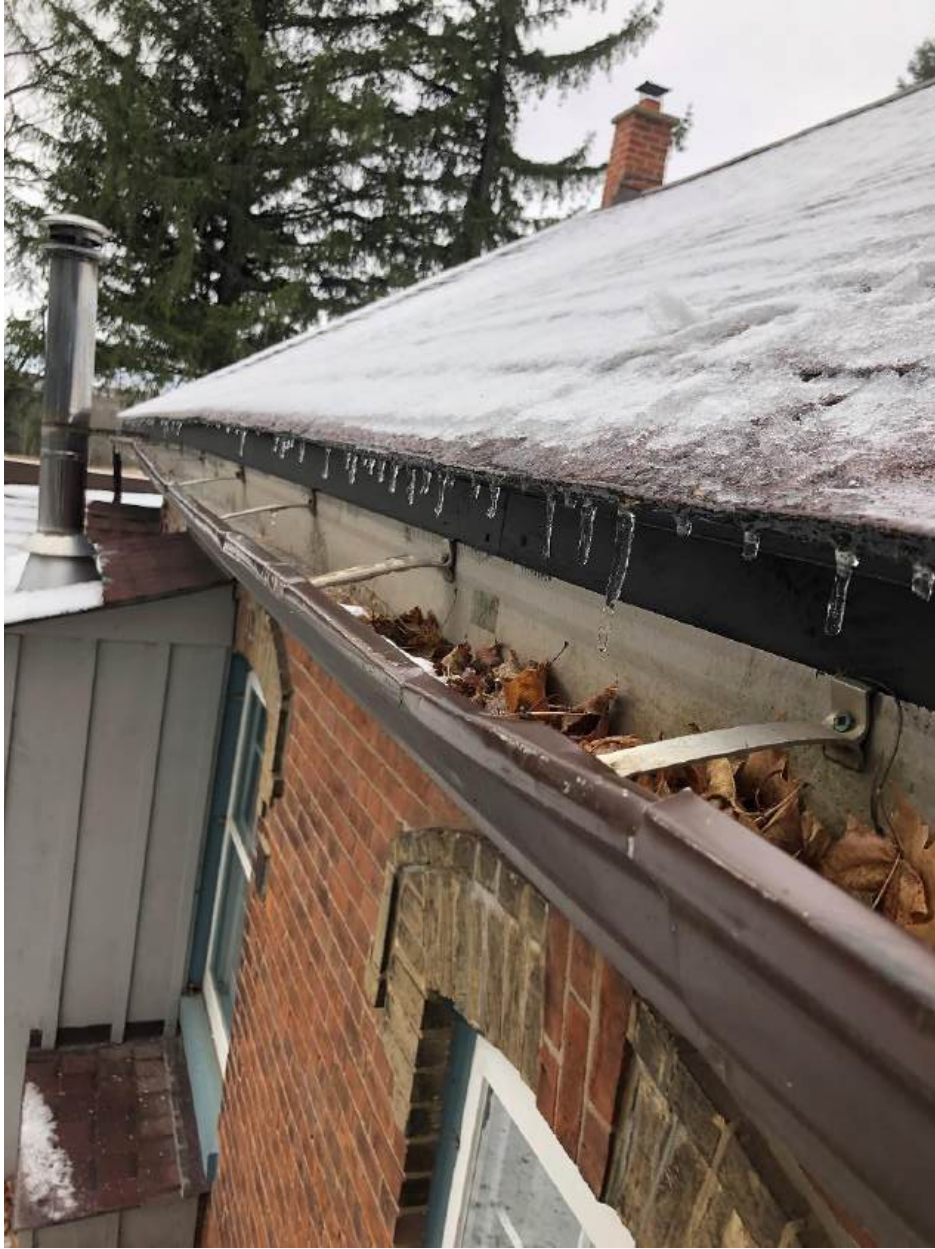
Some repair and additional fasteners are required at the eaves trough system.

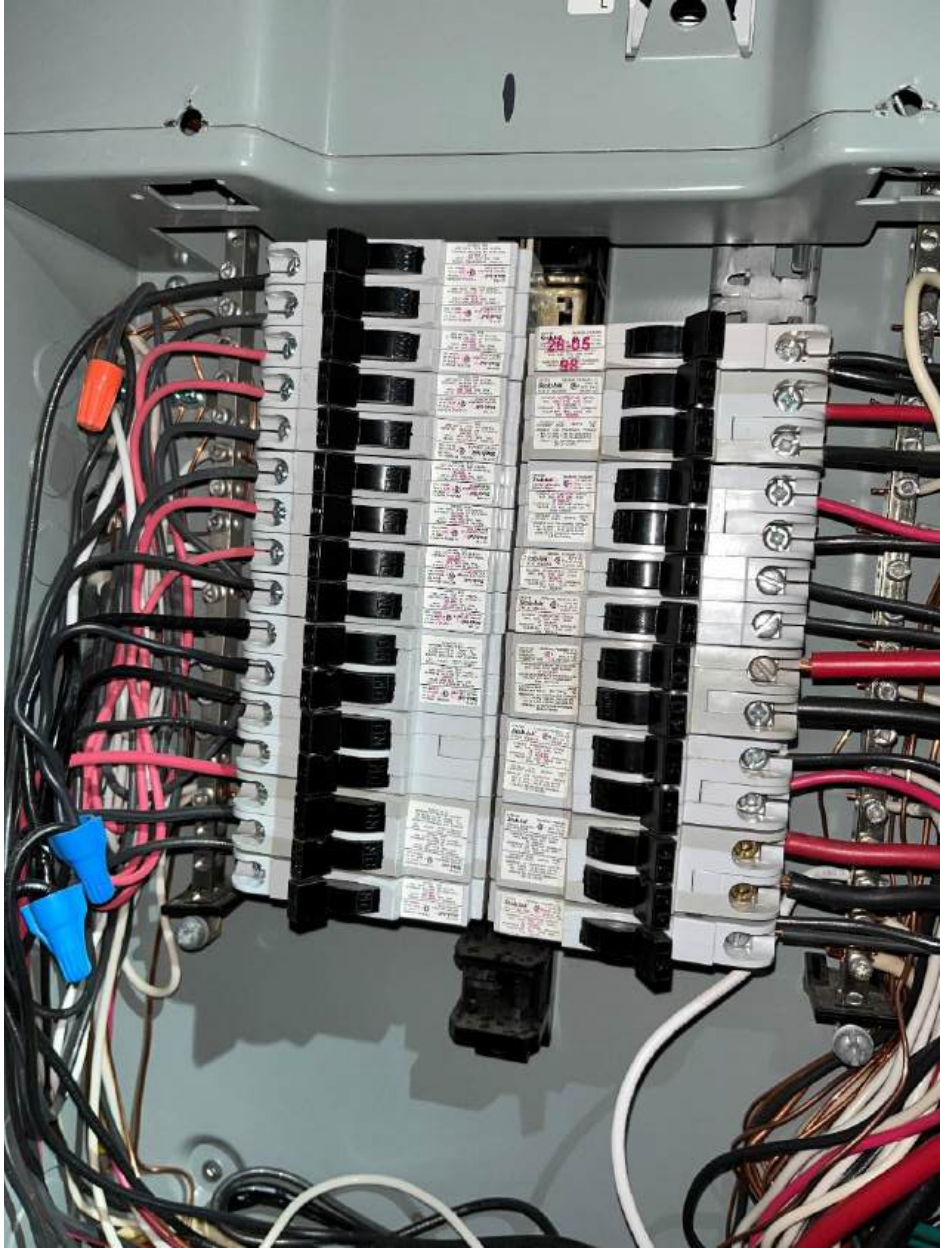
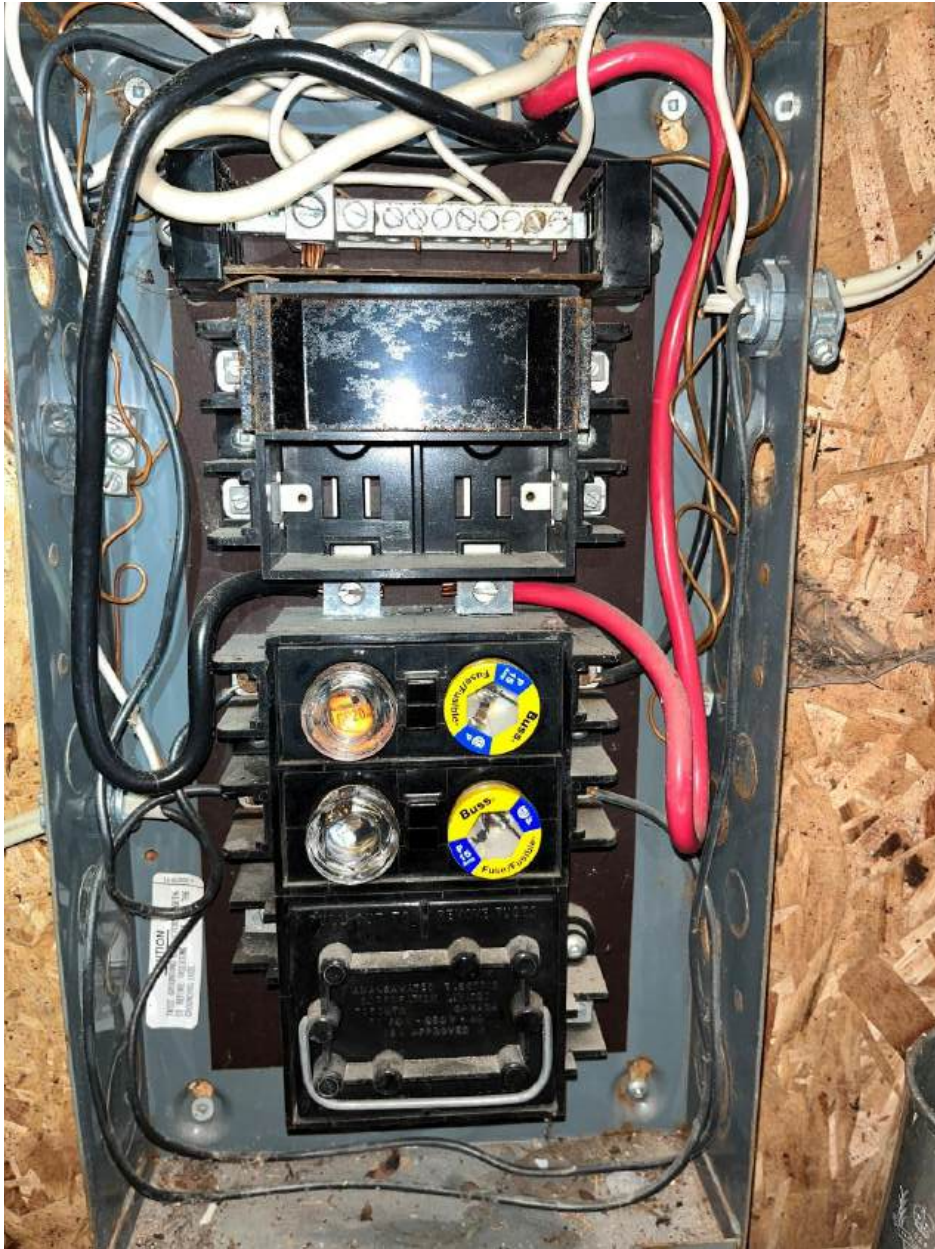
There are no hot spots in the panels.

Two contactors have been doubled in the main panel; provide dedicated breakers if desired, mostly for identification purposes.

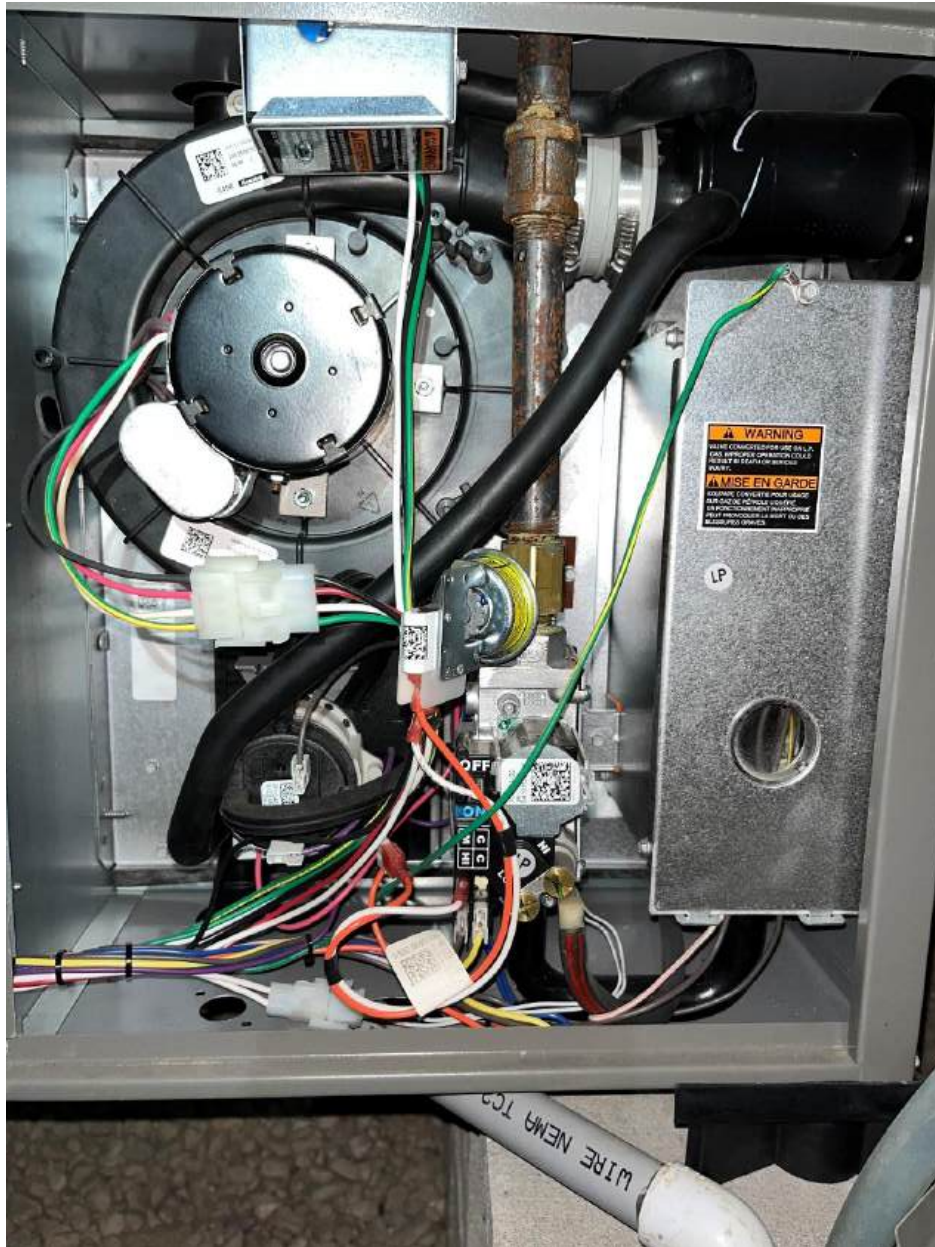
There is no significant corrosion inside the furnace.
