# SAFE HOMES CANADA HOME INSPECTION REPORT

## Tarion Inspection – First Year

**ADDRESS:** xx Mumberson Street, Cookstown, ON

**This inspection is a Tarion Warranty inspection for a new home.**

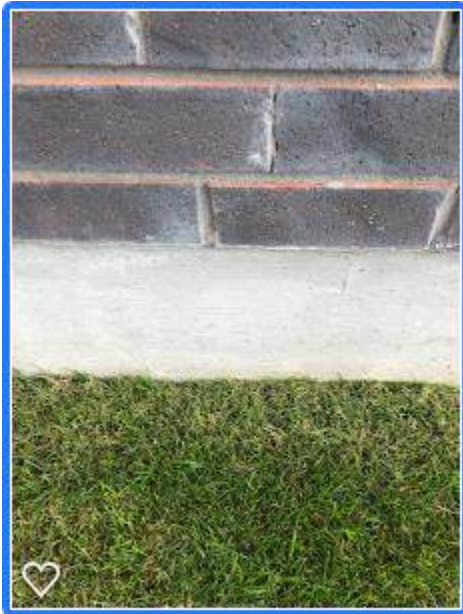
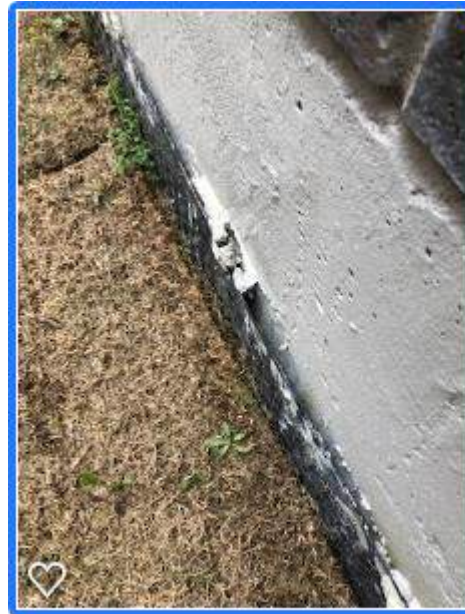
The poured concrete foundation walls are completely stable, as observable.

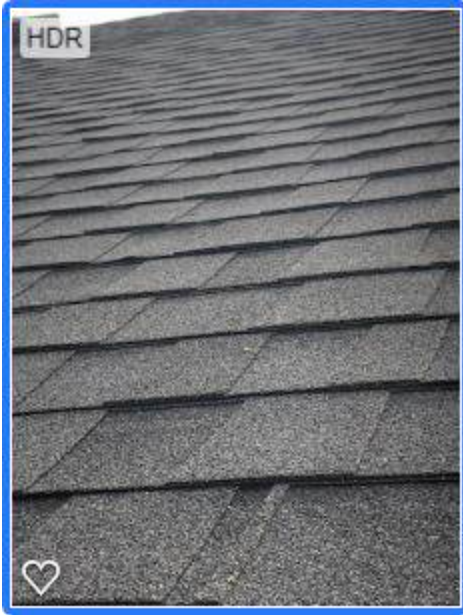
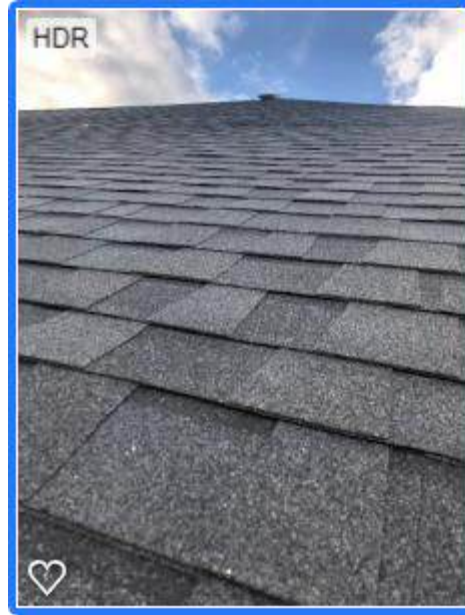
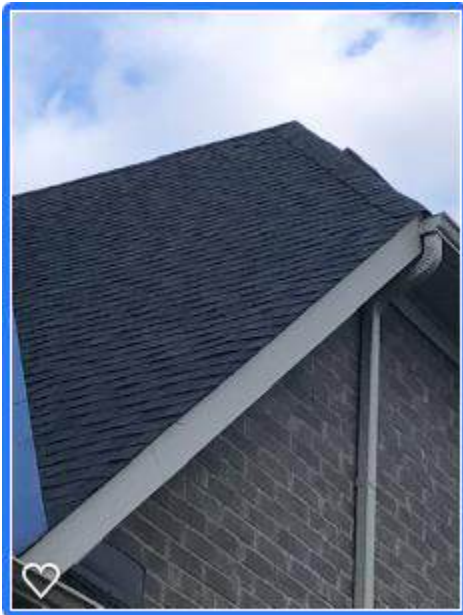
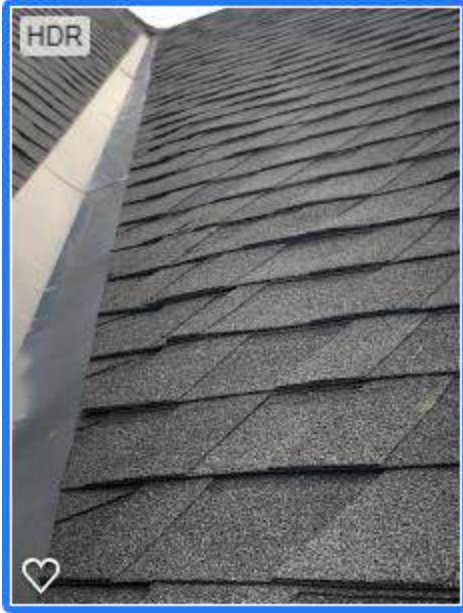
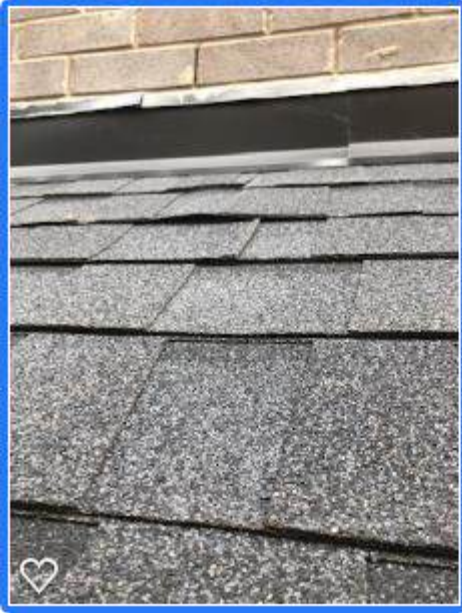
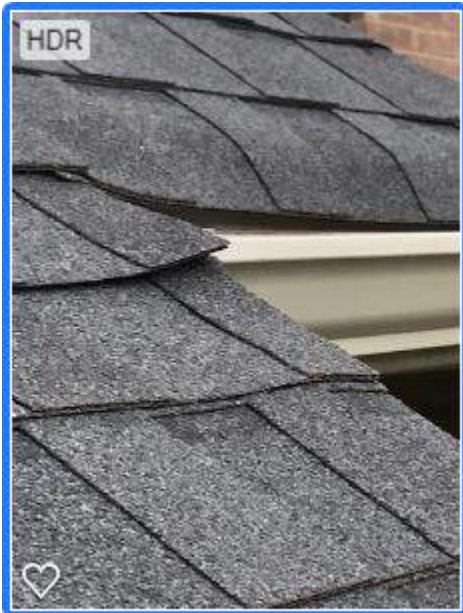
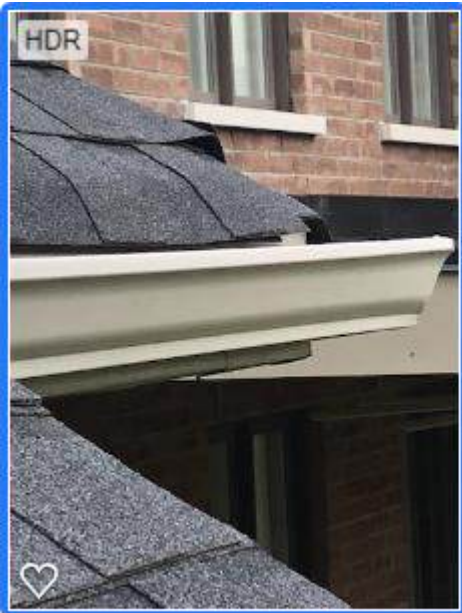
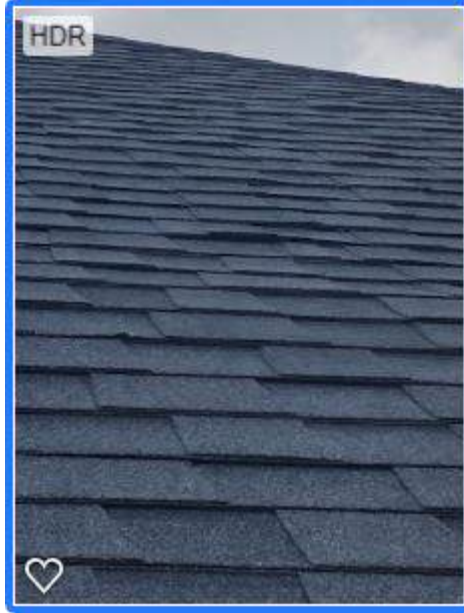
**Half a dozen or so nails were not fully sunk at the shingles.**

**The roofer should be invited to fully sink all nails to help prevent shingles from blowing off the roof.**

**All exposed nail heads must be fully caulked.**

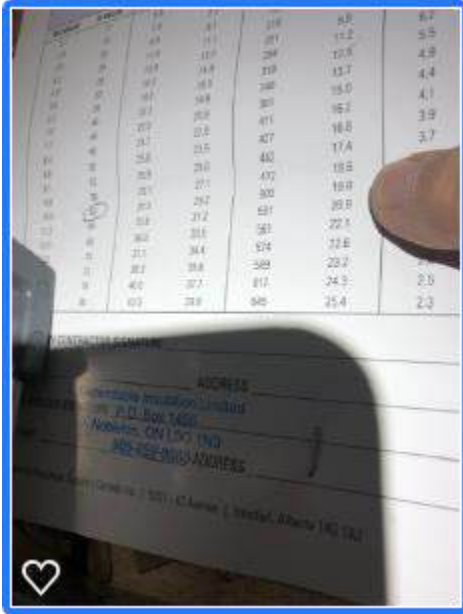
The current building code requirement is R60. The depth to provide that R value is approximately 20 inches.

Insulation is significantly lacking at much of the attic; that includes at the loose insulation and the batts that have been installed over cathedral assemblies.

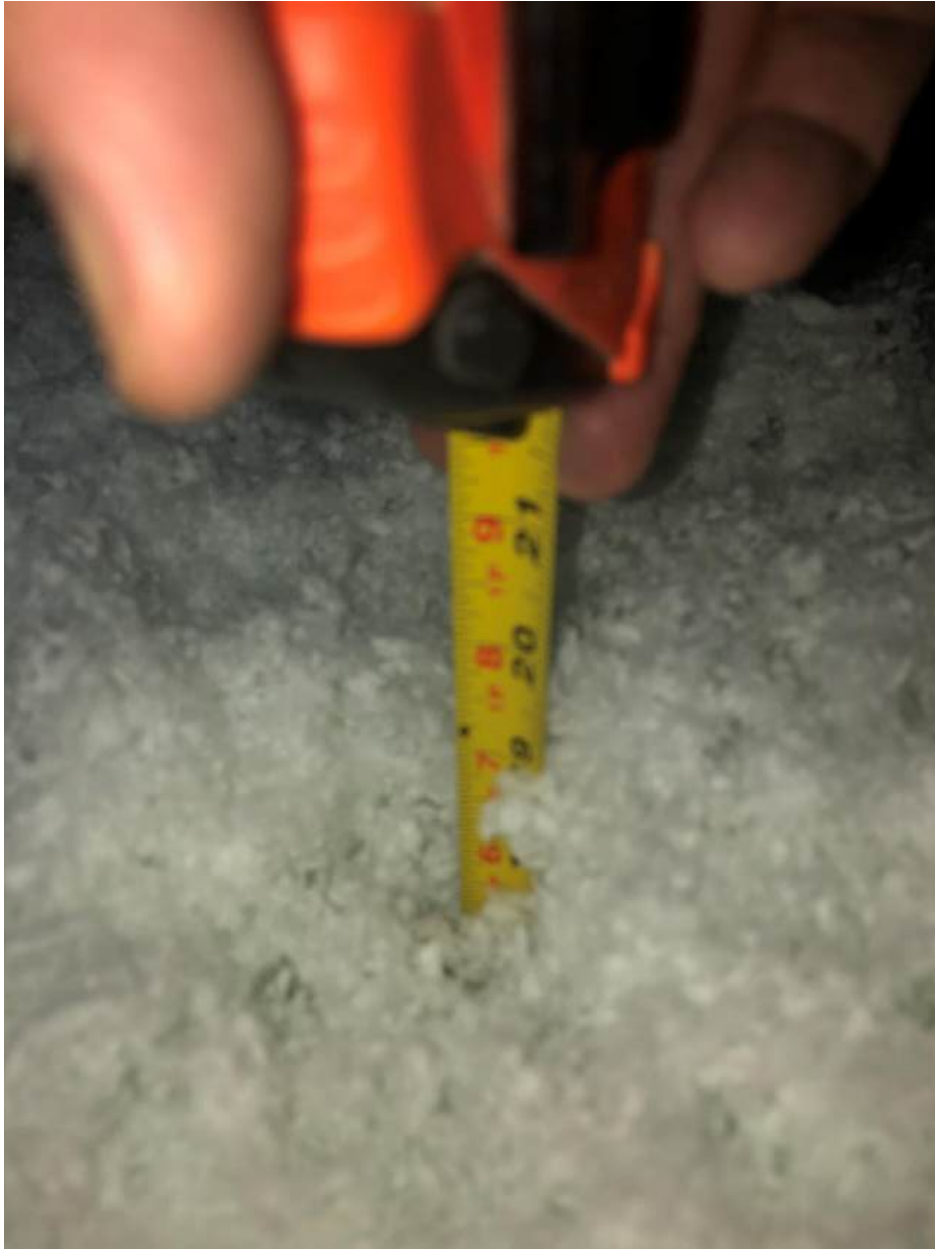
**A significant amount of insulation appears to have been added since the first inspection.**

**It appears to be the required 20 inches deep, or close to that depth, at most areas.**

**However, the insulation is a few inches low just rear of the access point in the rear attic; it should be topped up there.**

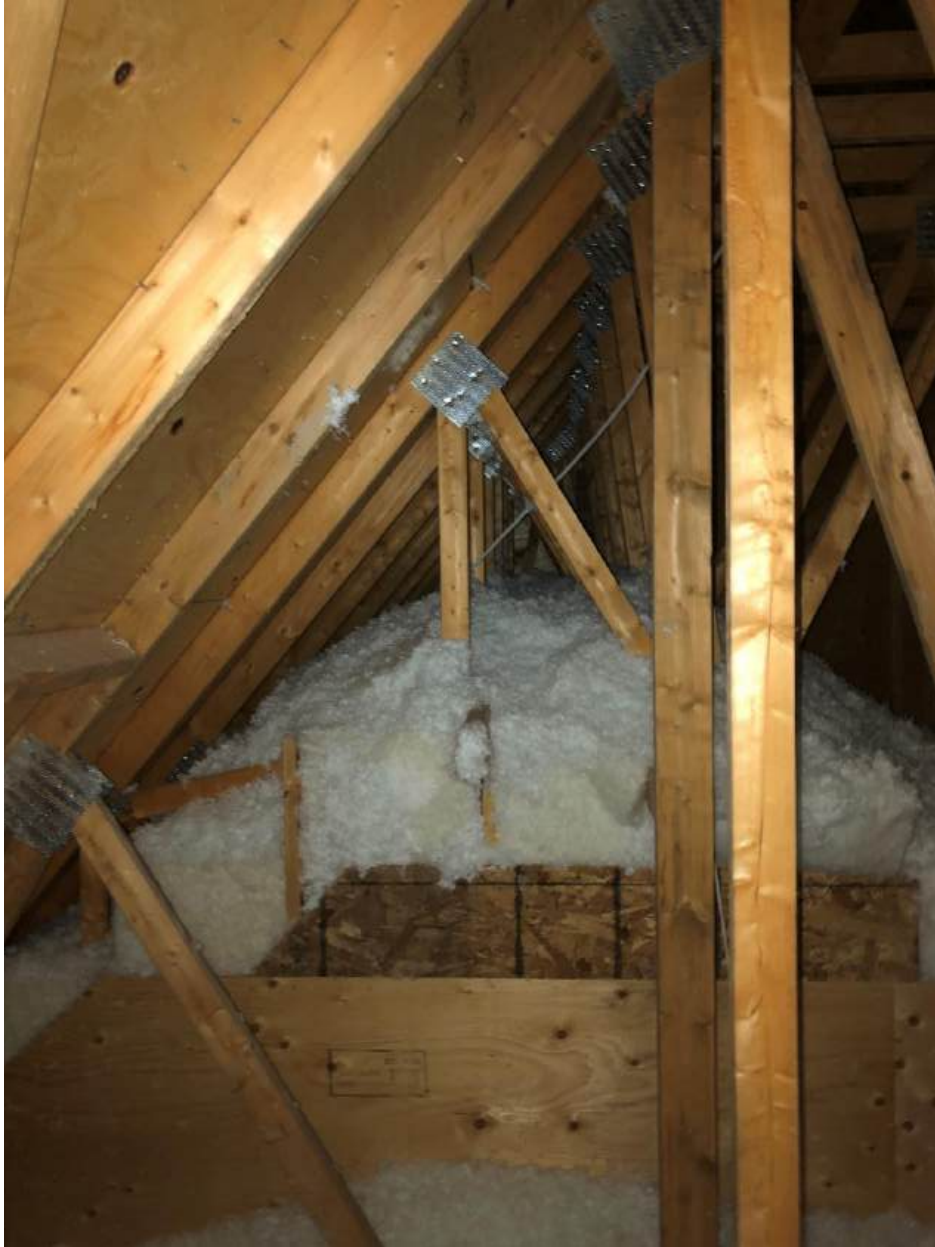
The following photo shows that insulation has been added above the cathedral assemblies.

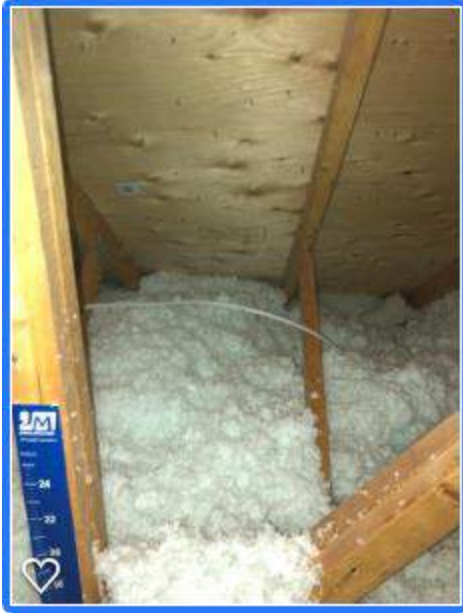
**Ventilation is lacking at the soffit level. The builder should be invited to add soffit baffles so the ventilation complies with the building code requirement.**

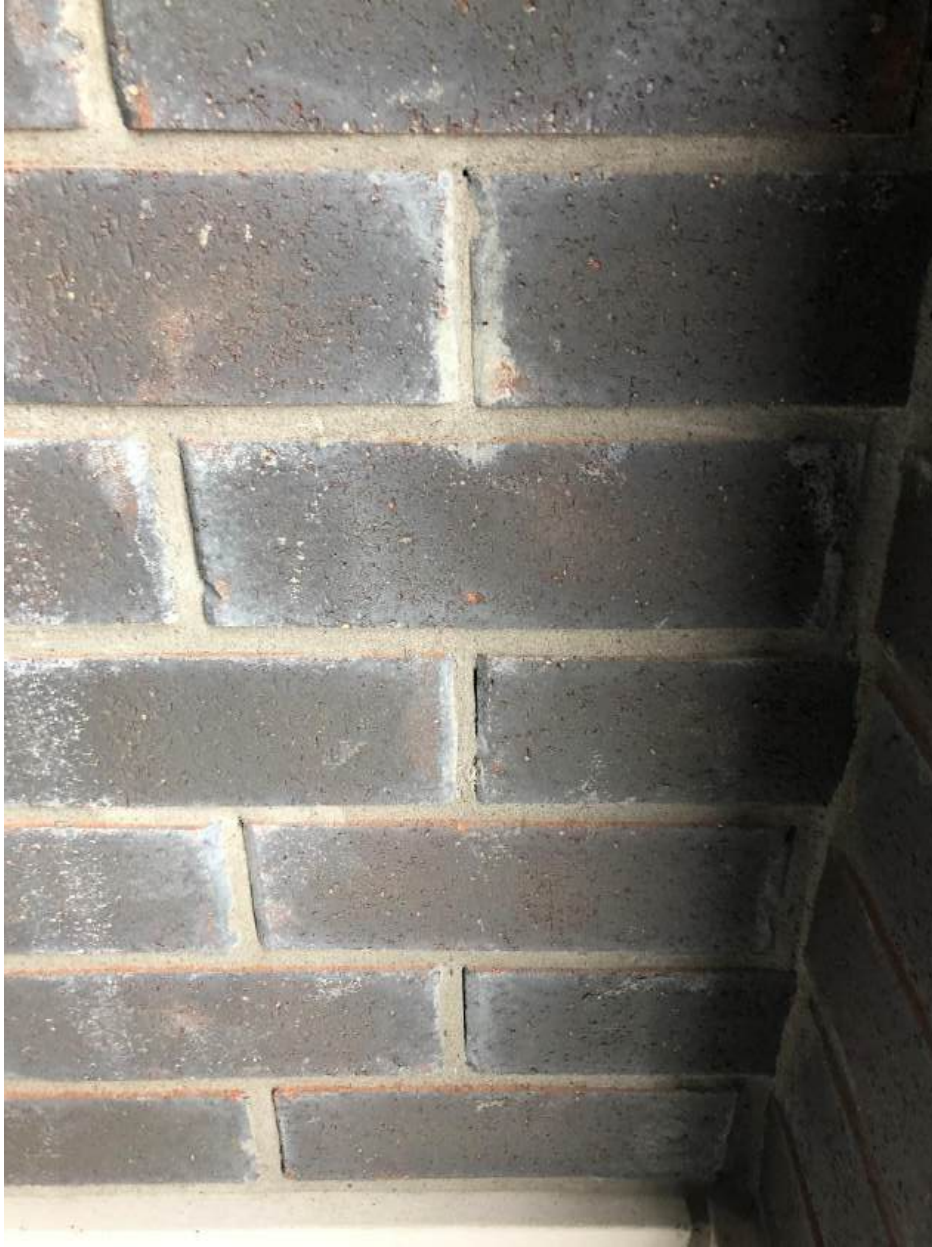
There are no significant settlement/stress cracks at the brick masonry system. One or two possible, very minor cracks are observable.
