# **SAFE HOMES CANADA HOME INSPECTION REPORT**

**ADDRESS:** x Lavender Hill Road, Dunedin, ON

**DATE:** December 12, 2022

**AGE OF HOME:** 120 years (approximately)

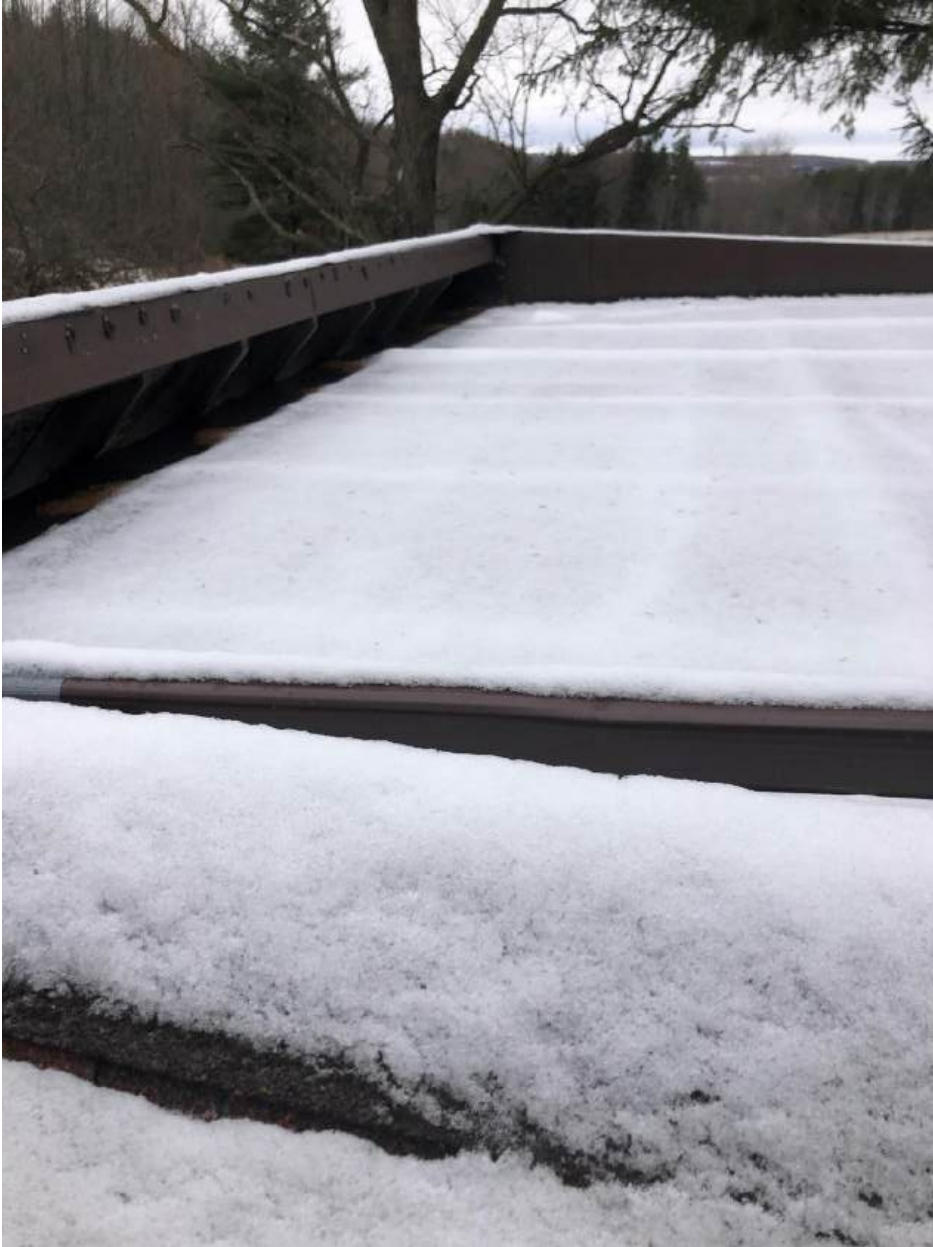
As seen above, much of the roof surface was not observable due to snow and ice. That includes the shed roof. Note that the shed is to be removed by the buyer anyway.
